**ISSUE 57 Aug/Sep/Oct 2007**

## 12-VALVE DOWEL PIN COMMON-SENSICAL SOLUTION (and 24-VALVE?)

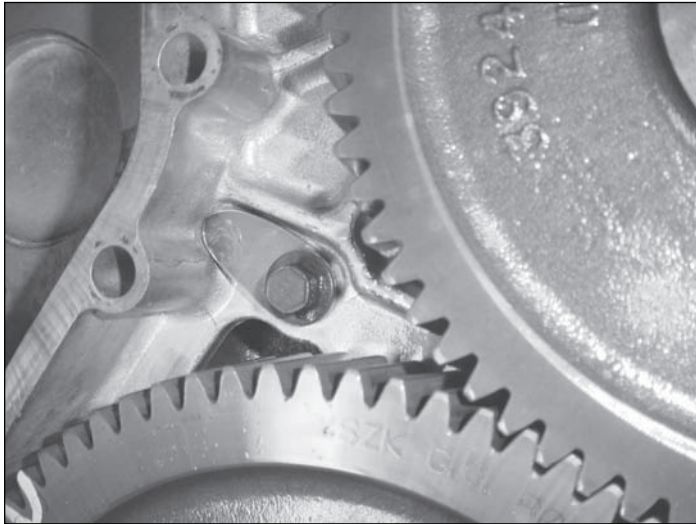
Above is a picture of an egg-shaped washer that is the TST solution to the problem.

- 13) Lucky step 13! Time to install the special egg-washer, preventive maintenance part. Locate the 10mm bolt next to the dowel pin and remove it, reinstall the longer bolt using the special washer supplied in the kit. This washer will prevent the dowel pin from backing out. Apply Loctite high strength (red) thread locker to the threads and torque the bolt to 18 ft-lbs.
