THIRD GENERATION SUSPENSION UPGRADES: PART THREE

by Doug Leno

In this article I will describe my repair of the factory steering linkage system and discuss my choice to upgrade to the newest factory design.

BALL JOINT REPLACEMENT

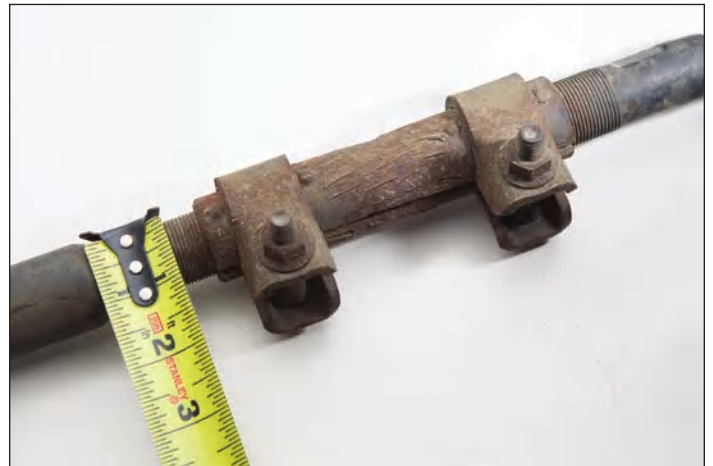
Beyond the geometry differences themselves, the new T-type steering system provides additional stiffness and stability via larger diameter tubes, 1.5" versus 1.25", compared to the older Y-type system (see figures 6 and 7). This made the decision to upgrade easy. Because the job would be a simple one, I decided to perform the upgrade myself.

Figure 6: My tape measure shows the 1.25" diameter steering linkage tubes used on the 2003-2008 "Y-type" steering system that I replaced. The newer "T-type" system uses larger 1.5" diameter tubes.

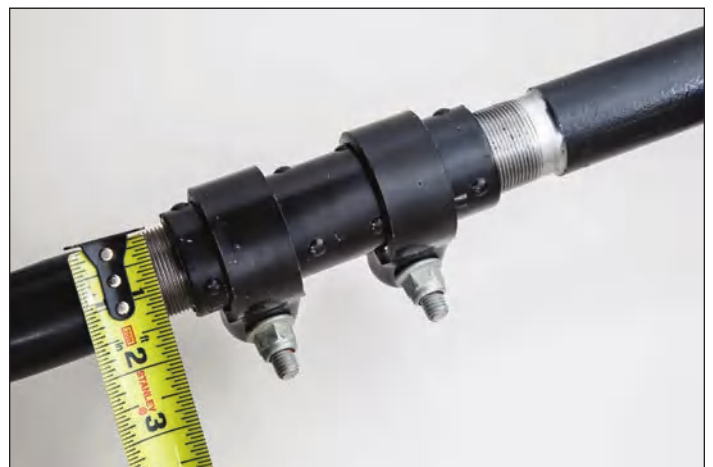
Figure 7: T-type steering system is made with 1.5" diameter tubing, and is considerably more robust than the older, Y-type steering system. The new system is over five pounds heavier.

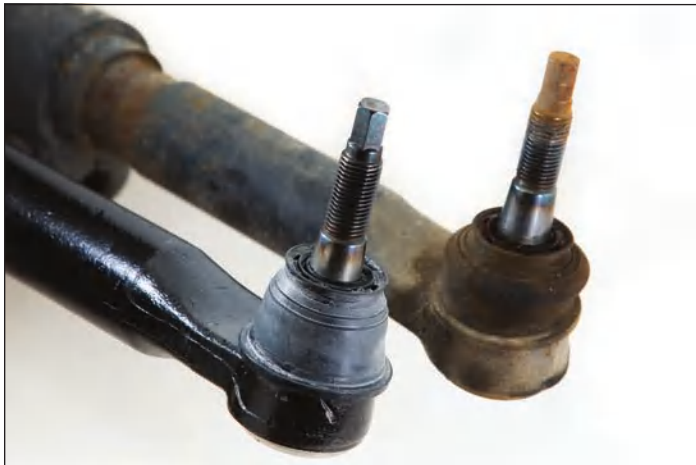
The left tie rod ball stud on about 264,000 of the above vehicles may fracture under certain driving conditions. This could cause loss of directional control and/or crash without warning.

N49 is a comprehensive recall: All 2008-2012 vehicles equipped with T-type steering systems are updated with a newer T-type steering linkage at factory expense. What was wrong with the parts that are replaced under the N49 Recall? I contacted my dealer, who was (understandably) unable to give me any information beyond N49 itself (stated above).

Figure 10: I found no difference between "good" and "recalled" tie rod ball studs, the subject of N49. On the left is a verified "good" part which I installed on my truck. On the right is a recalled part from my dealer's boneyard.

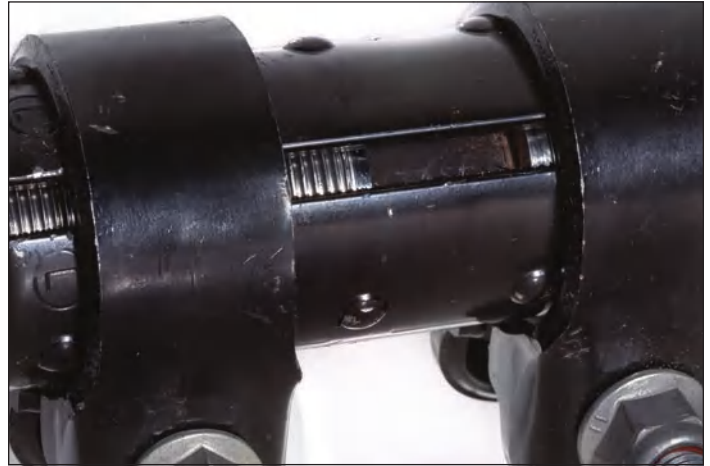
After further investigation I found what I believe to be the real reason for the recall: The recall does not appear to address the ball stud itself; it addresses the probability that a careless alignment technician might pre-stress the left-side ball stud during toe adjustment! If you carefully inspect figure 11, you will see the update: The newest tie rod has an internal mechanism to prevent the right-hand tube from rotating along with the toe adjustment collar. The older (recalled) tie rod has no such mechanism, as you can see in figure 12.

Figure 11: The adjustment collar on the newest T-style steering system. Note the inner mechanism in between the two threaded halves. This prevents the right hand tube from rotating along with the adjustment collar.

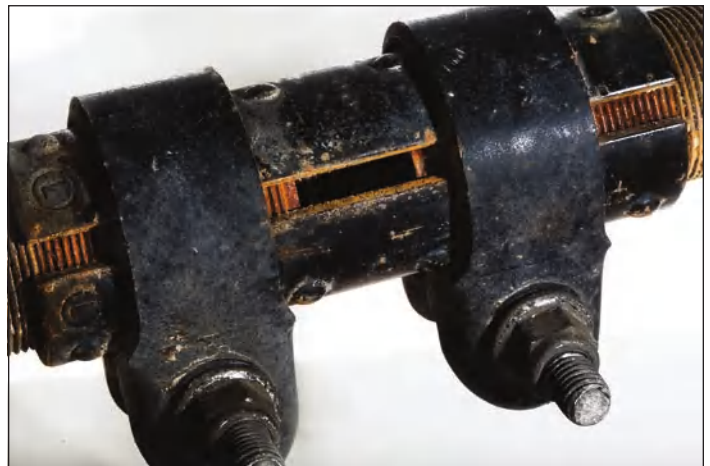
It addresses the probability that a careless alignment technician might pre-stress the left-side ball stud during toe adjustment!

Figure 12: The older (recalled) system allowed the right hand tube to rotate along with the adjustment collar, allowing a careless technician to pre-stress the ball stud inside the steering knuckle.

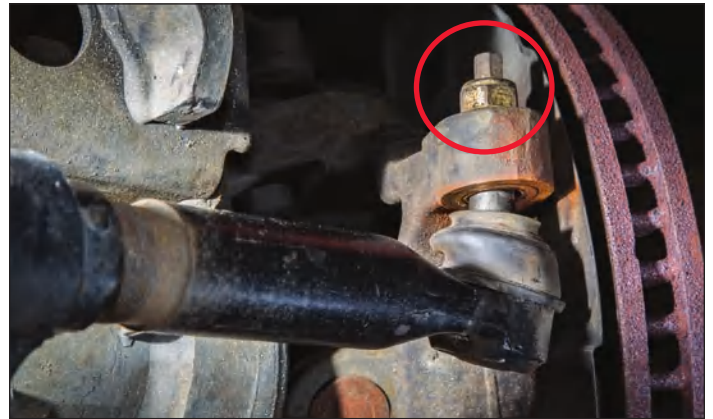
Figure 8: Dropping the old Y-type tie rod from the driver-side steering knuckle. The nut in this photograph (circled) is only partially removed.

After removing the Pitman arm from the steering box, the entire system can be removed by loosening the nuts on the left and right ball studs (see Figure 8).

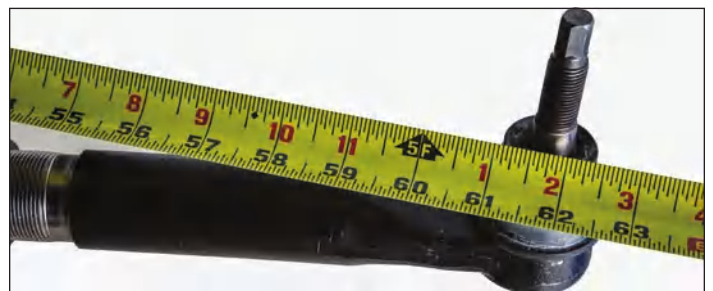
Figure 9: pre-adjusting the length of the new tie rod before installation.

Although most of us rely on alignment shops to check or perform the adjustment, our Turbo Diesels are easy to align, even in a home garage. "Total Toe" is the only adjustable alignment parameter, determined by the length of the tie rod set via the adjustment collar. This meant I had to set "Total Toe" myself, at least initially. Rather than measure the parameter directly on the vehicle, I decided to pre-adjust the length of the new tie rod to match the length of the old one (see figure 9), and then go to an alignment shop for final adjustment. It turned out my pre-adjustment was only 1/32" off!

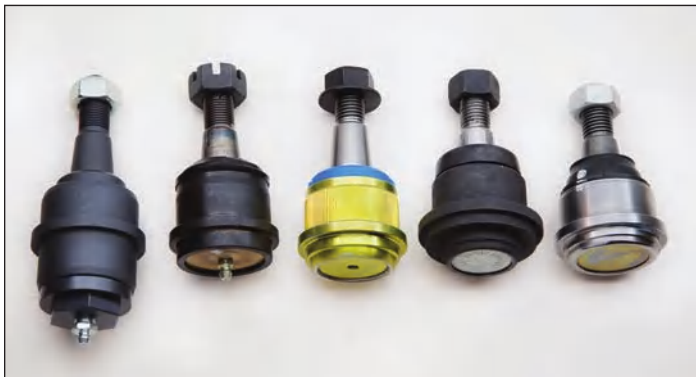
Figure 1: from left to right: Upper ball joints from Carli Suspension, Moog, Napa, Duralast, and Mopar. Some are smooth, some are knurled, some have a grease zerk, and some are sealed. The Zerk on the NAPA part in this photograph has not yet been installed.

Two characteristics were immediately apparent. First, note that the ball joints from Carli Suspension, Moog, and NAPA are outfitted with a grease zerk, while those from Duralast and Mopar are not. Secondly note that some parts are knurled, while others are smooth. In a surprising twist, I found that the two Moog parts supplied by my local O'Reilly Auto Parts store had different body textures: The upper ball joint (shown in figure 1) was smooth while the lower ball joint (see figure 2) was knurled. Both were supplied in identical boxes labeled "Moog Problem Solver."

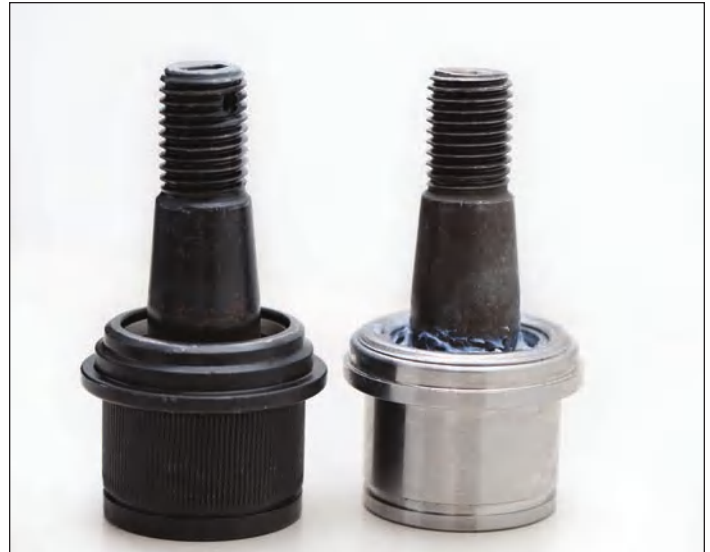
Figure 2: Lower ball joints from Moog (left) and Mopar (right). The Moog "problem solver" part supplied by my local O'Reilly Auto Parts store has a knurled body.

As you can see, the Carli Suspension ball joints were the only ones in my test group matching factory specifications, in both body size and surface type. The locally available parts from O'Reilly, Autozone, and NAPA all measured a few thousandths of an inch larger than the factory parts. The NAPA and Moog parts combine an oversize body with a knurled surface.

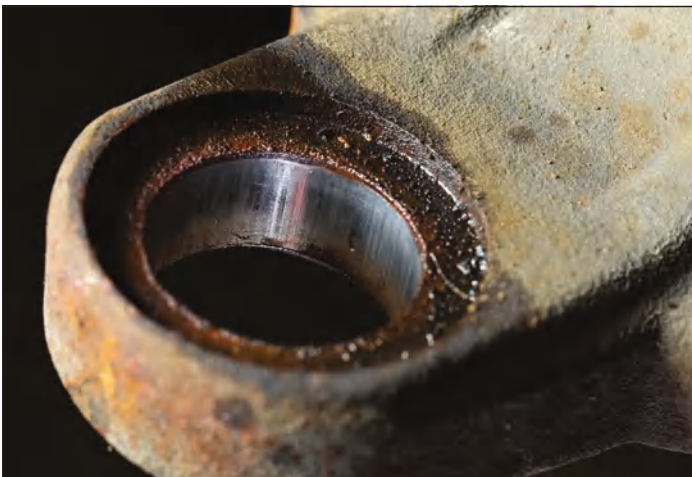
Figure 3: The smooth lower ball joint knuckle bore on my Turbo Diesel. I decided not to install a knurled or oversized part, in order to preserve the factory bore as long as possible.

- If the factory knuckle bore is not damaged it is best to choose replacement ball joints that match the factory supplied parts as closely as possible in surface finish (smooth) and in diameter (not oversized).

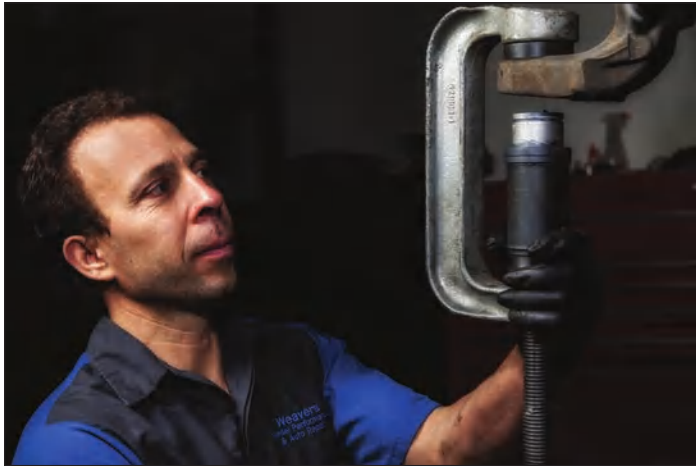
Figure 4: Raymond Driggs at Weaver's Diesel Performance, installing my lower left ball joint.

I made the choice to have Carli Suspension ball joints installed in my Turbo Diesel. For the installation work itself (see figure 4), I returned to Weaver's Diesel Performance in Dalton Gardens, Idaho—the same shop that installed my Carli Suspension “Backcountry 2.0” Kit, described in Issue 77. The photo in figure 5 shows the installed lower ball joint, with the accessible grease zerk.

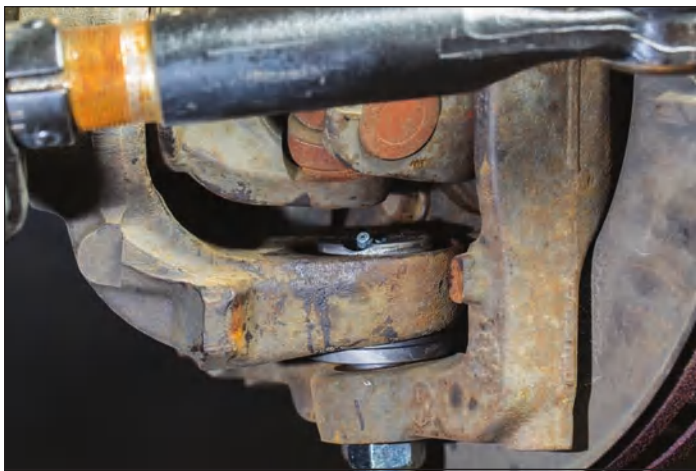
Figure 5: The Carli Suspension Lower Ball Joint, installed at exactly the right position so that the grease zerk is accessible.

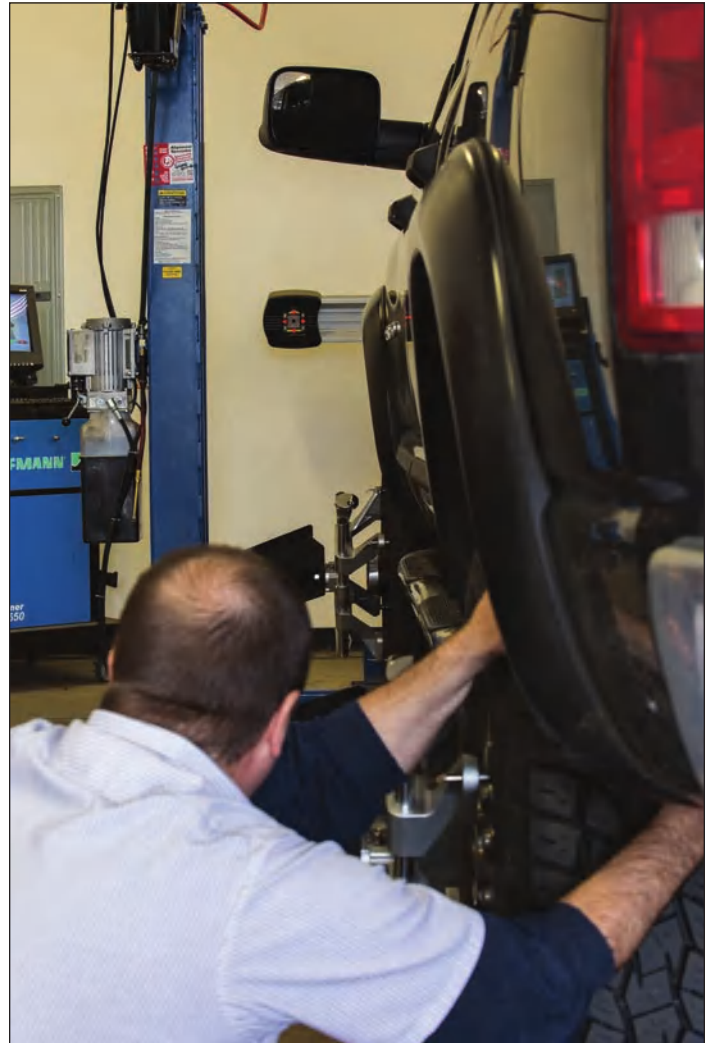
Before heading to the alignment rack, Troy Hocking, the shop owner, first drove my truck to see how the new ball joints felt in the steering wheel. A Turbo Diesel enthusiast himself, Troy wanted to see if he could detect any “return steering” binding or other issues that could be caused by faulty or improperly installed ball joints. Once everything checked out, we headed to the alignment rack to adjust the toe. All the non-adjustable alignment parameters were well within factory specifications.

Figure 6: Four wheel alignment in progress at Auto Works automotive repair in Coeur d'Alene, ID. In this photograph, Troy Hocking is rolling my truck back and forth several inches at a time, to check wheel runout. All parameters including camber, caster and caster sweep, checked out.

Changing the upper and lower ball joints can influence a number of important alignment parameters, such as camber, caster, and caster sweep; so I decided to have a four wheel alignment performed. I took my truck to Auto Works, a family owned automotive repair shop in Coeur d'Alene, ID (see figure 6).
