What's Wrong With My Truck?

GENO'S
GARAGE

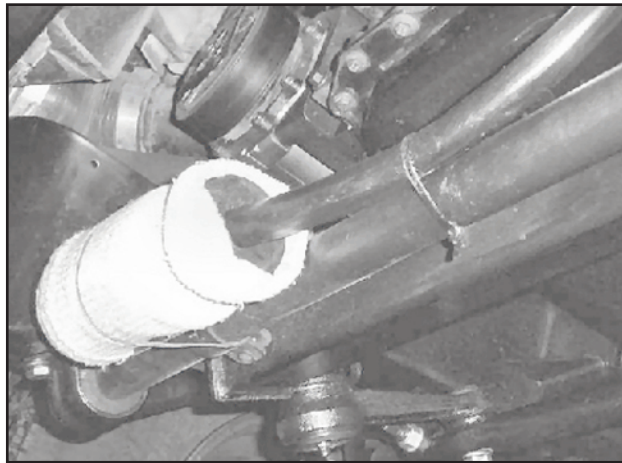
Flaw: My truck's dripping oil.

Fix: Until the introduction of the '07.5 truck and the new 6.7-liter engine, all Cummins 5.9-liter engines were positively vented to the atmosphere by a breather tube. The oil would drip out the bottom of the breather tube. When Second Generation trucks came out, this problem also resulted in a lot of erroneous front differential yoke seal replacements because the engine oil (not differential fluid) dripped down in the same area. Of course, if Dodge hadn't moved the differential to the left side, this problem wouldn't have existed. Most people simply put a small bottle with holes in the side on the bottom of the vent tube. It could still "breathe" but the oil was trapped in the bottle.

The old cotton sock idea is an easy fix with no drips or oily film on anything but the outer sock. Replace the sock while you are under the truck changing oil. Extend the tube and drip catch bottle down to the anti-sway bar and secured it with a couple of wire ties.

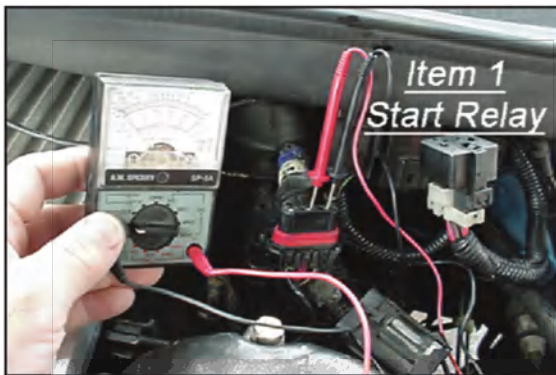
Flaw: Shut-down solenoid is shut down.

Fix: The fuel shutdown solenoid on '94-'98 12-valve trucks has caused its fair share of difficulties, leaving trucks that won't start, won't stay running, or won't shut off. In some cases a "manual" approach to fixing it (much like tapping an old starter solenoid with a mallet), might get you home. The usual suspects to make the repair: the start/run solenoid; the relay to the solenoid; the fusible link that protects the solenoid; or fuse #9 in the fuse panel. An alternate method is to delete the start/run solenoid and replace it with a cab controlled cable to move the fuel shut-down arm. This also makes a fine theft deterrent for the vehicle. Adjustments and replacements are do-it-yourself operations.

No voltage for "START" tells you to check the relay to the solenoid (Item 1).

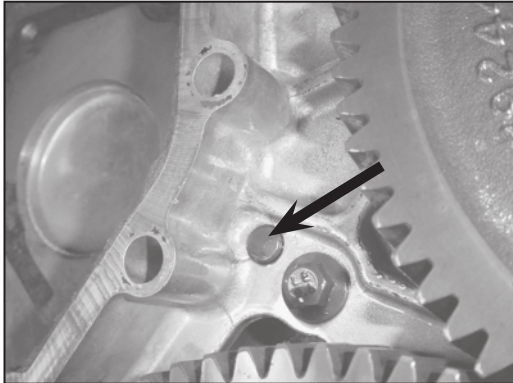
Flaw: The dreaded “Killer Dowel Pin”

Fix: A potential problem for ‘94-‘98 12-valve trucks and some ‘99 trucks is the dowel pin used to locate the aluminum timing gear cover on the front of the engine. When this cheap part falls out, expensive things happen, and it’s shown some proclivity for falling out. There are a number of preventative measures, some of which can be done with hand tools. When replacing the dowel pin, replace the crankshaft oil seal and vice versa due to a seal leak. The fix involves staking the pin, covering the pin with a teardrop-shaped washer placed under a nearby bolt, or removing the pin altogether since it has already served its purpose in locating the housing during engine assembly.

A close-up view of the dowel pin.

Geno’s Garage offers a “Killer Dowel Pin” Repair Kit for ‘89-‘93, ‘94-‘98 and ‘98.5-‘02 Dodge Turbo Diesel trucks. The TDR Buyer’s Guide has a four page article that discusses the proper repair procedure.

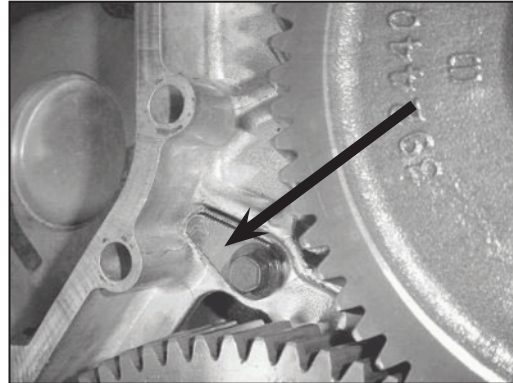
A picture showing an egg-shaped washer that covers the dowel pin.
