**ISSUE 53**

# FROM THE SHOP FLOOR

## SECOND GENERATION HANDLING AND SUSPENSION PROBLEMS, OPTIMAL ALIGNMENT SPECIFICATIONS AND TECHNIQUES

By Andy Redmond

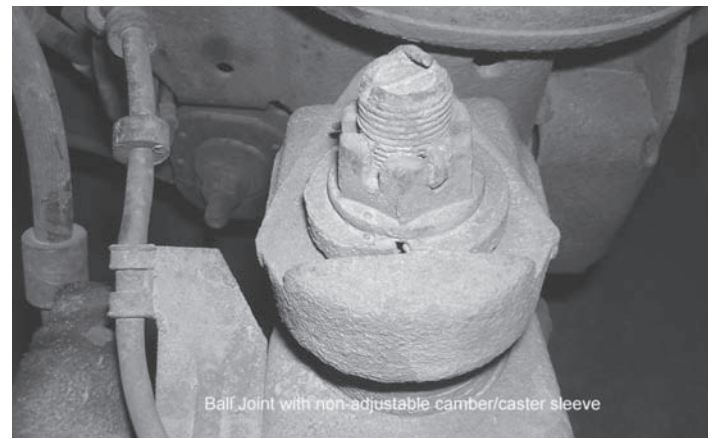
Ball joint with non-adjustable camber/caster sleeve.

Ingall's makes a slick product for the '94-'99 Turbo Diesel called an adjustable ball joint eccentric sleeve, part number 532 or 53200 (Ascot), suggested retail price of \$45. The eccentric sleeve allows for caster and camber adjustment, which the alignment tech can then set to the preferred settings. It fits in place of the fixed alignment sleeve that resides on the upper ball joint stud in the spindle, which is retained by the upper ball joint nut and cotter key.

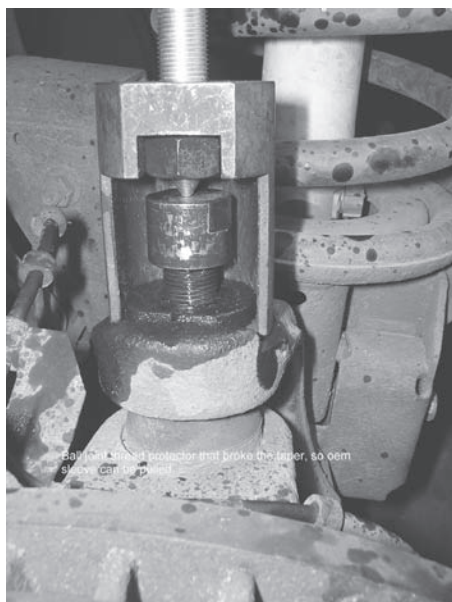
Ball joint thread protector that broke the taper, so OEM sleeve can be pulled.

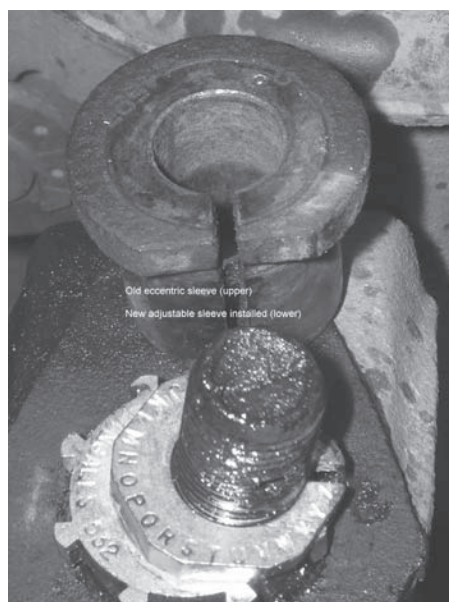
Old eccentric sleeve (upper).  
New adjustable sleeve installed (lower).

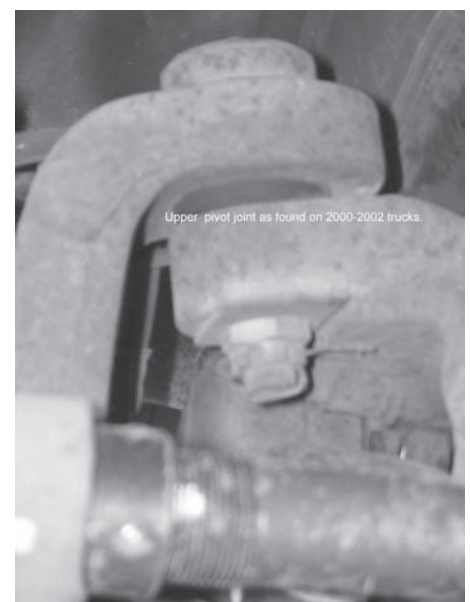
Upper pivot point as found on '00-'02 trucks.

Ingall's also makes a product for the '00-'02 four-wheel drive Turbo Diesel. The addition of the twin piston brake caliper caused many changes to the suspension components in these trucks versus the '94-'99 models. The upper ball joint on the later trucks is referred to as an adjustable joint or pivot. Ingall's makes such a replacement, which is swapped out for the original (non-adjustable) design. The part number is 61500 (Ingall's and Ascot). I have seen it retail for nearly \$150 dollars, per side.
