# MEMBER 2 MEMBER

## THIRD GENERATION SUSPENSION UPGRADES: PART THREE

by Doug Leno

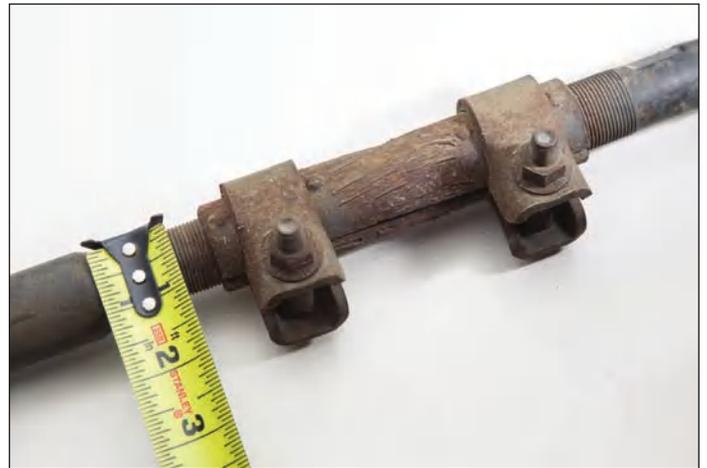
Beyond the geometry differences themselves, the new T-type steering system provides additional stiffness and stability via larger diameter tubes, 1.5" versus 1.25", compared to the older Y-type system (see figures 6 and 7). This made the decision to upgrade easy. Because the job would be a simple one, I decided to perform the upgrade myself.

Figure 6: My tape measure shows the 1.25" diameter steering linkage tubes used on the 2003-2008 "Y-type" steering system that I replaced. The newer "T-type" system uses larger 1.5" diameter tubes.

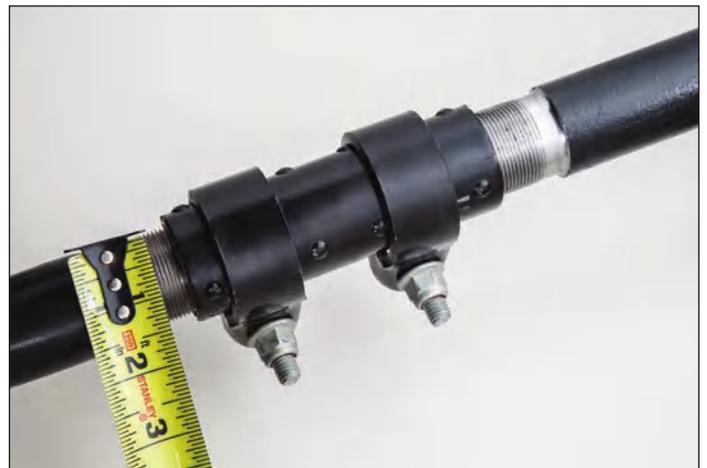
Figure 7: T-type steering system is made with 1.5" diameter tubing, and is considerably more robust than the older, Y-type steering system. The new system is over five pounds heavier.

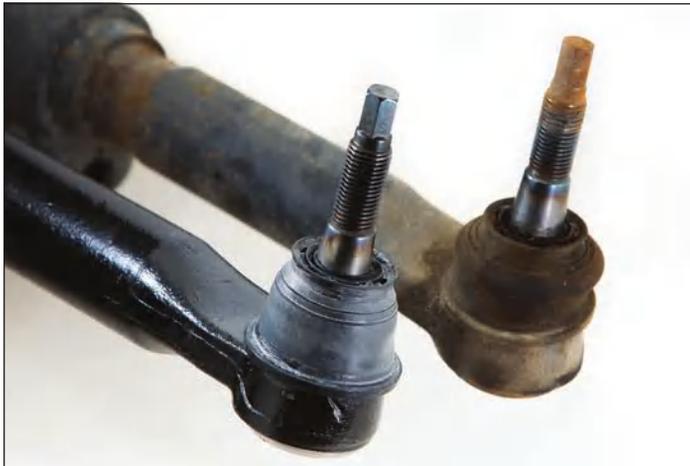
Unsatisfied with this lack of detail, I requested permission to inspect a few steering linkages which my dealer had already replaced under the recall. I started by inspecting the left tie rod ball stud of both "new" and "recalled" systems, as shown in Figure 10. Do you see any difference? I didn't either!

Figure 10: I found no difference between "good" and "recalled" tie rod ball studs, the subject of N49. On the left is a verified "good" part which I installed on my truck. On the right is a recalled part from my dealer's boneyard.

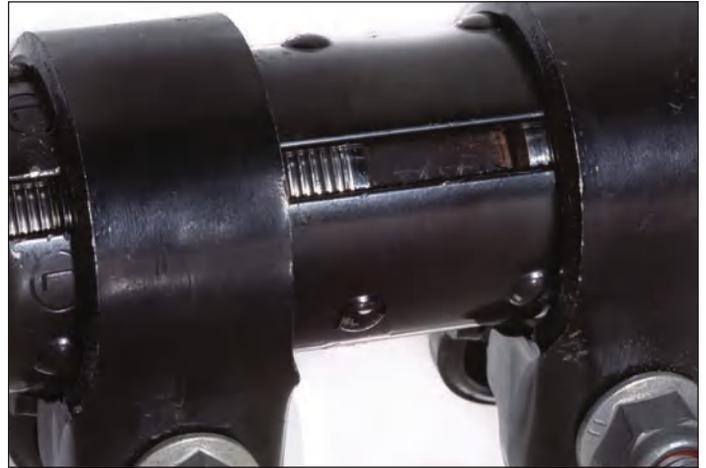
After further investigation I found what I believe to be the real reason for the recall: The recall does not appear to address the ball stud itself; it addresses the probability that a careless alignment technician might pre-stress the left-side ball stud during toe adjustment! If you carefully inspect figure 11, you will see the update: The newest tie rod has an internal mechanism to prevent the right-hand tube from rotating along with the toe adjustment collar. The older (recalled) tie rod has no such mechanism, as you can see in figure 12.

Figure 11: The adjustment collar on the newest T-style steering system. Note the inner mechanism in between the two threaded halves. This prevents the right hand tube from rotating along with the adjustment collar.

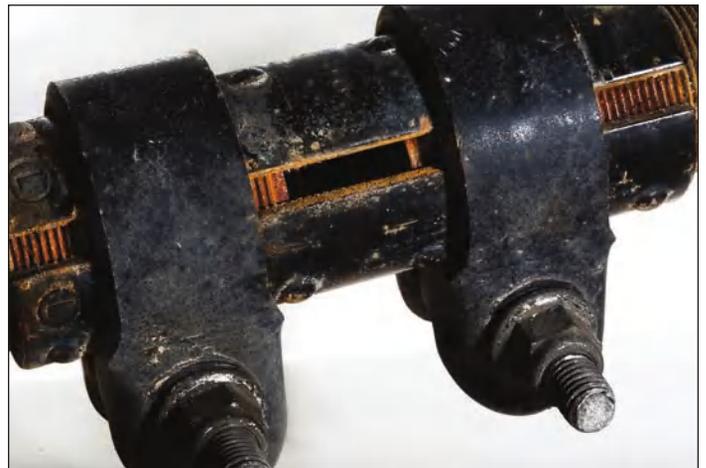
Figure 12: The older (recalled) system allowed the right hand tube to rotate along with the adjustment collar, allowing a careless technician to pre-stress the ball stud inside the steering knuckle.

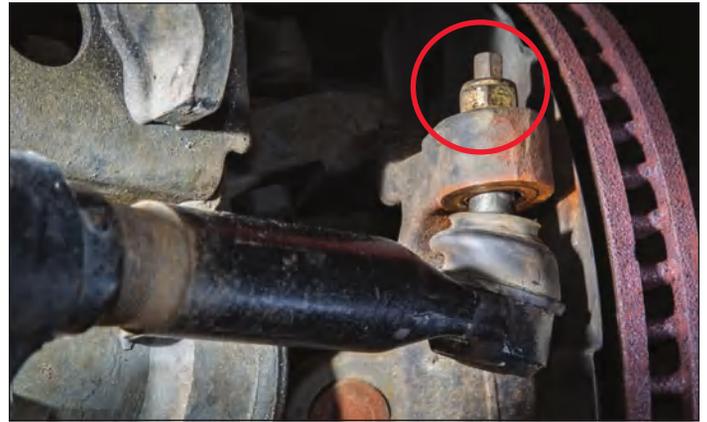
Figure 8: Dropping the old Y-type tie rod from the driver-side steering knuckle. The nut in this photograph (circled) is only partially removed.

After removing the Pitman arm from the steering box, the entire system can be removed by loosening the nuts on the left and right ball studs (see Figure 8).

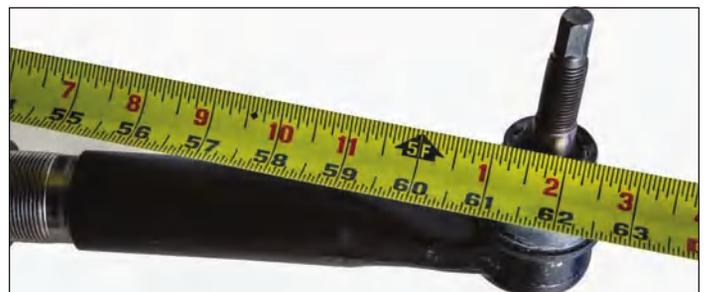
Figure 9: pre-adjusting the length of the new tie rod before installation.

Although most of us rely on alignment shops to check or perform the adjustment, our Turbo Diesels are easy to align, even in a home garage. "Total Toe" is the only adjustable alignment parameter, determined by the length of the tie rod set via the adjustment collar. This meant I had to set "Total Toe" myself, at least initially. Rather than measure the parameter directly on the vehicle, I decided to pre-adjust the length of the new tie rod to match the length of the old one (see figure 9), and then go to an alignment shop for final adjustment. It turned out my pre-adjustment was only 1/32" off!

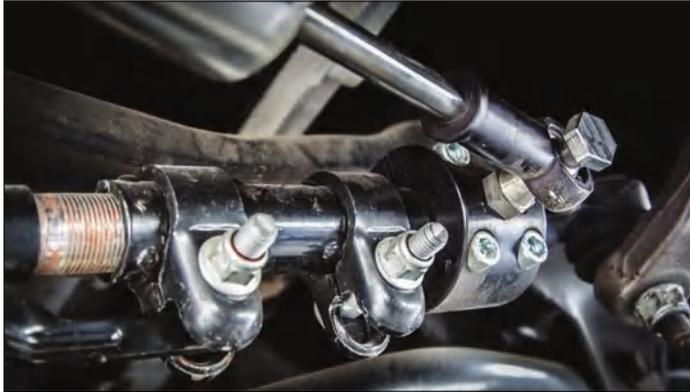
Figure 12: Installation of the Carli Suspension "High mount stabilizer" required a new clamp to accommodate the new tube diameter.

Carli Suspension's dual stabilizer system is compatible with either "Y-type" or "T-type" steering systems. As is the focus of this article, the newer steering system is manufactured with larger diameter tubes, which means that a different Carli suspension clamp is required for the upper stabilizer (see figure 12). Carli's low-mount stabilizer utilizes the factory supplied clamp, shown in figure 13. Note that for these photographs, I decided to break with tradition and show the installation after several hundred miles of road use. You won't see shiny new parts in these photos, but you will see how road grime accumulates, and how the axle tube itself protects the lower stabilizer (figure 13).
