# TURBO DIESEL Buyer's Guide

# Vintage '94-'04 Transmission Lock/Unlock Problem

# TRANSMISSION NOISE PROBLEMS

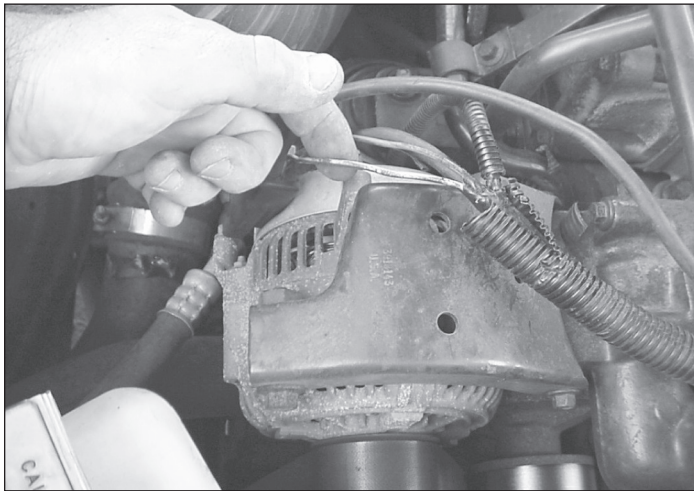
I have found the cause of the lock-unlock problem to be an AC frequency-induced electrical noise into the ground circuit of the battery which causes a fluctuating voltage signal from the TPS to the PCM.

The solution is to locate the 10-gauge ground wire that runs from the negative post of the passenger battery to the back of the alternator. This wire is often tan with a black stripe.

Starting at the back of the alternator loom where the tan/black striped wire originates and then goes to the battery, wrap the wire with a piece of tin foil about 4 to 6 inches in length. Wrap tinfoil with black electrical tape to secure it.

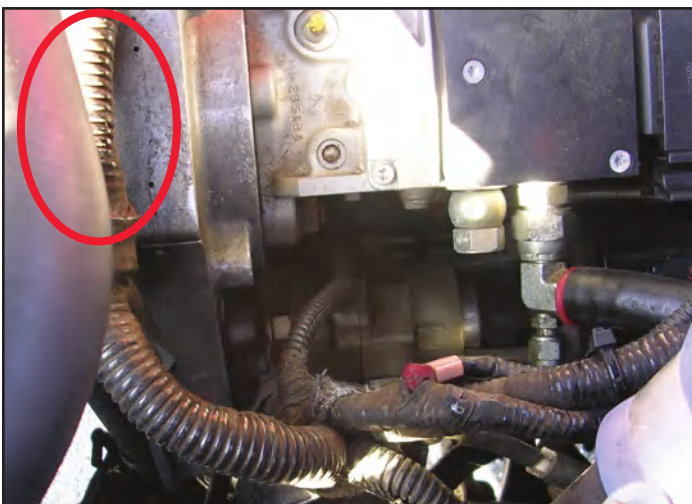
We left the charge wire alone and pulled the passenger battery small ground (it ties into a bunch of smaller engine grounds directly forward of the injection pump area) apart and started working backwards on the wires. At the driver's side forward corner of the block, we cut open a large splice area. What I found inside made me angrier than any other stupid stuff I've seen Dodge do over the years. There were at least four sensor grounds simply laying on top of the large ground wire and heat shrunk in place. No solder, no crimp connector...no nothing. This was factory wiring. Total garbage.

The "Before" picture. The area Don described runs from the alternator across the top/front of the cylinder head (circled area).

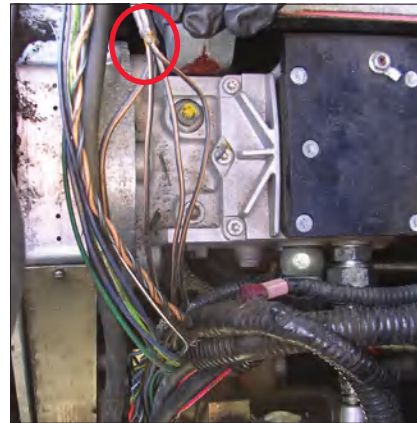
To test the "Final Answer" we cut into this '99 truck's wiring harness. The truck belongs to Geno's Garage employee Scott Sinkinson. We cut off a lot of wiring loom (down in the valley as well as across the front of the engine) to look for poor connections. The connection area is circled.

The above picture showed that we *really* cut into Scott's wiring loom. The actual "four sensor grounds laying on top of the large ground wire" is located just as Don described, forward of the injection pump area. It was easy to spot the wiring junction that Don described. It was not easy to access the wires. While I agree with Don, they are a bundle that is/was heat shrunk together, the bundle is well epoxied, the shrink is epoxied and the wires were air tight. I had to saw sideways through the heat shrink to get down to the wires. The shrink was not "sliceable."

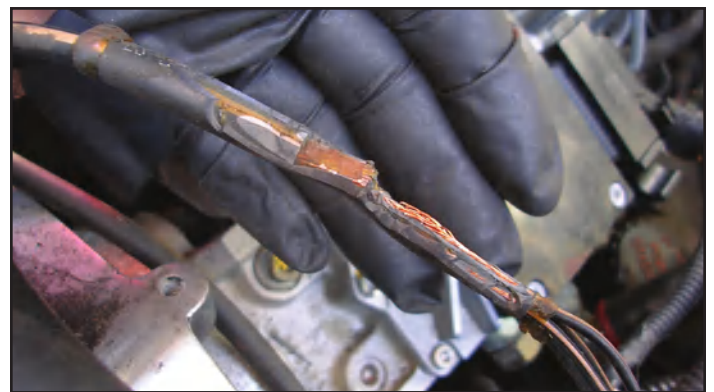
These wires are really secure.

Conclusion: I don't think we have the final answer. Scott and the Geno's staff agreed, his truck's wiring loom was tight and secure. Maybe, maybe if the wires were brittle and you happened to bend them at the junction? We covered the wires back up.
