# STILL PLAYS WITH TRUCKS

## **TURBO ACTUATOR FAILURE AND CITY DIESEL REPLACEMENT**

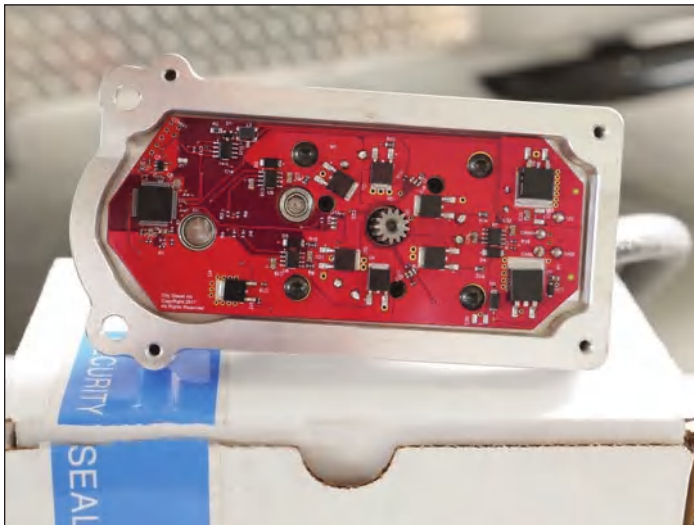
**City Diesel's VGT circuit board is designed to withstand higher temperatures than OEM.**

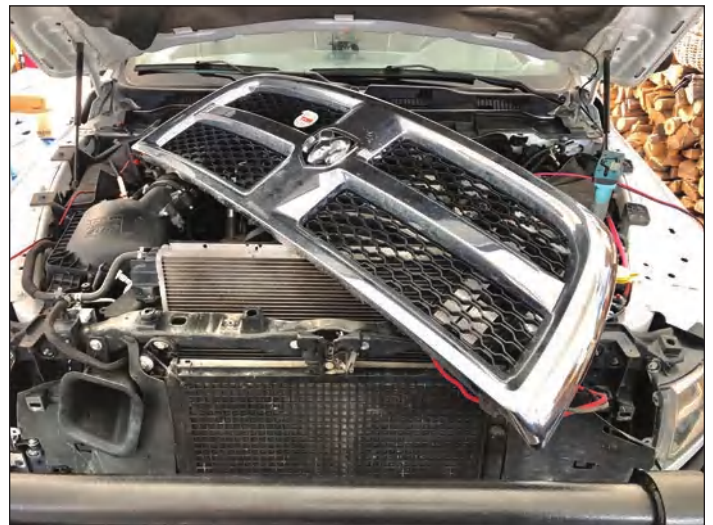
**Pulling the grille was optional, but I prefer fewer knuckle scrapes, hassles, and better access.**

- Place the front axle on a jackstand
- Remove right front tire and wheel
- Drop fender liner for access
- Remove the grille and radiator rubber side flap to access coolant drain plug
- Connect 5/16" hose to the radiator drain and route to a pan to limit mess (it worked)
- Open 16 mm radiator drain nut; access is tight
- Remove radiator cap
- Let everything drip and drain as much as possible

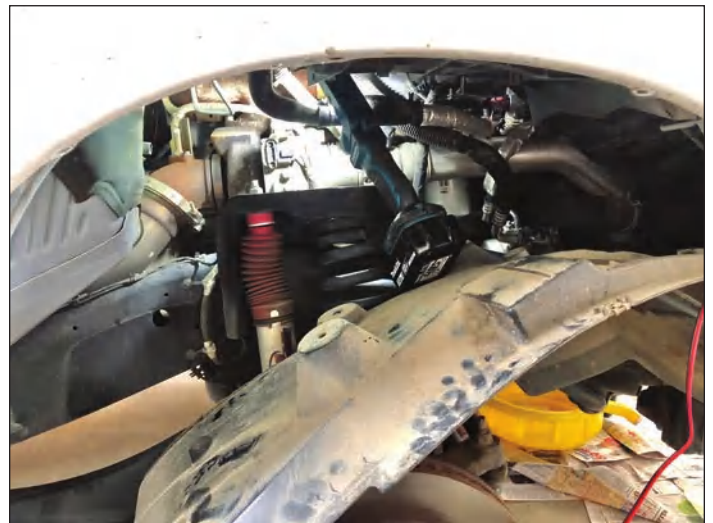
**Fender liner dropped (front still attached) to reach the actuator.**

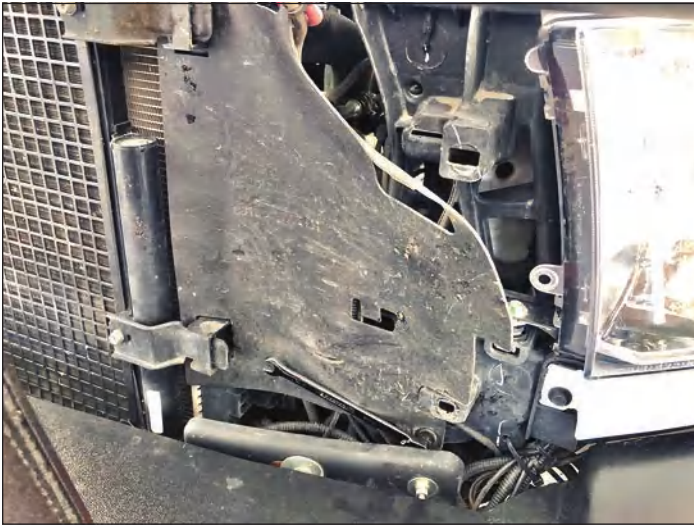
Combined with the grille, removing this wind flap made it much easier to fit a tube on the radiator drain.

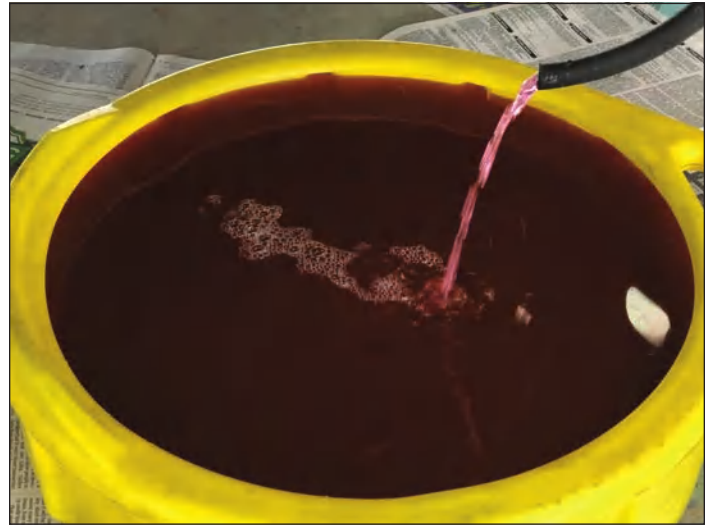
I didn't spill a drop, until the pan started to overflow.

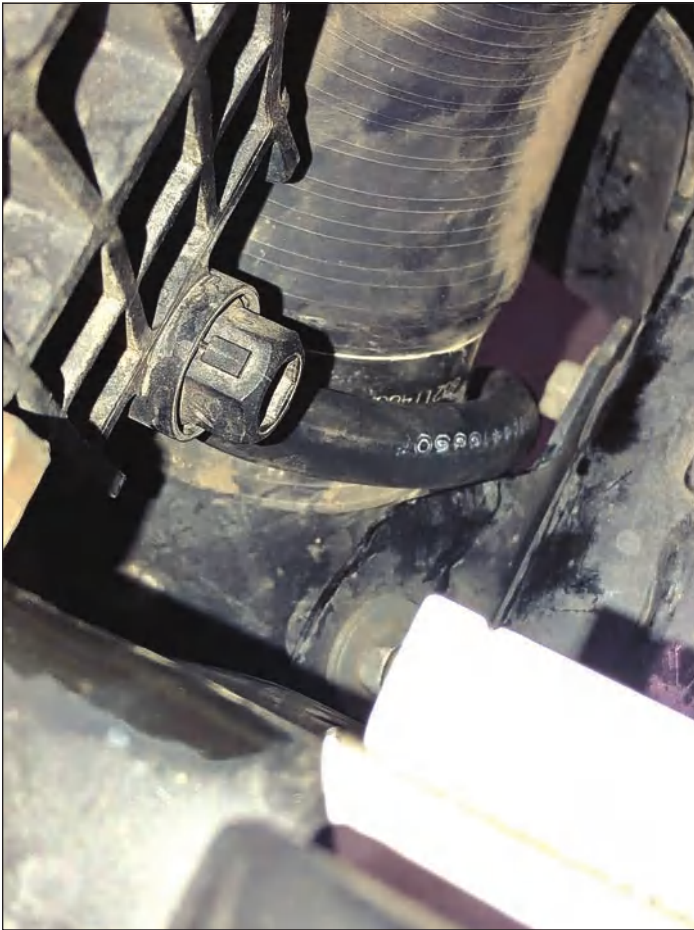
Radiator drain tube fitted. A new stubby 16 mm was helpful to open and close the drain.

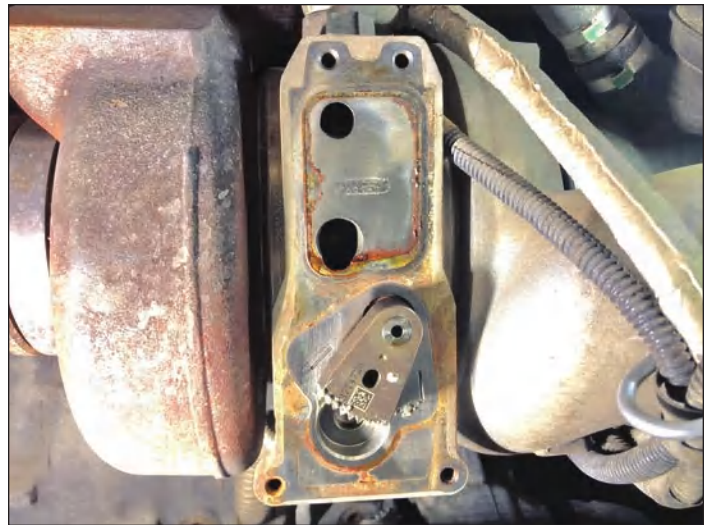
**Stock Holset actuator removed for the first time. Turbo actuator gear lever at bottom must not be seized.**

Like many shops and technicians that need to perform a task where access is difficult, City Diesel made a custom bit for these difficult bolts. (Hopefully I am not performing turbo actuator swaps often, maybe another on my 2017.) After trying all the hex bits and keys in my main toolbox, and confirming all were too long, I dove into one of the spare, cheap, extra tool kits I have lying around. I found a stubby 5mm bit intended to slide into the female end of a magnetic driver. As Jason suggested, turning this bit with a 1/4" box-end wrench is a good way to remove the hidden fasteners. With the Holset part off, I carefully cleaned the mounting surface with a razor blade and wiped it dry with a shop towel.

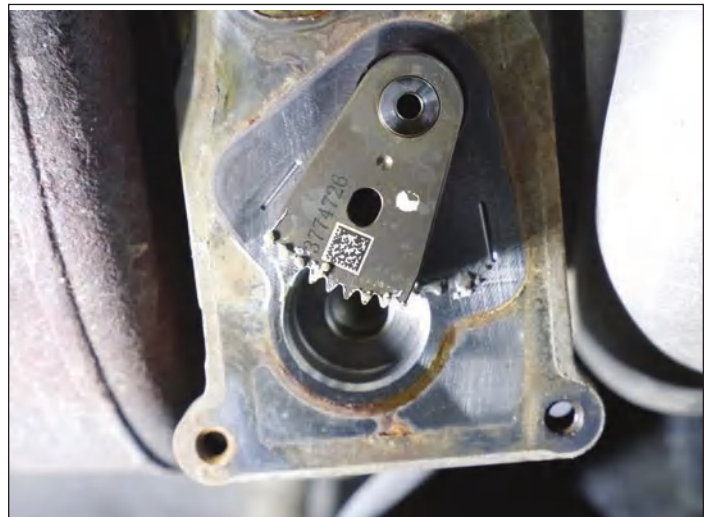
**Closeup of turbo actuator gear lever. Ensure it still works before breaking the security seal on the new actuator parts.**

You must also confirm that the turbo actuator gear lever, visible with the actuator housing removed, is not stuck. If it is, the turbocharger likely needs to be replaced. You should be able to move the gear lever right and to the left by hand (though it takes some strength). This is addressed in step six of the installation instructions provided by Geno's Garage. The total travel is approximately one-inch. Mine appeared fine. The City Diesel boxes have *security seal* tape, so don't break the seal if you're not sure the actuator is your (only) problem.

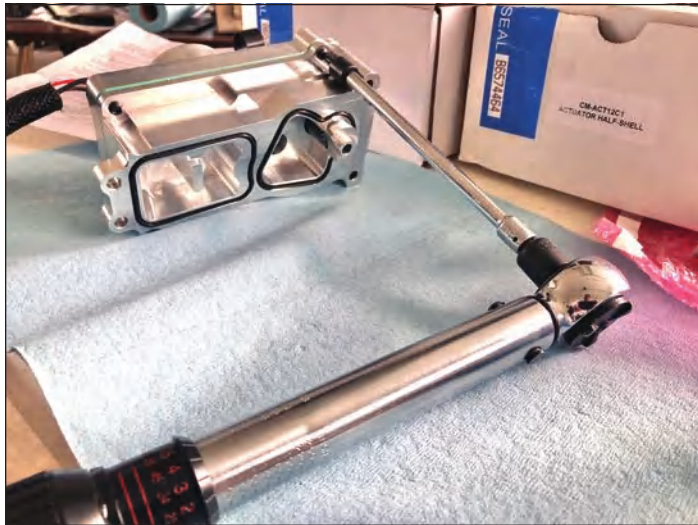
Assembling the new actuator upgrade kit from City Diesel.

My previously assembled City Diesel actuator and electronics were fitted to the turbo and the bolts snugged. When looking at the engine through the right wheel well, the lower left bolt needed to be *in* the new assembly, as there's not room to insert it with the actuator sitting on the turbocharger.

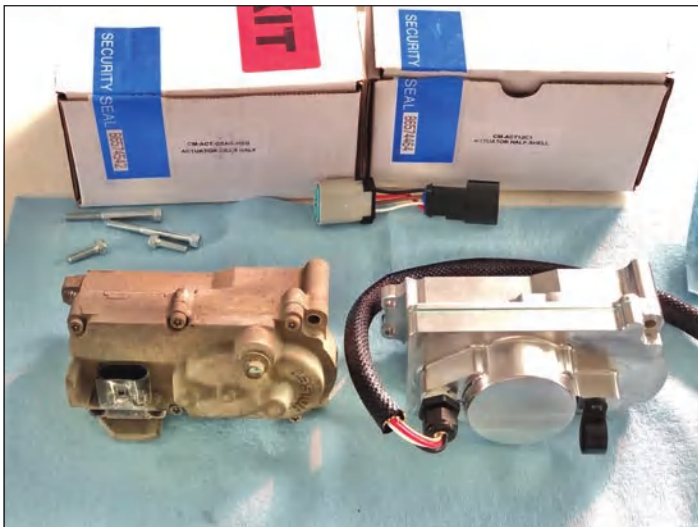
Factory Holset 6.7L VGT actuator left, and new City Diesel replacement on the right.

Again I slid the new actuator into place, and tightened the four, 5mm bolts. Recommended torque is "around 25-inch-pounds," but there's no space to use a torque wrench on the lower bolts. The top two were torqued to specification, with the bottom two tightened by *feel*.

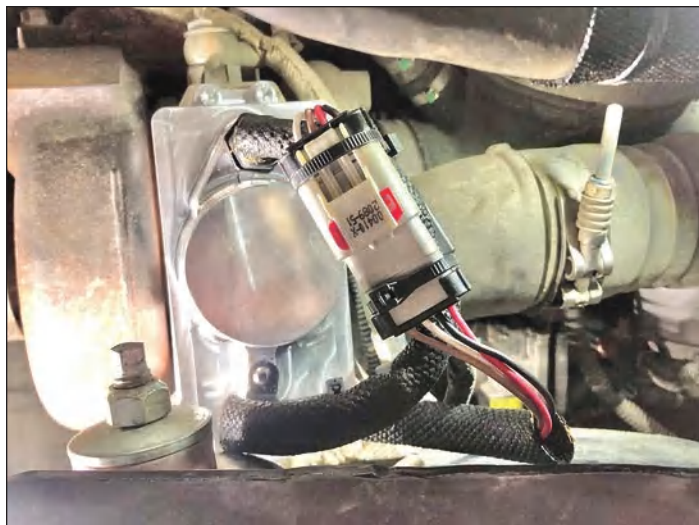
Wiring harness is longer than needed for my application, but secured, zip-tied, and tidy.
