HAVE RAM, WILL TRAVEL

INSTALLATION OF THE CITY DIESEL ELECTRONIC TRUBOCHARGER ACTUATOR – PART TWO

The Mechanical Steps for Replacing the Stock Turbo Actuator with City Diesel's Unit

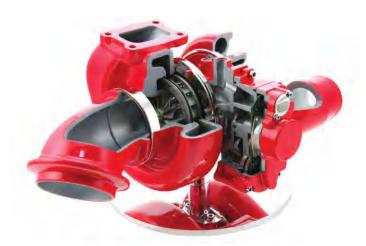
Up on a pedestal (and rightfully so), this Holset HE351 VGT is the key to managing intake air pressure for economy, power and emissions.

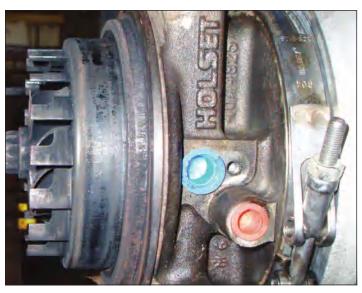
Closed

With the sliding vane fully extended, the turbo blades are closed to exhaust flow. This creates exhaust gas back pressure (the exhaust cannot escape) and the turbo acts like an exhaust brake.

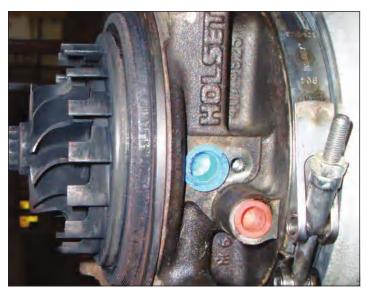
Open

With the sliding vane totally fully retracted, the turbo blades are open to exhaust flow. Exhaust flows freely and the pressure on the turbine blades builds intake air boost/pressure.

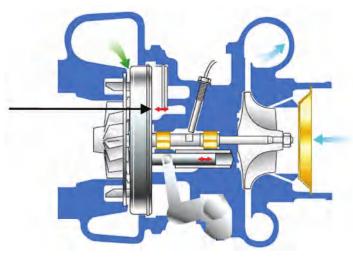
In this picture the sliding vane is closed. Exhaust gas flow (small red arrow, top left) is restricted and, thus, the turbocharger is acting like an exhaust brake. Allow the vane to move to the right and the exhaust gas flow is "full-on" causing the turbine (exhaust) blades of the turbocharger to spin faster and ceate more boost.

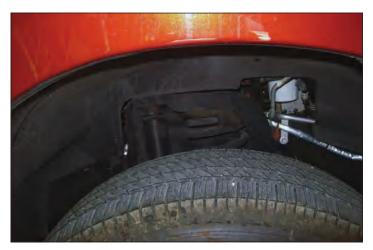
Initial view above right front tire with turbocharger covered by plastic inner fender. The shock absorber/coil spring tower can be seen, but not the turbocharger.

It is easier to remove the plastic inner fender after jacking up the corner under the suspension arm and putting jack stands under the arm and the frame behind it. Again, remove the tire for access.

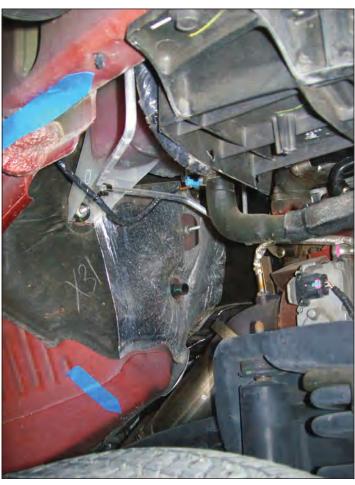
Blue arrows show rear and middle Christmas tree fastener positions. Turbo and actuator can now be seen.

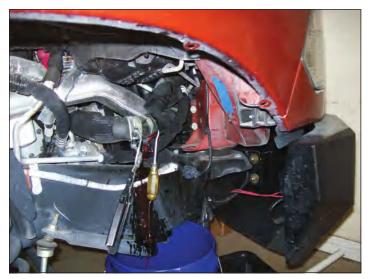
Coolant draining with ratcheting retainer clamp pliers and cotter pin removal tool between hose and plastic Y. Front Christmas tree retainer position is shown with blue arrow.

I discussed this easy method of draining the coolant in Issue 100 (pages 100-101) when replacing the water pump. A five-gallon bucket will catch the coolant, and I put a larger pan under it to catch any errant coolant. The coolant tank and banjo bolt for the upper coolant level air bleed are shown.

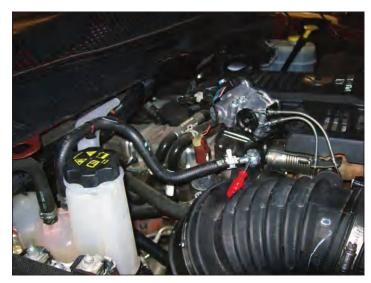
2013 coolant reservoir on left, red-handled screwdriver pointed to high-fill point banjo bolt.

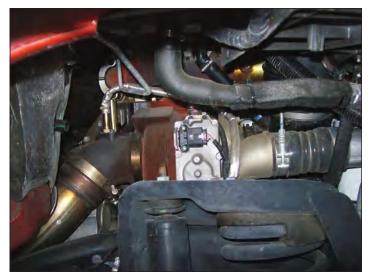
View of turbocharger and actuator with inner fender removed.

Access to lower actuator mounting bolts is restricted
by the shock absorber/coil spring tower.

The shock absorber/coil spring tower impedes access to the lower actuator bolts. For me, the next preparatory step was applying Mopar rust penetrant to the shoulders of the four actuator mounting bolts, and the exposed area of the bottom rear bolt. This bolt is the source of misery for a lot of people changing the actuator. By leaving the outer corner of the actuator open, water, salt, and dirt can enter and corrode the bolt to the actuator housing.

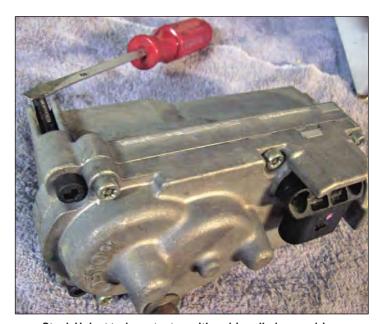
Stock Holset turbo actuator, with red-handled screwdriver pointing to the exposed left lower bolt from the cut-away design of the actuator housing. Here is where dirt, salt, and water enter and corrode the bolt into place.

I read stories of stripped-out hex sockets making removal of the bolt a very difficult undertaking. Because of my desert climate, I anticipated less trouble, but wanted to explore an approach to help ensure that the bolt could be removed even if some corrosion was between its shank and the actuator housing. In a "perfect world" an allen bit with a ratcheting box end wrench would work great. If your turbo actuator housing looks corroded by the elements, you will likely round out the hex of the left lower bolt by simply trying to turn it. Thus, the addition of "impact" in Step 5.

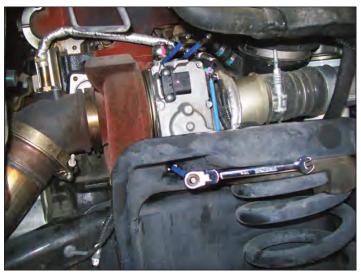
Blue tape-wrapped power bits on top two and bottom left actuator bolts. 5 mm allen key on bottom left actuator bolt.

Bottom left bolt is easily accessed through hole drilled in shock absorber/coil spring tower.

Next is removal of the shock absorber with a 21 mm socket on the bottom bolt, and an18 mm wrench on the top nut, holding the stalk with 11/32" six-point socket on the hex end. I carefully lined up the travel of that bolt with the spring/shock tower to get horizontal and vertical lines, and then drilled a 0.125" hole in the 0.190" thick shock/coil spring tower. If very close, I could simply enlarge it. If not, I could partially enlarge it, and partially use a carbide bur in the die grinder to open the hole in the direction needed to get direct, unimpeded access to the bolt. I did drill pretty close but used the latter approach to end up with a hole that is exactly where needed.

I bought some 5 mm hex power bits with 0.25" hex heads, 6 inches long. From other projects, I had found that there was much less chance of stripping the hex if I used a proper bit, applied constant pressure in the direction of removal, and hit the end with a hammer to provide "shock" or "impact" to aid in removal. The same 0.25" ratcheting box end wrench that you got to use the hex bit that Geno's supplies with the actuator will work nicely with the power bit. You can actually use the power bit on the top two and, with the hole you drilled, the bottom left (rear) actuator mounting bolt. Geno's short hex bit with the ratchet works well on the lower right (front) bolt which has better access from the factory. You can also use a conventional allen key to break the bolt loose.

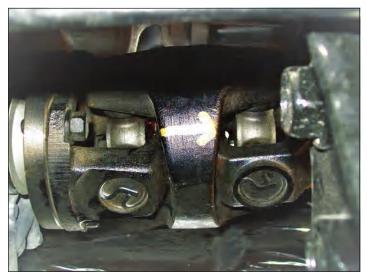
Front driveshaft double cardan joint with arrow pointing to the flush-mount grease fitting.

In Issue 114, both Stan Gozzi (page 108) and Andy Redmond (page 117) reminded us to grease the center bearing of the double cardan joint in the front driveshaft. These are good reminders of the procedure I described in Issue 86, p. 105. I showed how to find the flush-mounted fitting, included an extra one on the CarQuest label, and included the CarQuest needle attachment and angle adapters I use on my small hand-held grease gun.

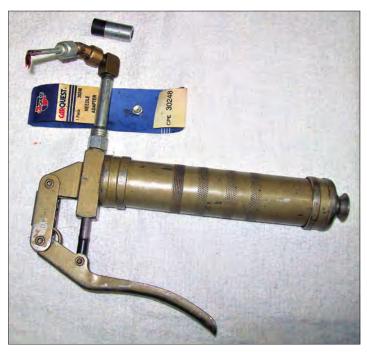
Needle type attachment on hand-held grease gun.
