THE NUMBER ONE DODGE/CUMMINS TURBO DIESEL RESOURCE

ISSUE 74

IS THE “STEERING WOES’ ARTICLE STILL RELEVANT?

STEERING WOES

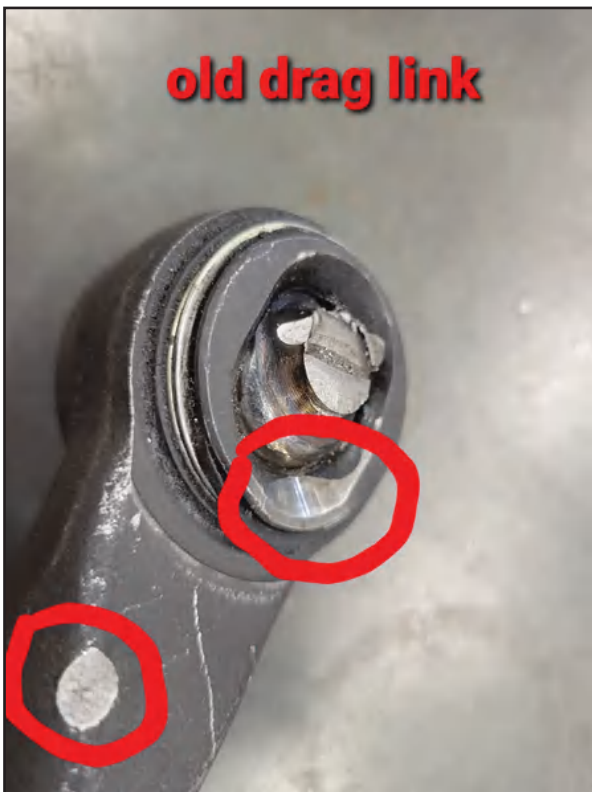
MOOG is not the company they were in 2012 when this article was written. The quality has been in a downward spiral for many years. This is confirmed by many customers, shops, and most recently, the problem of a tie rod stud breaking due to poor metal and visible porous holes.

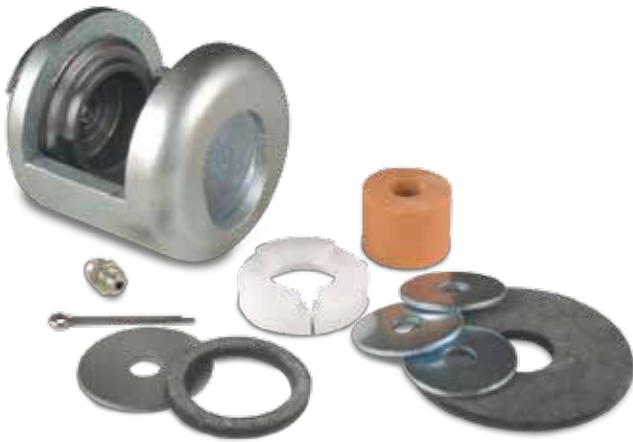
The Luke's Link replacement ball stud parts.

- The person in the driver's seat should move the steering wheel back and forth fairly hard. Under the vehicle you should examine the ball stud joint to see if there is any movement up or down. Make sure you are looking at the track bar as well as the tie rod ends. The main objective is to use the weight of the truck against the axle. That is why it is important to leave the truck completely on the ground. If there is movement, your ball stud joint is likely in need of replacement. (Please note that the tie rod ends will swivel and that is normal. The track bar, however, should not move at all.) The entire replacement part kit for this repair is \$69.

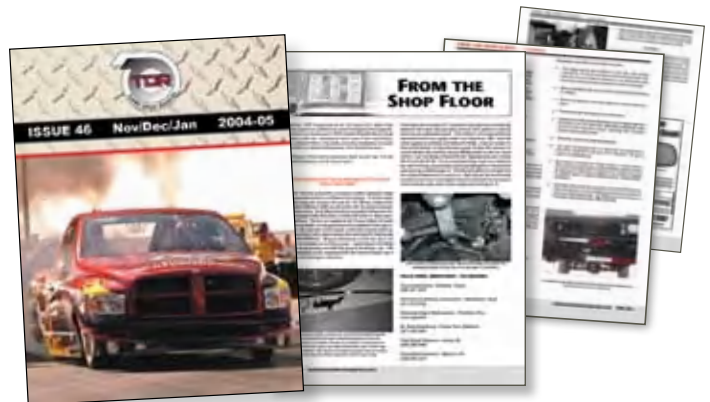
The Issue 46 article (pages 154-156) has the details of the SSI bracket with the Mopar track bar.

For the Death Wobble problem on a Second Generation truck, I wrote an article in Issue 46 (November 2004) that covered the installation of a truck bar relocation bracket and a new Mopar '03-'08 track bar. Since the editor sent this article to me for my review, I went back seven years to Issue 46 to see if my opinion had changed. It has not. As I mentioned, the repair is more involved than the simple rebuild of the track bar with a Luke's Link. The parts used back then were a track bar relocation bracket from Solid Steel Industries (www.solidsteel.biz, part number DSS0019402-4, \$209) Mopar '03-'08 track bar (part number 52106795AC, at about \$250). I still use these parts. Since 2004 other companies have introduced different versions of this kit; specifically, the folks at BD Power offer a bracket and track bar kit (BD part number 1032011, \$480). My experience with the BD kit is that it is more difficult to install.

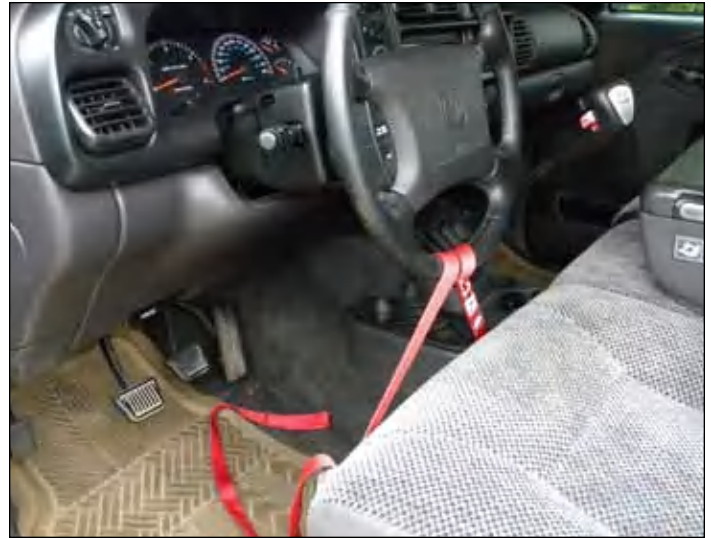
This technique makes the steering stay put while you work which avoids clock spring damage.

To fix one of these issues I decided to replace the bearing in the bottom of the steering column with the bushing offered by <http://rocksolidramtrucksteering.com>. The instructions supplied with the kit were very straightforward and it appears to be somewhat easier to do on my truck given it is a manual rather than the automatic trucks with the column gear selector. One note worth mentioning here is that any time you uncouple the steering system, the steering wheel is free to turn inside the cab. This must not be allowed to happen as it may bring about the destruction of the “clock spring” inside the column. The clock spring is actually a thin ribbon cable type electrical connection between the portion of the column that rotates and the part that doesn’t rotate. The catch here is that the cable or clock spring is a fixed length so if you connect the steering back up in a different orientation than it currently is, you may run out of cable when turning left or right. The best way to avoid this is to put the truck’s front wheels straight ahead prior to disassembly. Then take a cargo strap and attach it to one of the driver’s seat floor supports, thread it through the steering wheel and connect to the other seat support as shown below:

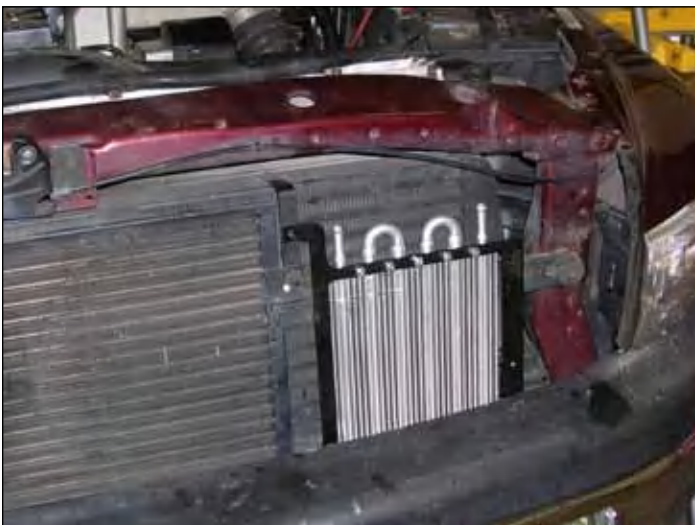
An automatic transmission fluid cooler in its new job as a power steering fluid cooler.

This fluid cooler plumbed into the return line worked like a charm to keep the power steering fluid cool. Even on a 100° day, after driving in traffic, you can put your hand on the return line going from the cooler to the pump reservoir and it is warm/hot to the touch, a major improvement over the "roast your finger" stock system.

One problem became readily apparent when I removed the power steering hydraulic hoses. My power steering fluid smelled burned and was unnaturally dark in color. I then decided to take the power steering pump off and check the condition of the pump. This observation fit with the extremely high temperature of the hose fittings near the hydraulic brake assist unit I have observed over the life of the truck. I decided to do something about high temperature of the power steering fluid. So I found an automatic transmission fluid cooler that would fit on the driver's side of the air conditioning condenser in front of the intercooler. I designed a bracket and mounted the cooler in line in the return hose from the steering gear box back to the power steering pump reservoir.

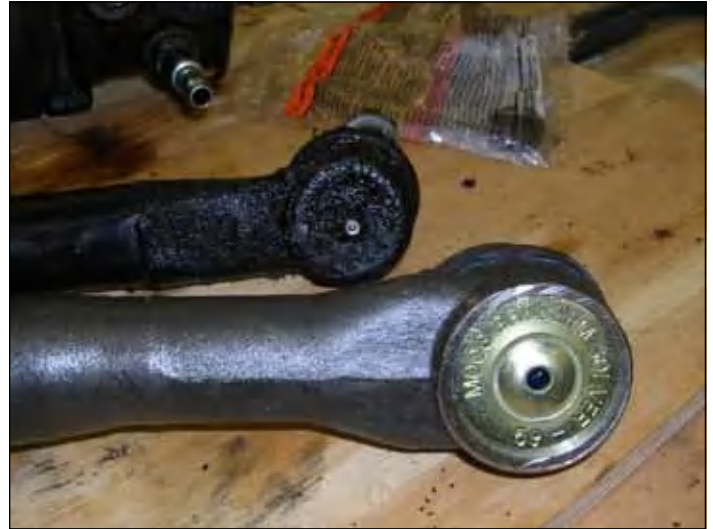
I chose Moog parts for all my front suspension replacements. It is easy to see why the Moog components are better, below is the new Moog track bar lying next to the stock bar.

This track bar replacement settled the truck down quite a bit and gave it some fairly decent road manners. I drove the truck for several months with it at this stage and decided that while it was tolerable, it still lacked the control and stability it had when new.

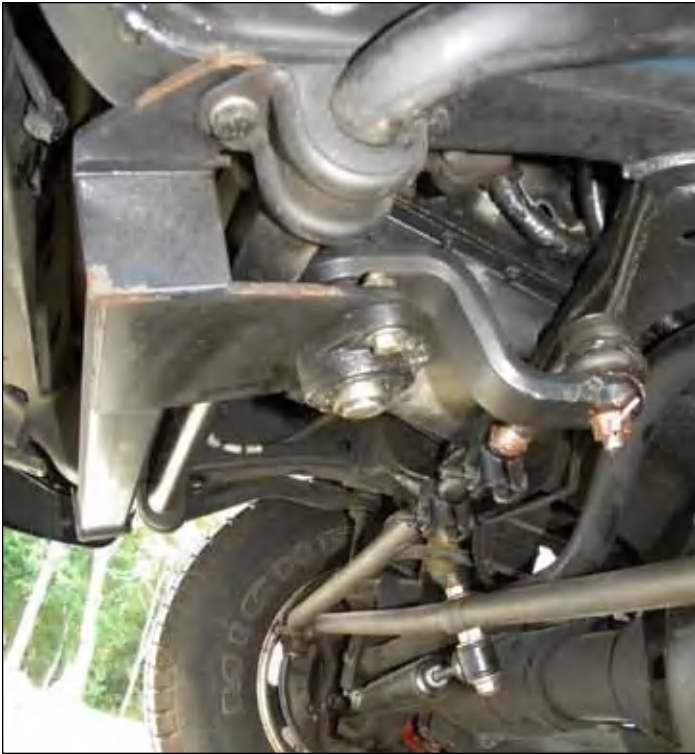
The picture below shows the BD steering box stabilizer installation after two years of use.

The BD steering box stabilizer enhances the truck's steering system by giving the steering shaft support out past the point of load application which reduces stress on the steering box's output shaft bearings. It also stiffens the frame rail near the steering box mounting location, reducing side-to-side flexation.

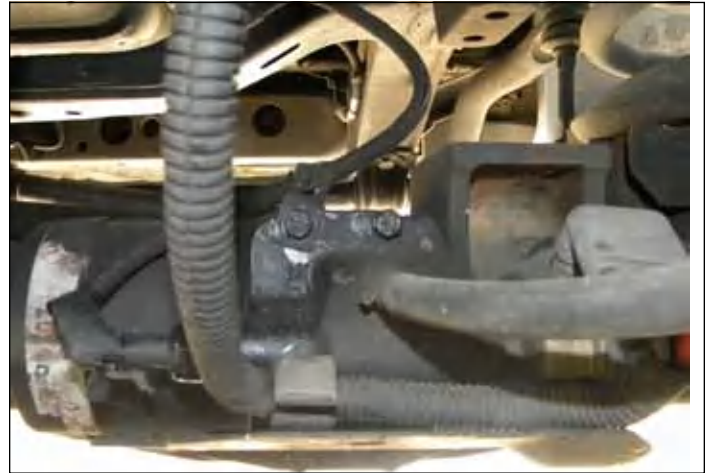
Spline engagement housing on back side of front axle.

The ball joints and tie rod ends are the only tasks left! Many will advise putting the truck in four-wheel drive prior to removing the front axle half shafts. Engaging 4WD puts the spline engagement collar (central axle disconnect – CAD) inside the axle housing half on the intermediate shaft and half on the passenger side half shaft. This allows you to remove the passenger side half shaft without the collar falling down in the housing. If you leave the truck in 2WD as I did and remove the passenger side half shaft, the spline engagement collar will fall down in the engagement housing. This is not a major issue at all since you can disconnect the 4WD sensor and remove the four 1/4-20 bolts holding the spline engagement actuator/housing cover.

Once removed simply put the collar on the intermediate shaft while reinstalling the passenger side half shaft. Then position the collar on the spline so that the actuator fork engages the collar and you can bolt up the actuator/housing cover. I recommend removing the spline engagement housing cover anyway to wipe the old differential lube and crud out of the sump.

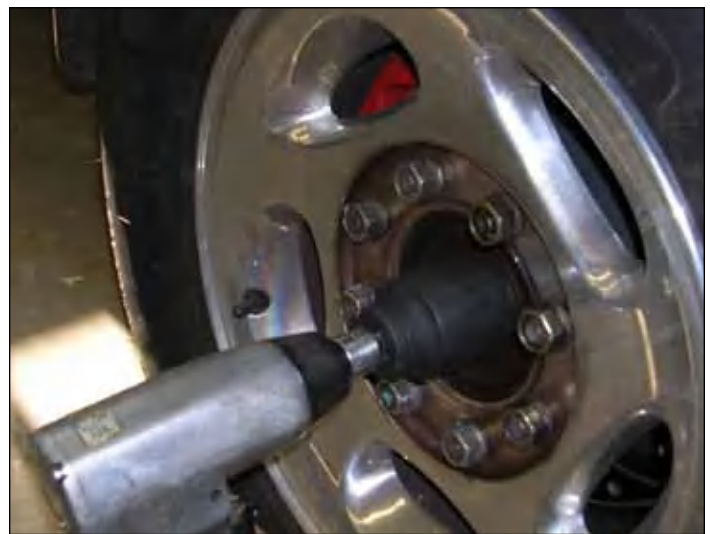
My old Chicago Pneumatic 1/2" impact wrench having a go with a 3/4" socket adapter and 1 11/16" socket. Both nuts are standard clockwise tighten so remember patience and penetrating oil. My impact wrench took about 20 seconds per side and the nuts were off.

Before you put the truck up on the four jack stands, remove the hub caps and take the half shaft hub nuts off. This requires first removing the cotter pins and then a 1 11/16" socket. Penetrating oil and patience are important components for this phase of the project. In my experience the best penetrating oil you can get is mixture of 50% acetone and 50% automatic transmission fluid. One word of caution is that the penetrating oil isn't friendly to the clear coat on your aluminum wheels, so caution with runoff is necessary. However, repeated application of penetrating oil over a week's time prior to disassembly will make the job go much easier, especially with the bearing hubs.

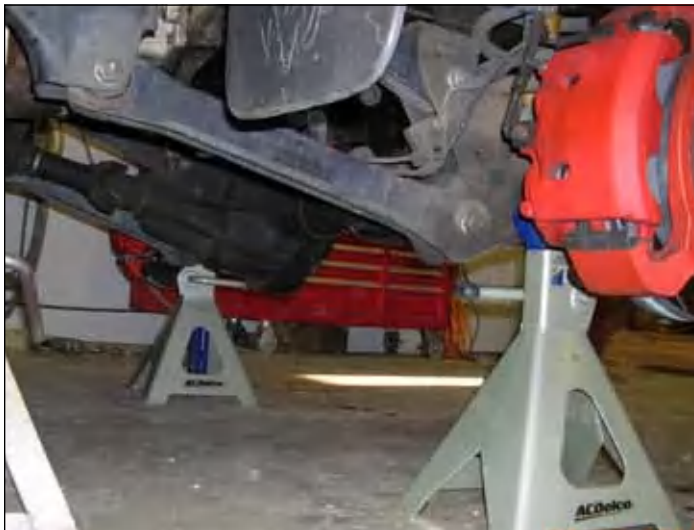
The jack stand configuration I used is shown below.

I had two jack stands with a capacity of six tons each and thought that would be plenty. After using my floor jack and placing my two jack stands under the frame rails just aft of the control arm brackets I decided I had too much weight too high! The truck was fairly steady but it was possible to move it around slightly by pulling on it with my hands. It only took a second for me to decide this wasn't secure enough for me to lie under so I purchased two additional six-ton jack stands and added them under the axle.

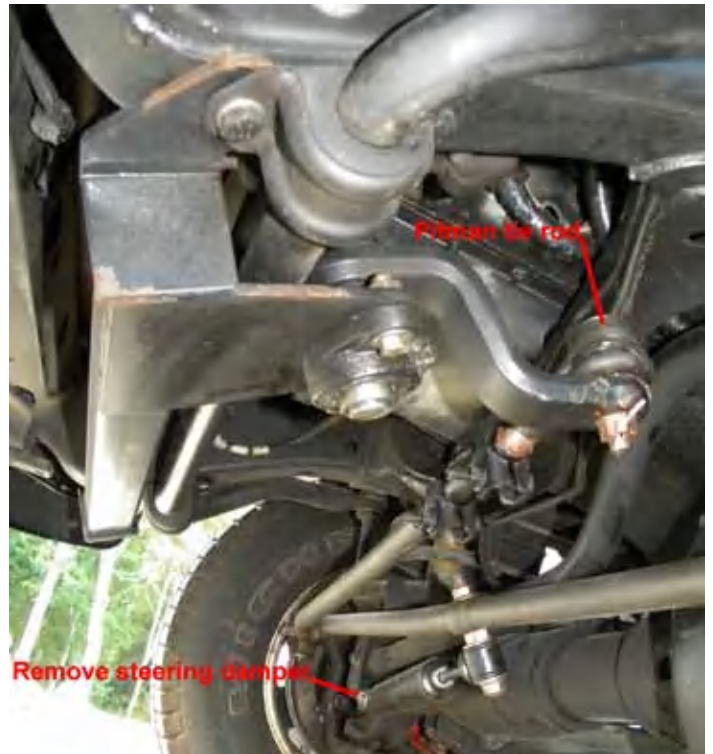
Remove steering damper.

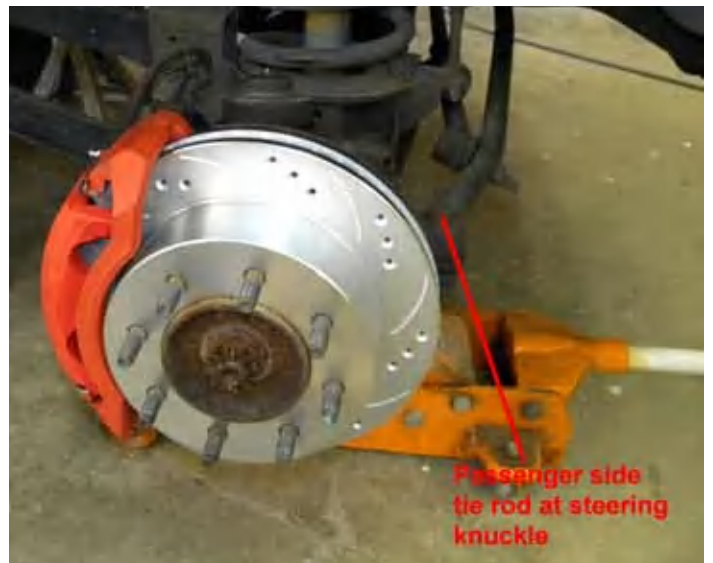
This allows the entire steering tie rod system to come off in one assembly so the new components can be assembled to match. Care must be taken when handling the entire steering system as an assembly since it is heavy and the tie rods can allow the components to rotate and pinch your finger(s) between the various rods. (Ask me how I know.)

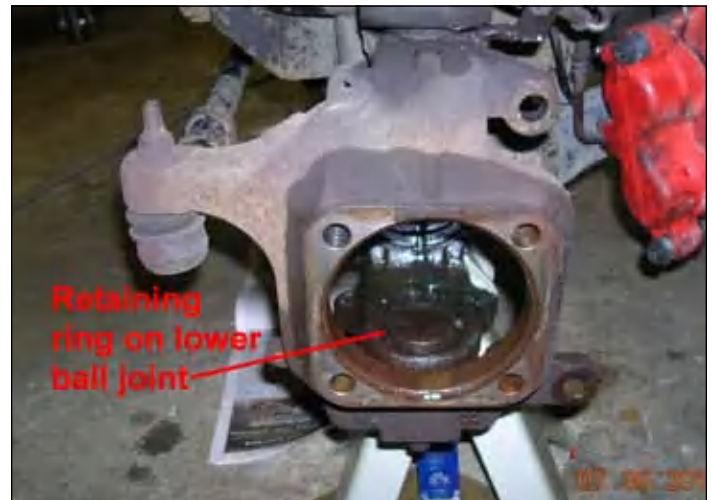
With the bearing hubs and half shafts out, remove the nuts on the ball joints and the large retaining ring off the bottom ball joint as shown below.

Also note extensive use of penetrating oil, it really does help.
