# MEMBER 2 MEMBER

## THIRD GENERATION SUSPENSION UPGRADES: PART THREE

by Doug Leno

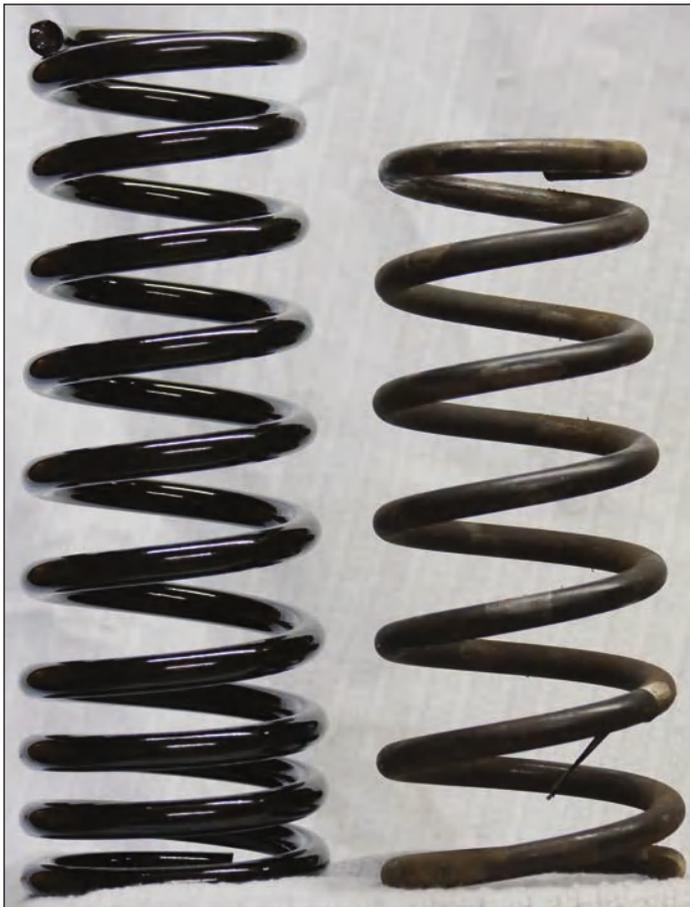
Figure 1: Carli Suspension multi-rate coil spring (left) installed in 2012, provided approximately three inches of lift compared to the factory spring (right)

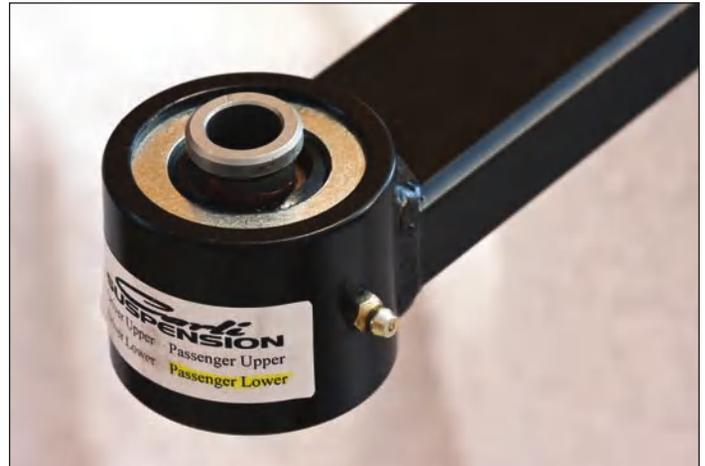
Figure 2: Carli suspension lower control arm, installed in 2012. The serviceable bearing eliminated the friction caused by the rubber bushings in the factory control arm.

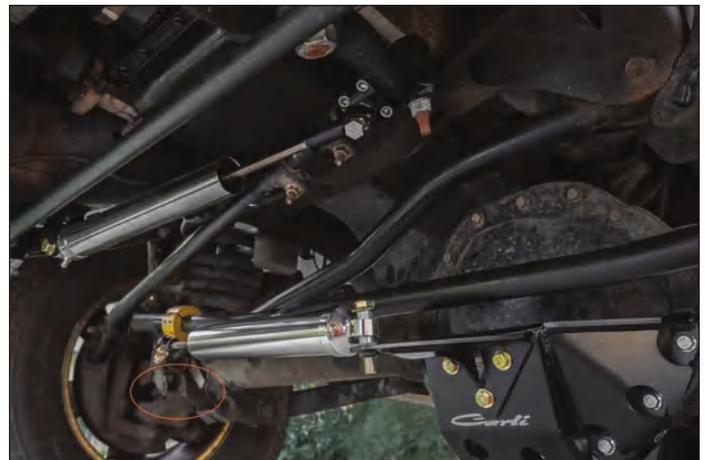
Figure 3: My (Issue 87) Installation of the Carli Suspension "Dual opposing steering stabilizers." Without using the factory mount point, the lower stabilizer is located above the bottom of the axle tube, reducing the risk of damage in off-road situations.

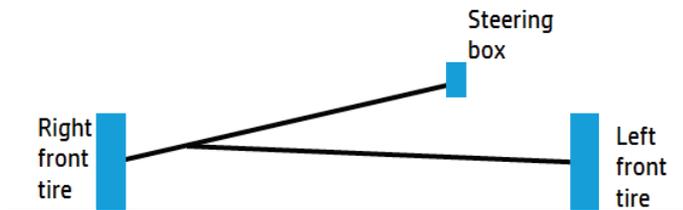
Turbo Diesels from 2003 through the mid-2008 model year were manufactured with what is known as a "Y-type" steering system, illustrated in figure 4. In the illustration, note that the tie rod from the left front tire connects to the steering drag link, forming a "Y" configuration. Why is this important? Imagine, for example, that the steering box in Figure 4 moved upward. This action would pull the left and right steering knuckles closer together, causing the tires to "toe in" (pigeon-toed). Conversely, moving the steering box downward would push the steering knuckles farther apart, causing the tires to "toe out." The main point of interest for this geometry is that *suspension toe changes dynamically during normal vehicle operation.*

Figure 4: "Y-type" steering system supplied on 2003-2008 model year trucks. In this configuration, suspension toe changes dynamically during normal vehicle operation.

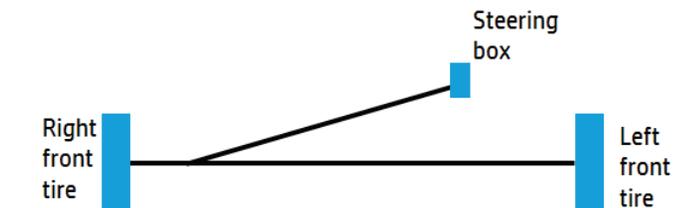
During the 2008 model year, Chrysler began to ship model 2500 and 3500 model Turbo Diesels with a different steering linkage geometry known as the "T-type", illustrated in figure 5. Note that for this geometry, the distance between the left and right steering knuckles is fixed, due to the rigid tie rod connecting the two together. *This means toe is not affected by suspension flex.*

Figure 5: During the 2008 model year, Chrysler introduced the "T-type" steering system, so named because the steering drag link "tees" into the steering tie rod. For this geometry, the distance between left and right steering knuckles remains fixed, keeping toe constant during suspension flex.

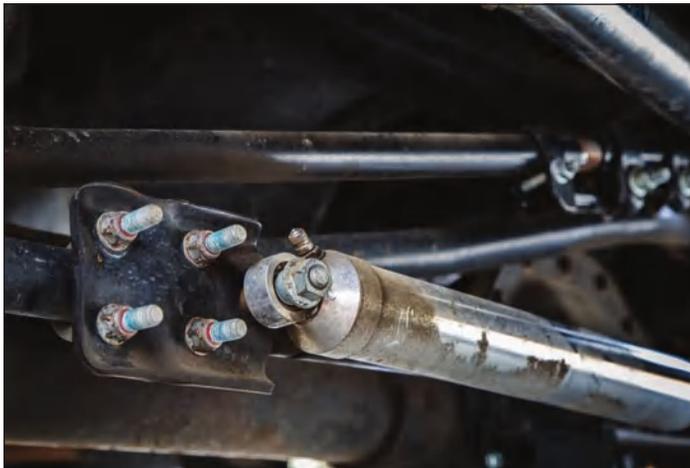
Figure 13: The Carli Suspension Low-mount stabilizer utilizes the factory supplied clamp, repositioned to the correct location per instructions from Carli Suspension.
