THIRD GENERATION SUSPENSION UPGRADES: PART THREE

by Doug Leno

In this article I will describe my repair of the factory steering linkage system and discuss my choice to upgrade to the newest factory design.

BALL JOINT REPLACEMENT

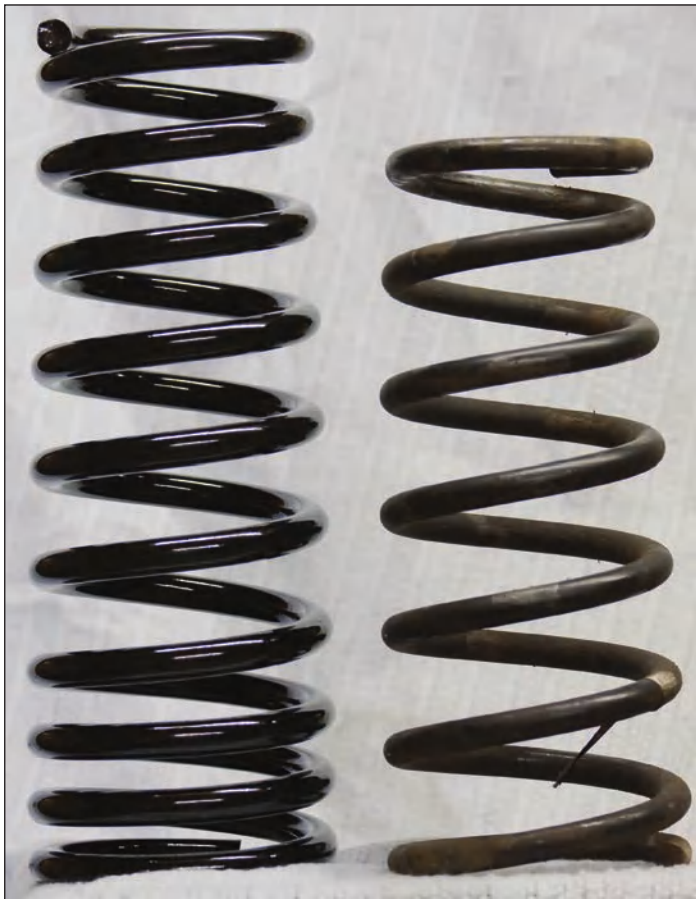
Figure 1: Carli Suspension multi-rate coil spring (left) installed in 2012, provided approximately three inches of lift compared to the factory spring (right)

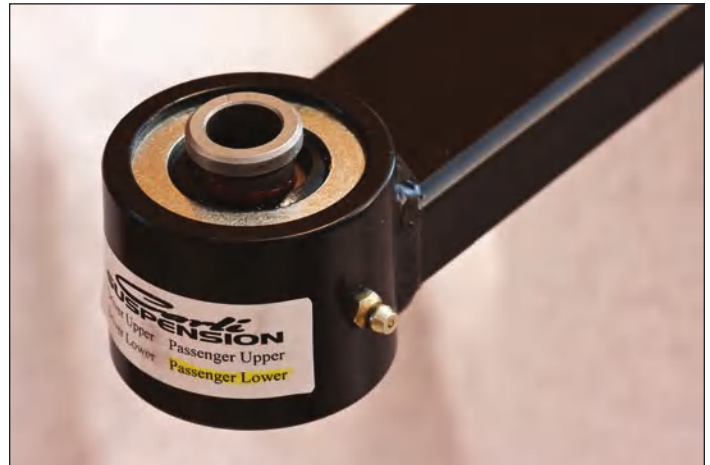
Figure 2: Carli suspension lower control arm, installed in 2012. The serviceable bearing eliminated the friction caused by the rubber bushings in the factory control arm.

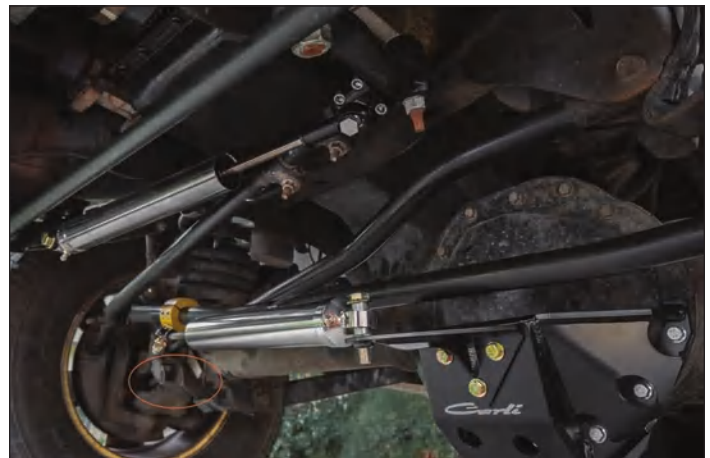
Part Two of the project was covered in February 2015, TDR Issue 87 (pages 13-17). In this article I described the Carli Suspension "dual-opposing steering stabilizer" solution. This upgrade greatly reduced the risk of stabilizer damage in off-road situations by locating both stabilizer bodies above the bottom of the axle tube (see figure 3).

Figure 3: My (Issue 87) Installation of the Carli Suspension "Dual opposing steering stabilizers." Without using the factory mount point, the lower stabilizer is located above the bottom of the axle tube, reducing the risk of damage in off-road situations.

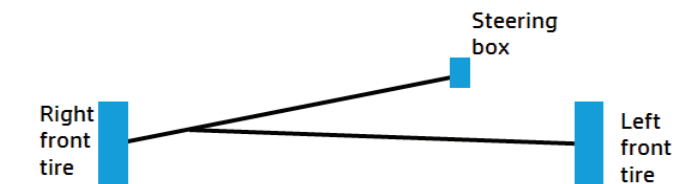
Turbo Diesels from 2003 through the mid-2008 model year were manufactured with what is known as a "Y-type" steering system, illustrated in figure 4. In the illustration, note that the tie rod from the left front tire connects to the steering drag link, forming a "Y" configuration. Why is this important? Imagine, for example, that the steering box in Figure 4 moved upward. This action would pull the left and right steering knuckles closer together, causing the tires to "toe in" (pigeon-toed). Conversely, moving the steering box downward would push the steering knuckles farther apart, causing the tires to "toe out." The main point of interest for this geometry is that *suspension toe changes dynamically during normal vehicle operation.*

Figure 4: "Y-type" steering system supplied on 2003-2008 model year trucks. In this configuration, suspension toe changes dynamically during normal vehicle operation.

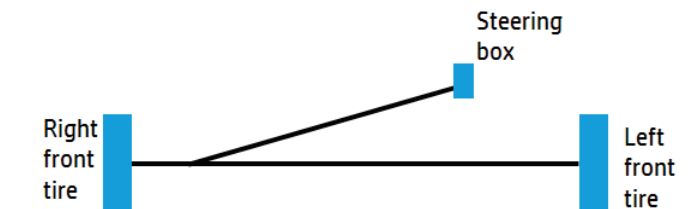
During the 2008 model year, Chrysler began to ship model 2500 and 3500 model Turbo Diesels with a different steering linkage geometry known as the "T-type", illustrated in figure 5. Note that for this geometry, the distance between the left and right steering knuckles is fixed, due to the rigid tie rod connecting the two together. *This means toe is not affected by suspension flex.*

Figure 5: During the 2008 model year, Chrysler introduced the "T-type" steering system, so named because the steering drag link "tees" into the steering tie rod. For this geometry, the distance between left and right steering knuckles remains fixed, keeping toe constant during suspension flex.

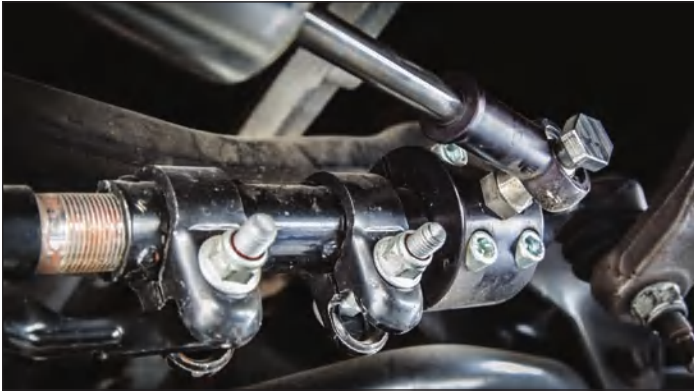
Carli Suspension's dual stabilizer system is compatible with either "Y-type" or "T-type" steering systems. As is the focus of this article, the newer steering system is manufactured with larger diameter tubes, which means that a different Carli suspension clamp is required for the upper stabilizer (see figure 12). Carli's low-mount stabilizer utilizes the factory supplied clamp, shown in figure 13. Note that for these photographs, I decided to break with tradition and show the installation after several hundred miles of road use. You won't see shiny new parts in these photos, but you will see how road grime accumulates, and how the axle tube itself protects the lower stabilizer (figure 13).

Figure 12: Installation of the Carli Suspension "High mount stabilizer" required a new clamp to accommodate the new tube diameter.

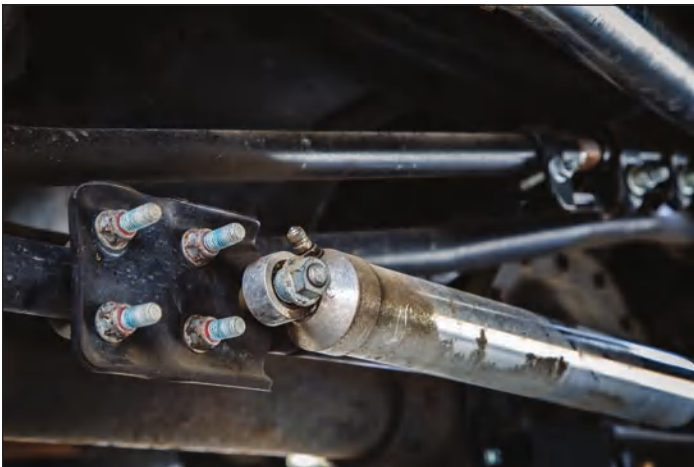
Figure 13: The Carli Suspension Low-mount stabilizer utilizes the factory supplied clamp, repositioned to the correct location per instructions from Carli Suspension.
