# TURBO DIESEL Buyer's Guide

# Vintage '94-'04 Transmission Lock/Unlock Problem

# TRANSMISSION NOISE PROBLEMS

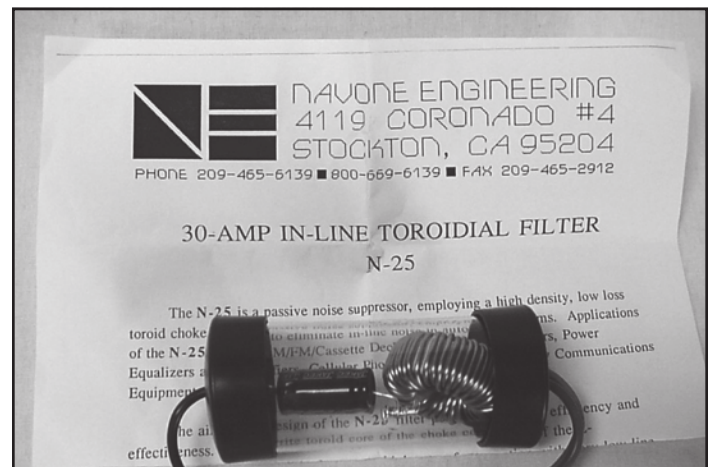
A final correction method was provided from a source on the TDR website. I have not tested this fix, but it looks promising. According to the description of the problem and its repair, the noise generated on the TPS signal wire is fed to the ECU, which sends it to the JTEC, which in turn controls torque converter lock/unlock. This fix consists of installing a filter at the JTEC connector C-1, pin 23, an orange/dark blue wire labeled TPS SENS IN. This wire is cut back from the connector, and the filter kit is soldered in place. The red filter wire is soldered to the cut wire on the connector side. The green filter wire is soldered to the cut wire on the harness side. The black filter wire is spliced and soldered to any one of three ground wires on C-1. All splices are secured by heat shrink and taped. It should be noted that the filter kit is not waterproof. The filter kit, with part number N-25, may be sourced through [Navone Engineering](#), telephone number (209) 465-6139.

The Navone Engineering N-25 noise filter kit.
