# HAVE RAM, WILL TRAVEL

**IS THIS THE “KDP” OF THE 6.7 ENGINE?  
PART ONE OF MY TURBO ACTUATOR STORY**

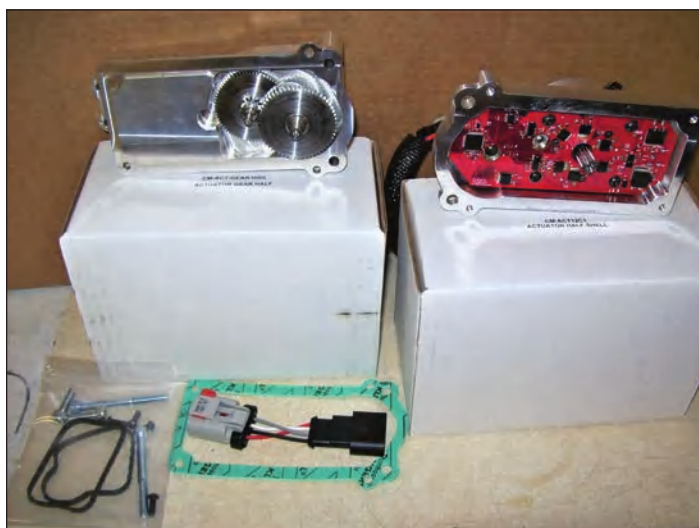
The City Diesel gearbox on the left, and the electronics and drive gear module on the right. This photo shows the halves that mate together, with the gasket and controller cable adapter below.

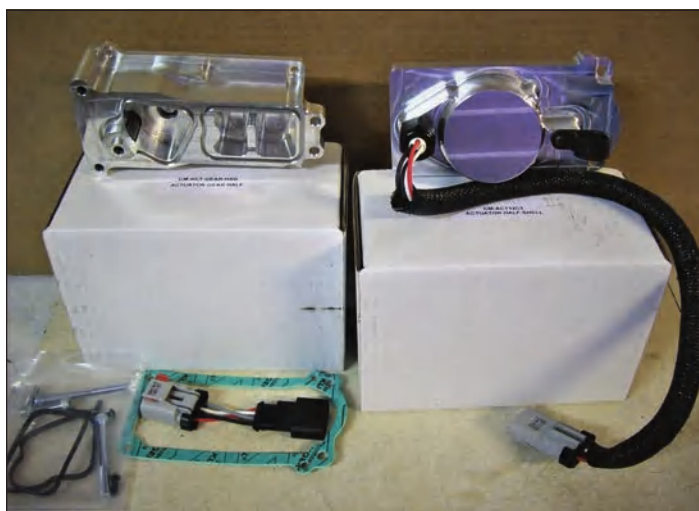
This photo shows the opposite sides of the City Diesel actuator. Both halves are machined from billet aluminum, not made of castings like the Cummins OEM parts.

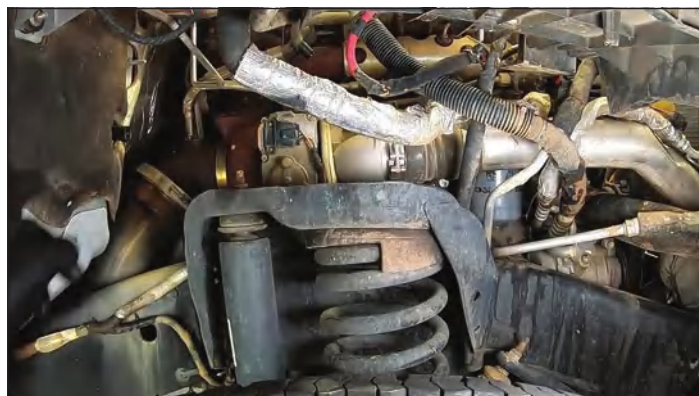
**Stock actuator on a 2013-up Turbo Diesel, as shown in David Pike’s video.**
