# TURBO DIESEL Buyer's Guide

A Publication of the *Turbo Diesel Register*

## A WORD ABOUT THE TURBO DIESEL BUYER'S GUIDE

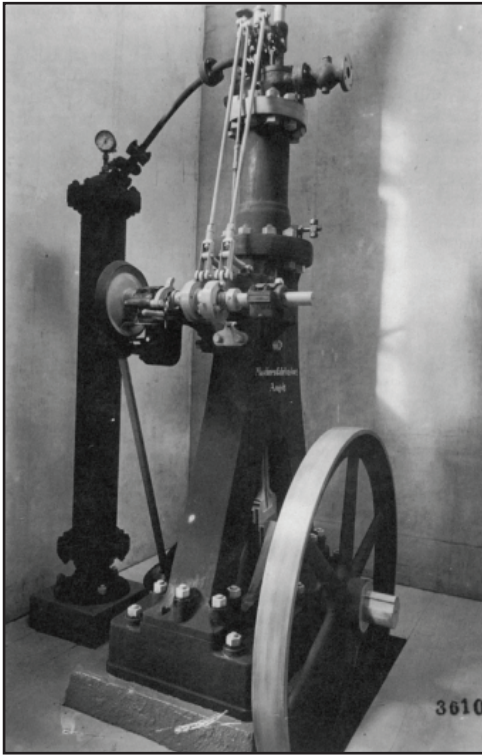
Diesel's first engine at the start of an 1893 test (photo courtesy of C. Lyle Cummins).

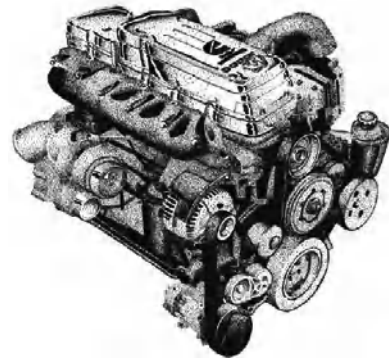
The Cummins engine used in today's Dodge pickup.

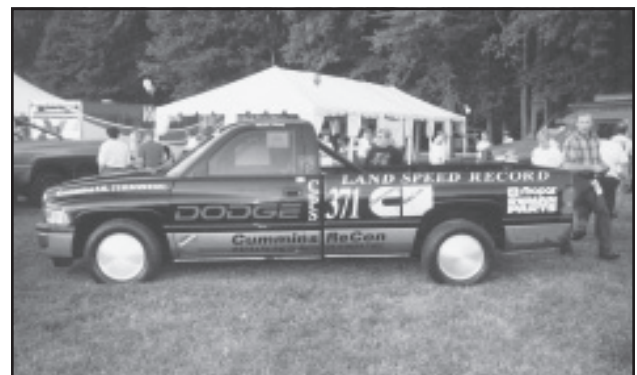
This interesting photo is an early '94 model truck that was modified to run at Bonneville. It successfully set a class record at the 1997 Bonneville Speed Weeks of 141.256 mph. (TDR Issue 15, page 44).

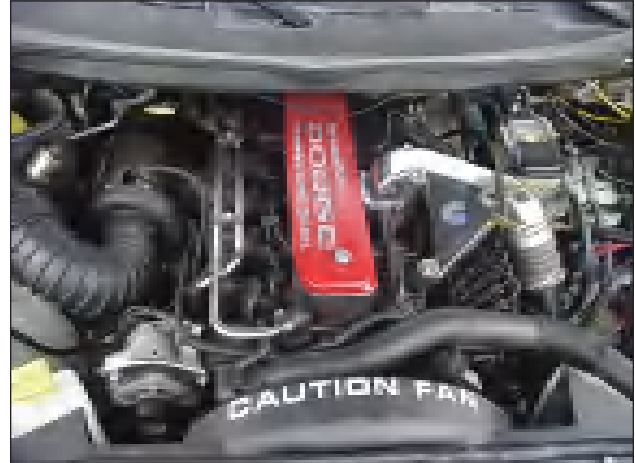
In the world of ever tightening exhaust emissions, long gone is this 12-valve engine with its mechanical P-7100 fuel pump.

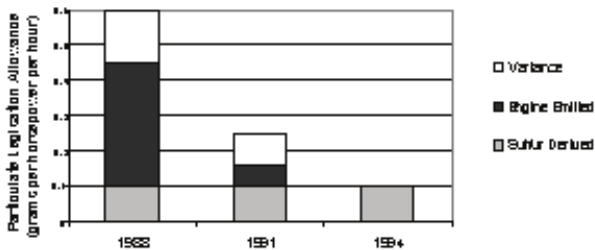
### Diesel Particulate Emissions Makeup

As you can see from the graph, low sulfur fuel was a necessity for 1994. Without low sulfur fuel, the diesel particulate output of 0.1 gram/hp/hr would result from fuel sulfur alone, allowing for no design variance or engine-emitted particulates.

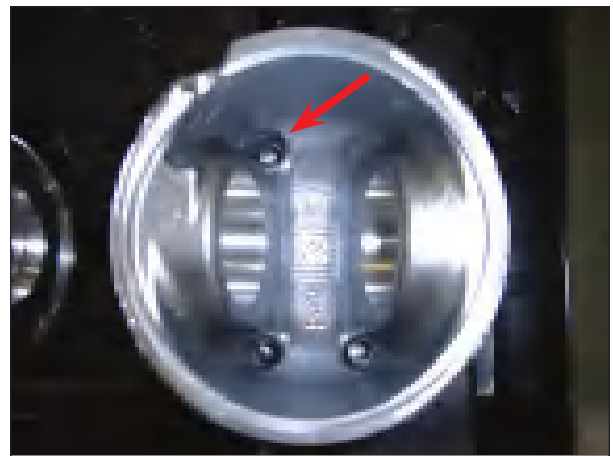
**Underside of the HO piston. Note the passageway for oil to flow through the piston.**

HO engines use a new system that includes a component called a "J-jet" for each piston. The J-jet nozzle is bolted to the block and directs a stream of oil to the underside of the piston. HO pistons have a passageway to direct the flow of oil through the piston head to cool it. HO engines also have an exhaust manifold that is capable of higher exhaust temperatures.

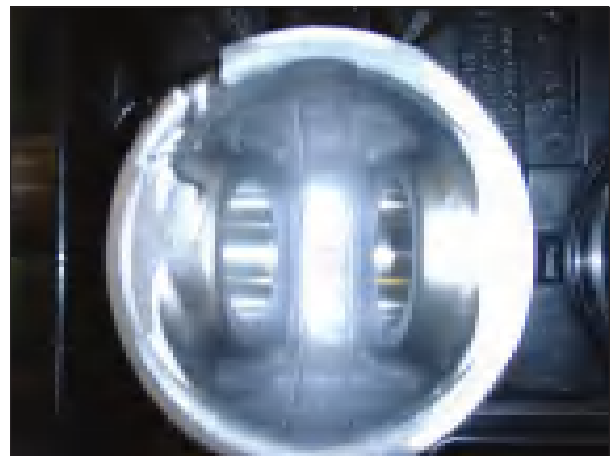
**Underside of the standard piston.**

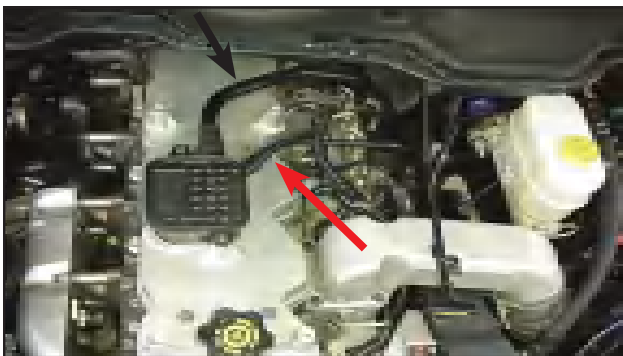
The 2003 crankcase vent system. The white arrow shows the inlet from the crankcase to the filter assembly. The red arrow points to the outlet hose that vents to atmosphere.

The crankcase vent system has been a point of contention for many Turbo Diesel owners. To virtually eliminate the driveway-drip problem Cummins and Fleetguard have redesigned the crankcase vent system. Thankfully the crankcase vent (read: low pressure vaporized oil) is *not* routed to the engine's air intake system [like the new 6.0 liter Power Stroke (Issue 39, page 96) or the Volkswagen automotive diesel (Issue 38, page 28)]. I can tell you from firsthand experience with crankcase vent oil and exhaust gas recirculation with a Volkswagen passenger car that it is messy. The vent on the Cummins engine goes from the engine to an oil separator box on top of the valve cover then is vented to atmosphere.

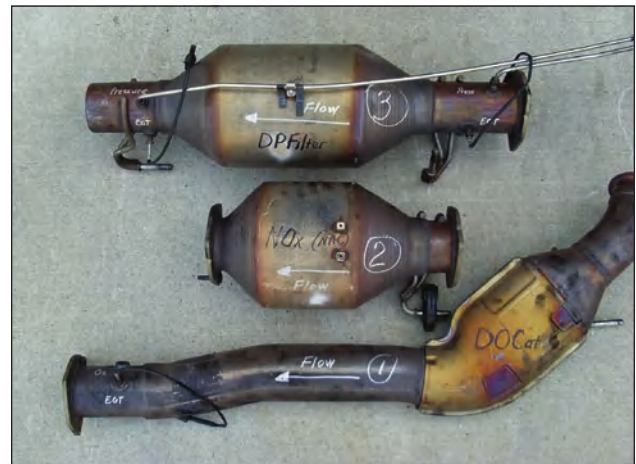
These components were taken from a Cummins test vehicle.

1. diesel oxidation catalyst (DOC)
2. NO<sub>x</sub> adsorber catalyst (NAC)
3. diesel particulate filter (DPF)

"The system begins with a close-coupled catalyst—essentially a conventional diesel oxidation catalyst (DOC) incorporating a metallic substrate—mounted to a short downpipe just off the back of the turbocharger. A short distance behind and below the close-coupled catalyst is the NO<sub>x</sub> adsorber unit, which is followed by a particulate filter. Both the NO<sub>x</sub> adsorber and diesel particulate filter (DPF) use ceramic substrates.

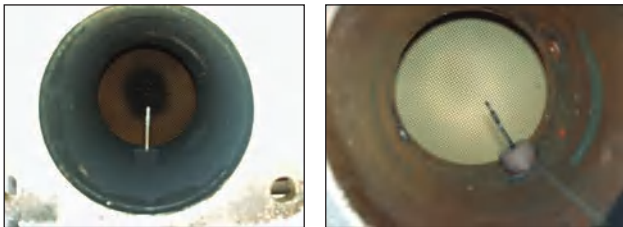
The “in” and “out” sides of the DPF.

“The third part of the aftertreatment is the diesel particulate filter (DPF). The DPF is regenerated when differential pressure sensors in the exhaust system detect a specified amount of loading on the substrate. Unlike the PM filter systems used on heavy-duty applications, there is no ash cleaning required, and the PM filter—like the NO<sub>x</sub> adsorber and close-coupled catalyst—is rated for the life of the vehicle.

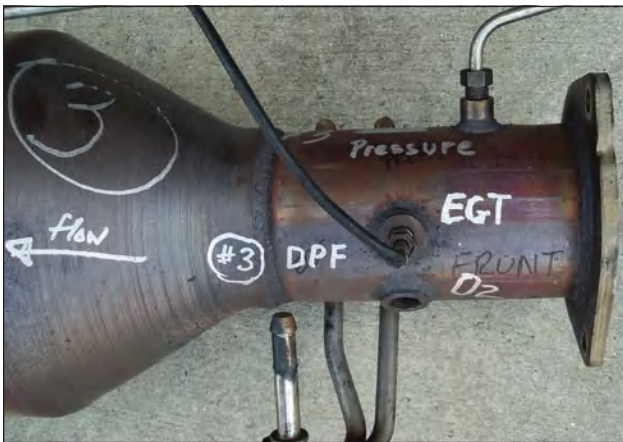
EGT, oxygen and pressure sensors monitor the need for regeneration of the NAC and DPF.

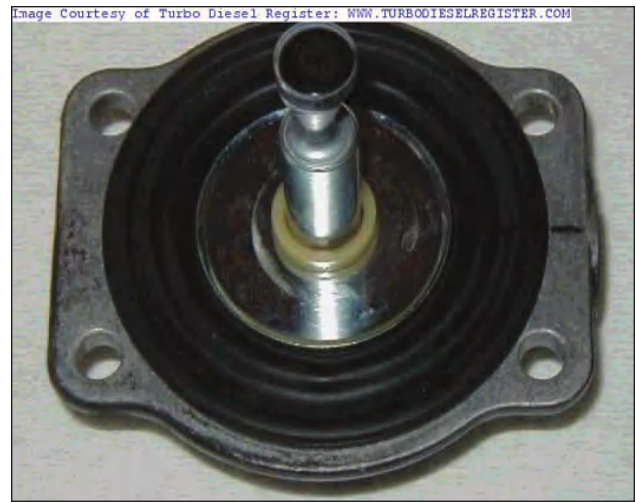
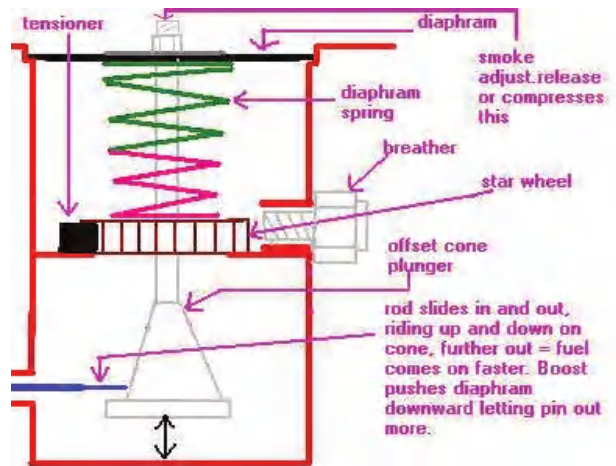
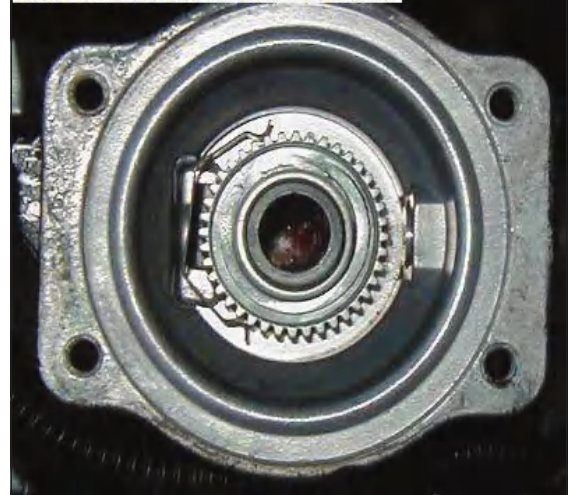
**The AFC diaphragm.** This is located under the domed housing on top of the injection pump which, once removed, will reveal the black rubber diaphragm and its attached stem and cone supported by a spring. The diaphragm responds to engine boost pressure and deviates (deflects) downward. As this occurs, the cone at the bottom of the stem moves down and allows the fueling *rate* to increase. This adjustment is made by rotating the diaphragm with its attached cone from a slight to aggressive setting. You will need to remove this diaphragm and look very closely at the cone on the bottom. It is in fact, not on the center of the stem axis but offset. In the hole that this assembly fits down into, there is a small pin that pops out from the bottom/front of the hole. This pin rides up and down on that cone. Once the diaphragm has been removed, you’ll likely see some marks on the cone from the pin contacting it. Rotating the diaphragm/cone so that the deepest part of the cone faces forward (toward the pin) will allow for more fuel per pound of boost.

**The starwheel.** When you removed the diaphragm from the pump, you will have exposed the AFC spring. It is often a dual colored spring (it makes no difference which way is up). The spring sits on the *starwheel*. Rotating the starwheel up or down will place more or less spring load on the diaphragm. Turning this up (clockwise) will result in more boost being needed to start the deflection, and counter-clockwise reduces the amount of boost needed to perform the same deflection. Adjustment will also impact your overall smoke levels and mileage.

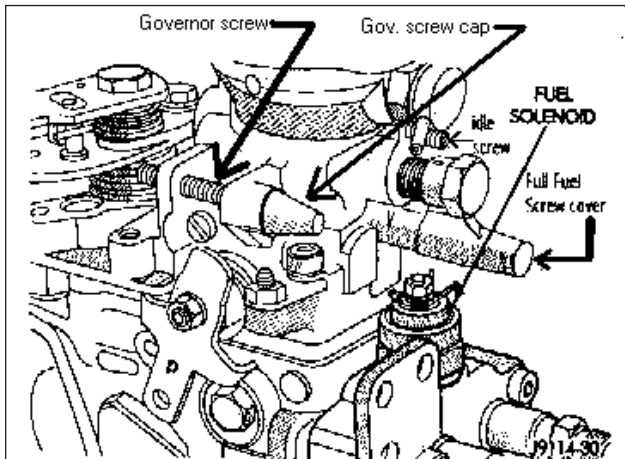
**The full fuel screw.** This is located at the back/inside of the injection pump against the engine. It is also covered by a tamper cover, assuming this hasn't already been removed. In most cases you will need to loosen and move the boost tube attached to the rear/top of the pump to get to the fuel screw as well as the idle screw.

Under the tamper cover is a screw with a 6mm hex tip, and a 13mm locknut. The firewall end of this screw will normally have a tack welded lock collar on it. Some basic adjustments to the full fuel screw can usually be made without removing the lock collar.

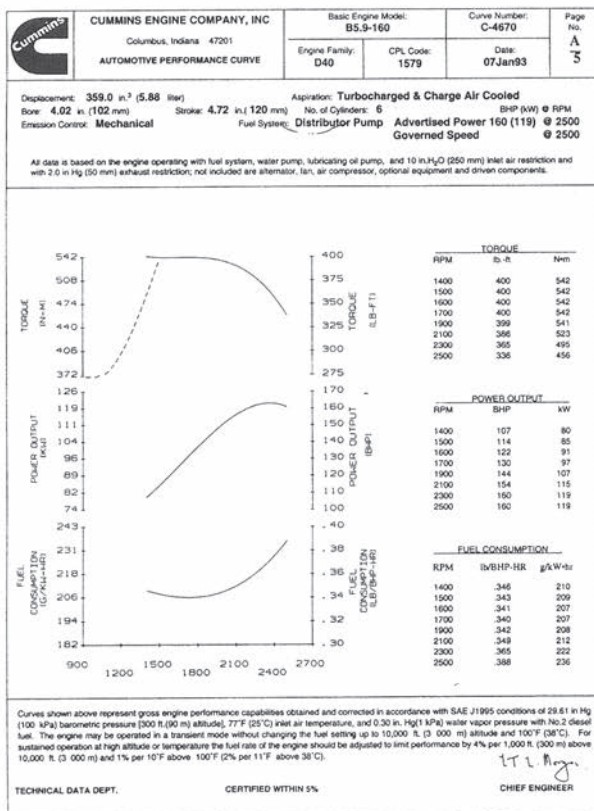
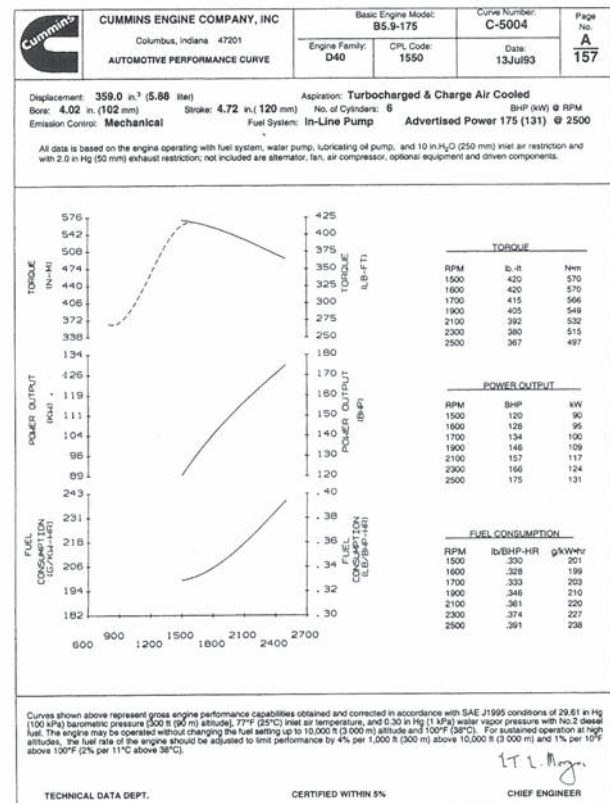
**performance curve. For 24-valve owners please see our discussion in the 24-valve topics on page 48. At 1,600 rpm you've got the torque peak of the engine available to keep your speed constant as you encounter a grade. If your speed drops below 1,600 rpm, you had better downshift because it's all "downhill" (back side of the torque curve) from there. You've obviously exceeded the maximum torque produced by the engine and multiplied by the gearbox/rear end ratio of the load you're trying to propel.**

Final note, volumetric efficiency reaches its peak at the rpm at which the torque peak occurs. The physics to produce torque peak requires the greatest cylinder filling or volumetric efficiency.

Interesting stuff? What does it mean to you? I hope you've learned from the efficiency relationships that it would be best to put your engine on cruise control at a speed corresponding to 1,600 rpm for the given 12-valve

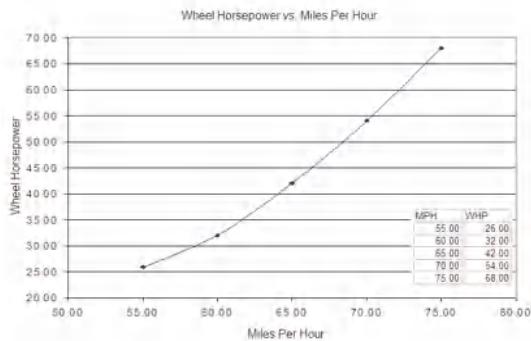
I felt finding a BSFC-like number for a Turbo Diesel would be a good way to check the relative fuel consumption. I knew our chassis dyno could be set to measure the horsepower at the wheels. But at what horsepower did we need to run the tests? The TST staff brainstormed the question and decided we needed to determine the actual horsepower it took to move a Turbo Diesel pickup at various road speeds. We took our '03 Dodge Ram out on the Interstate highway and ran it for several miles in both directions while recording instrument readings for air temperature, mph, gear selected, turbo boost, egt, rpm, and rail pressure. We gathered data for road speeds from 55 mph to 75 mph, in 5 mph increments. We then tied that truck to the chassis dynamometer and tried various loads until we could reproduce the instrument readings we took out on the Interstate. This gave us a horsepower value to use in our fuel economy tests for various road speeds. (See figure 1)

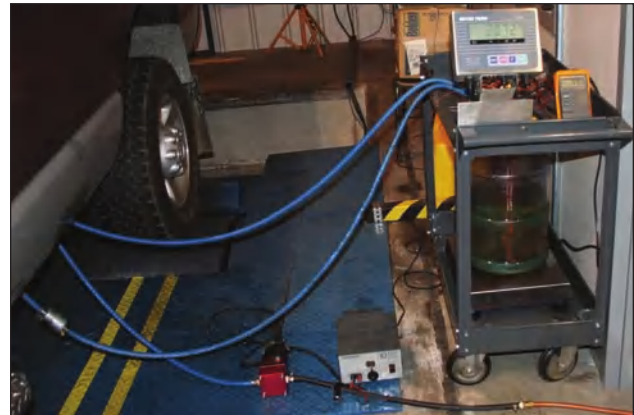
weigh the fuel as it is consumed. By carefully weighing a gallon of fuel, we could then determine the number of pounds per gallon. We could then use this pounds-per-gallon number to convert our pounds of fuel used back to gallons for the mpg calculation. This is the procedure that is used by Cummins in official ASE-type testing of big rigs at fleet accounts. We purchased an electronic scale with a digital readout that was guaranteed accurate to one hundredth of a pound and used a transparent five-gallon plastic jug as our fuel tank. We unhooked the quick connects from the truck tank and plumbed them such that the engine would draw and send its return fuel to the plastic jug (See picture below).

It took about four hours to add 50 feet of copper tubing to our return fuel line. We dropped that copper line into a large cooler and returned the fuel to the plastic jug. We then used a garden hose to run cold city water through the cooler to keep the returned fuel cool. By regulating the city water flow we could maintain the fuel temperature at a usable level.

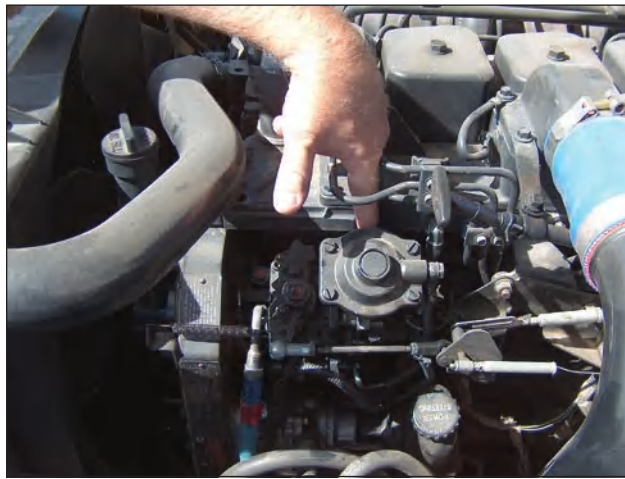
**A Bosch VE pump on a Cummins B engine, with a finger showing the clearance between the AFC module and the cylinder head.**

There are official tools and procedures for setting the timing of the VE pump. Many years of working with these pumps on Dodge applications have resulted in some "quick and dirty" procedures that you can use on a try-and-fit basis. You can try small incremental positioning (turning) of the pump to see what effective timing works best for your truck. If you want to take the pump timing about as far advanced as you would want, for good performance and economy, the result will be around 5/8" to 3/4" clearance between the air-fuel control module (afc) and the cylinder head, about a finger-width. Advancing the pump too much (moving the top toward the

head) gives white smoke, but not the amount of engine fuel knocking or rattling that you would get from advanced timing with an in-line P7100 pump. Better mpg may occur with advancing the VE pump timing slightly from stock. Retarding the pump timing will generally result in lower engine power.

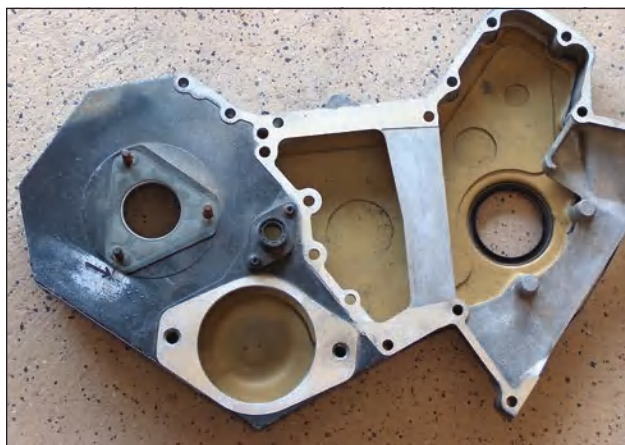
**Engine side of a VE-pump style Cummins gear housing.**

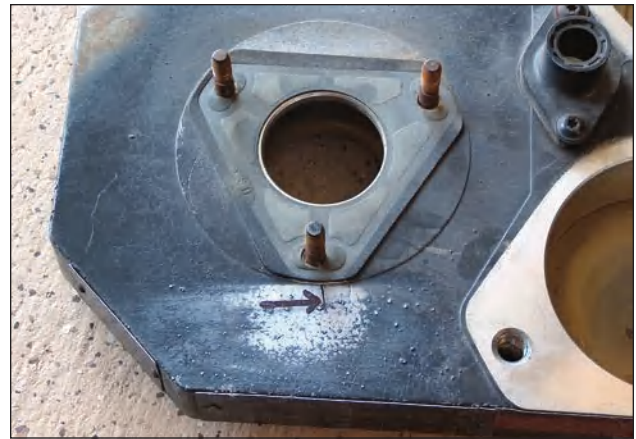
**Close up view of the VE pump mounting area of the gear housing with the housing timing mark and the pump-to-housing gasket.**

If you decide to use the “finger clearance” method, first look closely at the pump flange to the outside of the outermost mounting stud and nut. You should find a chisel notch on it, and a corresponding notch in the gear housing. These marks serve to indicate the “factory” timing setting. To rotate the pump and advance the injection timing, you need to loosen the three 13 mm headed nuts and the injector line nuts at the back of the pump (so you won’t twist the lines and strain them). The pump will resist turning until the nuts are loose enough, because of the fiber mounting and sealing gasket that can be seen in the photos. The Snap-on Blue Point SP144 wrench helps greatly in removing the two hard-to-access pump mounting nuts. The Snap-on flare nut crow’s-foot helps to loosen the injector line nuts. It should be 16 mm (5/8”, part number FRH200S) or 17 mm (part number FRHM17).

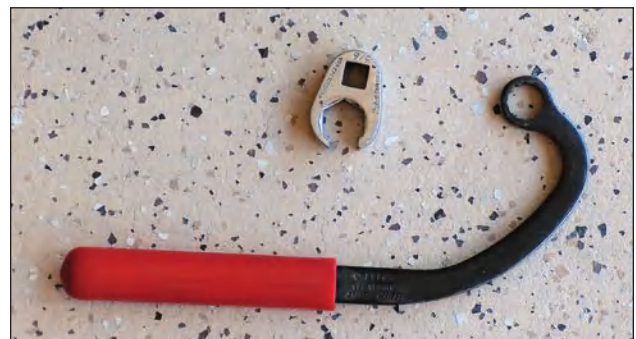
**Snap-on flare nut crow’s-foot and pump mounting nut wrench.**

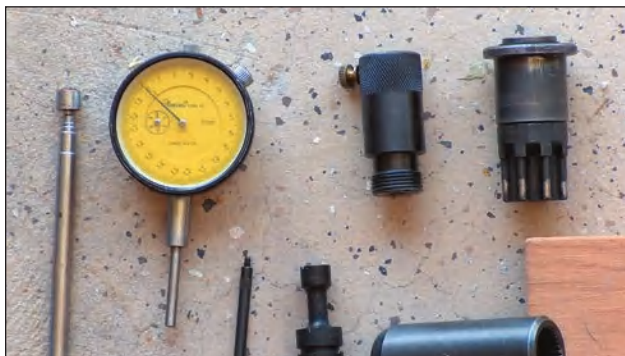
**T5. Miller MLR-6860 P7100 pump timing tool kit. At the left is a magnet on a telescoping “stick.” To its right is the dial indicator with the stem extension below and to its right. To the right of that is a timing pin with a steel tip epoxy glued onto it. The special splined socket is at bottom right, with the splined end resting on a block of wood. At top center is the adapter that holds the dial indicator and screws into the top of the pump barrel. At top right is an engine barring tool that plugs into the aluminum block adapter plate and meshes with the flywheel teeth.**

To set the timing of the P7100 pump, you need precision tools and all fuel system internal parts must be kept scrupulously clean. You need Miller MLR 6860 pump timing tool kit and a Snap-on Blue Point SP504 plate style gear puller (or equivalent). When you remove the #1 delivery valve, do not touch it dry with bare fingers. Use a clean telescoping stalk/magnet and keep it covered with clean diesel fuel.

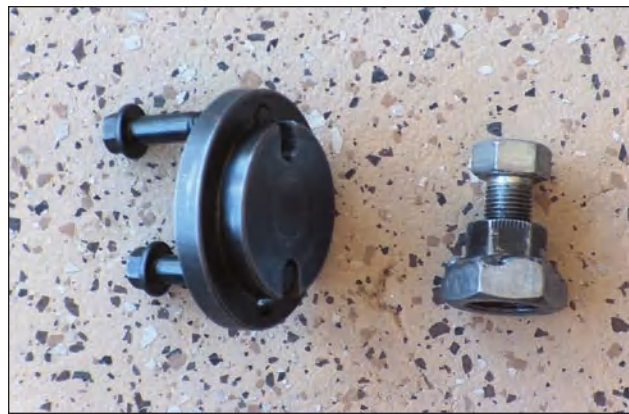
**T6. The Snap-on SP504 gear puller with M8x1.25x40 bolts and the home-made pump shaft turning tool at right.**

The P7100 injection pump cannot be simply rotated so the top is closer to the cylinder head. Its mounting ears do not have elongated slots, and the back end of this very heavy pump is supported on a flat pedestal mounted to the engine block. You must pull the drive gear and then rotate the pump shaft. Pulling the gear inevitably results in a shock as the taper fit “pops,” causing the pump shaft to jump out of time, in the retarded direction—but how much it jumps (rotates) varies with each time it happens. That is why you simply CANNOT use a shadetree trick like popping off the gear, turning the crank a little, and replacing the gear. You just cannot tell where the pump timing “went” without the dial indicator.

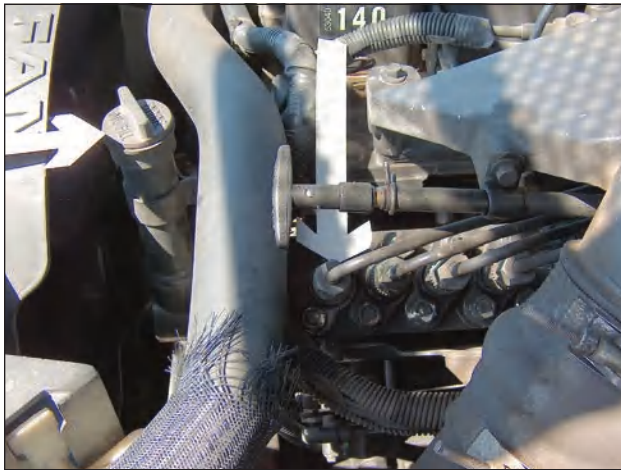
**T7. A Bosch P7100 pump on a Cummins B engine, with arrows pointing to the oil filler tube/cap, and to #1 injection line and pump barrel.**

1. Install a dial indicator so you can track the fuel injection event within the pump. Install the engine barring tool in the flywheel and rotate the engine crankshaft until the needle indicates the lowest point of the pump plunger. To get to the plunger, you have to remove #1 injection line, [right hand arrow in photo T7] use a special splined socket to remove the “tower” on the #1 pump barrel, and then use a magnet-on-a-telescoping-stick to pull the delivery valve and its steel casing (about 5/8” diameter) out of the pump barrel. [see photo T8] Then you thread on a special holder for the dial indicator, and install the indicator so the measuring stem is on top of the plunger. [see photo T9]

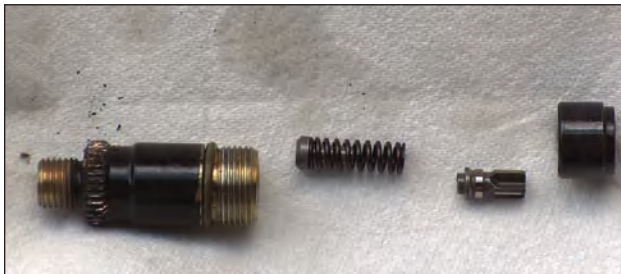
**T8. Delivery valve parts removed from #1 injection pump barrel assembly in order to set timing.**

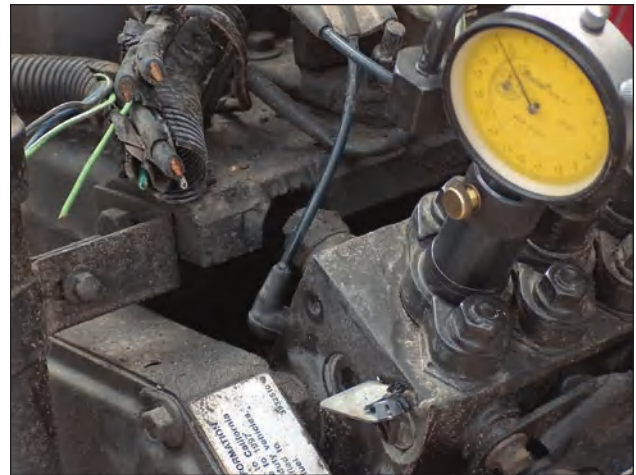
**T9. Dial indicator installed in #1 barrel of a P7100 injection pump.**

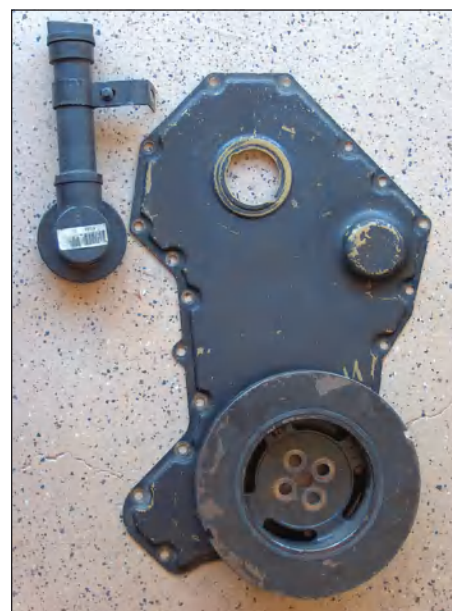
**T10. A Cummins gear housing, front side, with the oil filler tube at yop left.**

2. Rotate the engine crankshaft to TDC for #1 cylinder and make sure it is the TDC of injection (with a four cycle engine, one is injection/firing TDC and the other TDC is “overlap” of the exhaust and air intake events). The correct TDC will have #1 valves closed and both valves for #6 cylinder will be slightly open.
3. Compare the amount of plunger lift at TDC to timing in degrees using the table on page 105 for the specific version of your P7100 pump. Now you know what the timing is before you reset it.
4. While the barring tool prevents the engine from turning, remove the 30-mm hex nut and washer from the pump shaft. The nut is behind the oil filler tube (left hand arrow in photo T7, and bottom left in photo T10), and to access it you have to unthread the oil fill pipe from the base, and unthread and remove the base from the engine gear housing cover (T10).

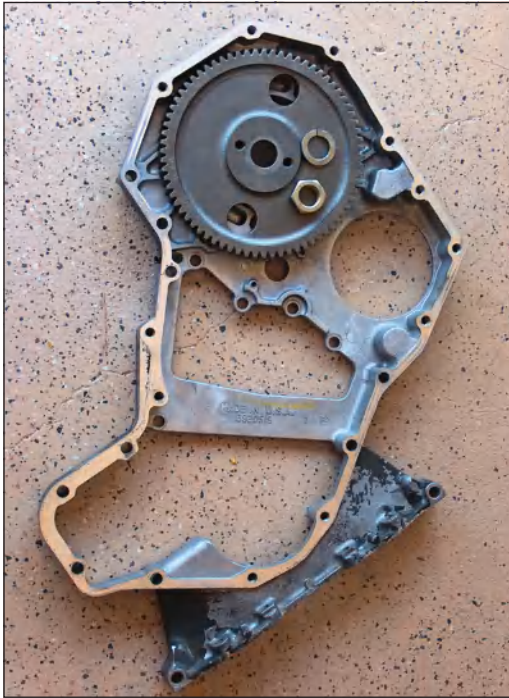
**T11. A Cummins B gear housing with a P-pump drive gear, washer, and nut.**

- Use a puller (Snap-on SP504 or similar) to “pop” the gear (photo T11) loose from the tapered pump shaft. If you watch the big and little dials of the indicator, you will see how much the pump timing retarded on this occasion. Use of the puller is illustrated on a CP3 pump and gear in Photo T12. (Notice that the CP3 uses a small 36 tooth gear and thus spins at crankshaft speed, not camshaft speed!)

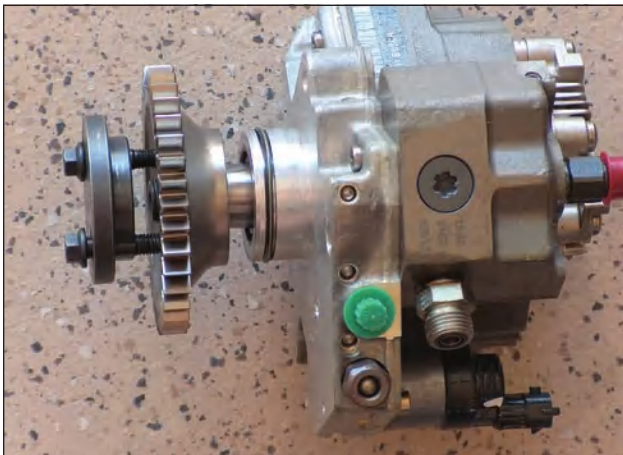
**T12. Use of the SP504 gear puller is illustrated here with a Bosch CP3 pump.**

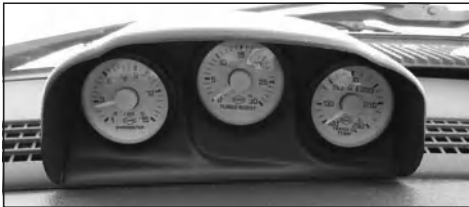
Now that you have the specifications in hand—wait a minute, you don't have a boost gauge? This instrument is easy to source, relatively cheap (\$40-\$60) and easy to install. The majority of gauges on the market are mechanical devices that do not require electricity to operate. To put a gauge in, one can use a "boost bolt" to access the pressurized intake air.

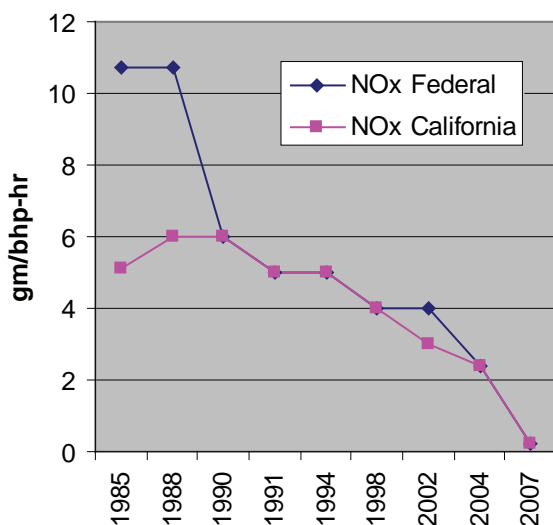
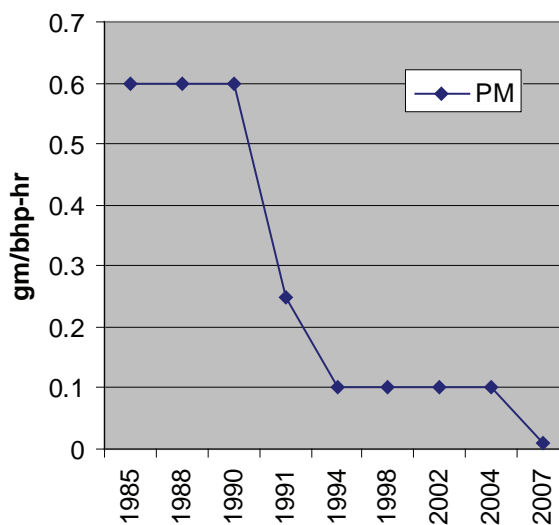
Note the sharp, ten-fold drop in emissions from year 2004 to 2007. I recall that one of the first TDR magazines stated that emissions were the driving force behind changes to the diesel engine. The 2007 emissions targets nail home that statement. Certainly ultra-low sulfur fuel will help, but the engineering it will take to meet the targets is difficult to imagine.

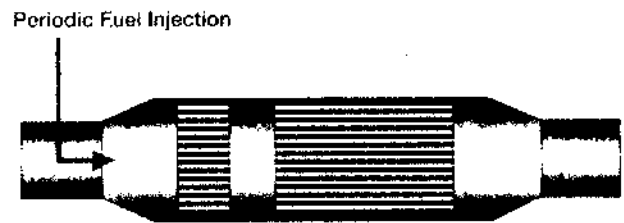
NO<sub>x</sub> Adsorber Catalyst

The elimination of all excess oxygen in the exhaust gas for a short period of time can be accomplished by operating the engine in a rich mode. This is done by injecting fuel directly into the exhaust stream ahead of the adsorber to consume the remaining oxygen in the exhaust. Either way, the engine and catalyst must be controlled as a system to determine exactly when regeneration is needed, and to control the exhaust parameters during regeneration itself.

The NO<sub>x</sub> adsorber catalyst (NAC) is a technology developed in the late 1990s. The NAC uses a combination of base metal oxide and precious metal coatings to effect control of NO<sub>x</sub>. The base metal component (for example, barium oxide) reacts with NO<sub>x</sub> to form barium nitrate—effectively storing the NO<sub>x</sub> on the surface of the catalyst. When the available storage sites are occupied, the catalyst is operated briefly under rich exhaust gas conditions (the air-to-fuel ratio is adjusted to eliminate oxygen in the exhaust). This releases the NO<sub>x</sub> and allows it to be converted to nitrogen

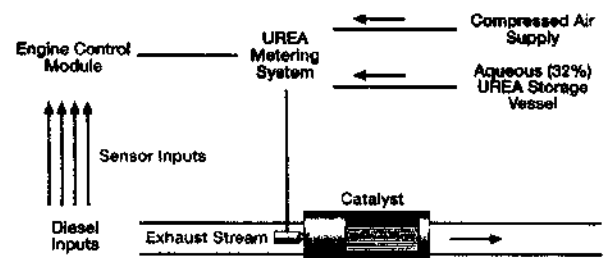
Basic Principal - Spraying UREA into the exhaust stream to promote NO<sub>x</sub> reducing catalyst activity.

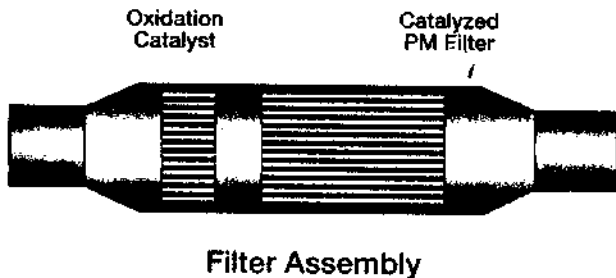
There are several methods to control or raise the exhaust temperature to manage the regeneration event in the DPF. The most promising methods for an active integrated system for 2007 are management of the engine combustion process in combination with an additional oxidation catalyst. This will allow regeneration to take place under low-ambient/low-load conditions when exhaust temperatures are low, as well as during normal operation.

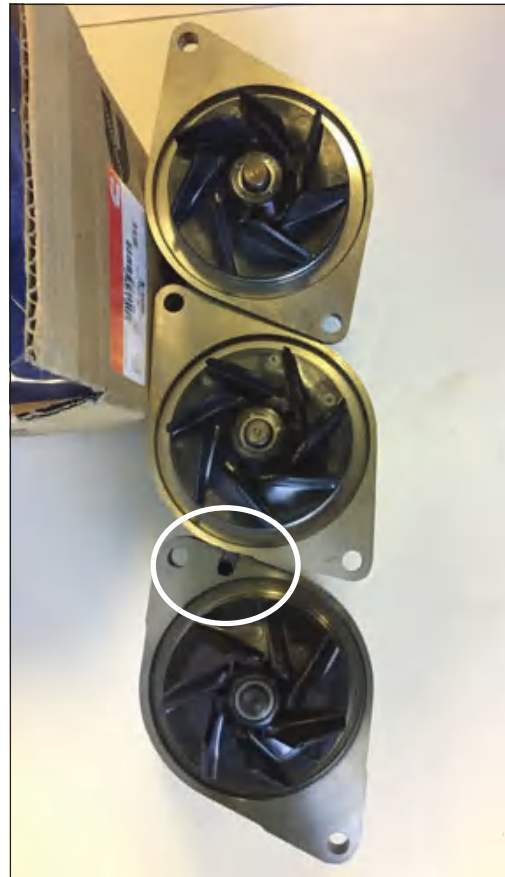
**The official T512AA water pump is on the bottom. We circled the weep hole which sets it apart from the other two pumps.**

However, from our close inspection of these two pumps (they appear to be identical) and the official number used in the recall part number CS2H T512AA, there is a subtle difference. We couldn't find a weep hole [not to say it isn't hidden behind the pulley (likely)] on the Cummins/Mopar parts. At a minimum you have replacement options.

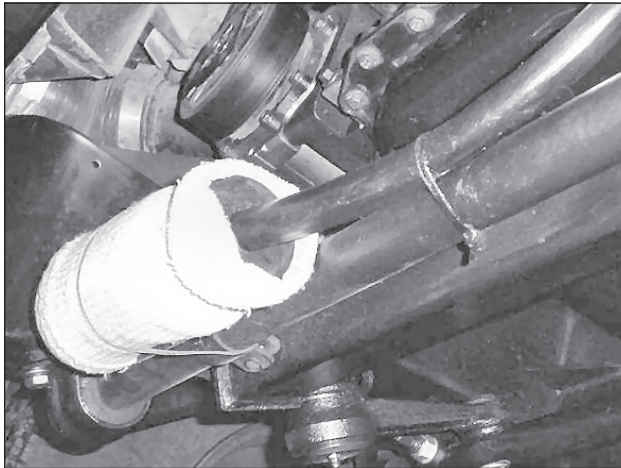
**The old cotton sock idea is an easy fix with no drips or oily film on anything but the outer sock. I replace the sock while I am under the truck changing oil. I extended the tube and drip catch bottle down to the anti-sway bar and secured it with a couple of wire ties.**  
**Gary-K7GLD, Canyon City, OR**

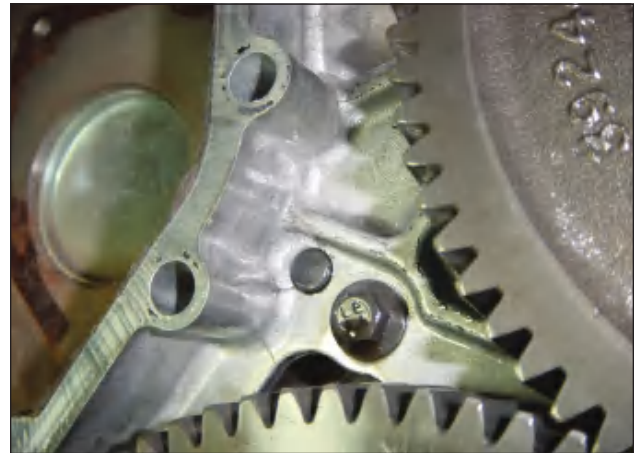
A close-up picture of the dowel pin.

leak. The fix involves staking the pin, covering the pin with a teardrop-shaped washer placed under a nearby bolt, or removing the pin altogether since it has already served its purpose in locating the housing during engine assembly.

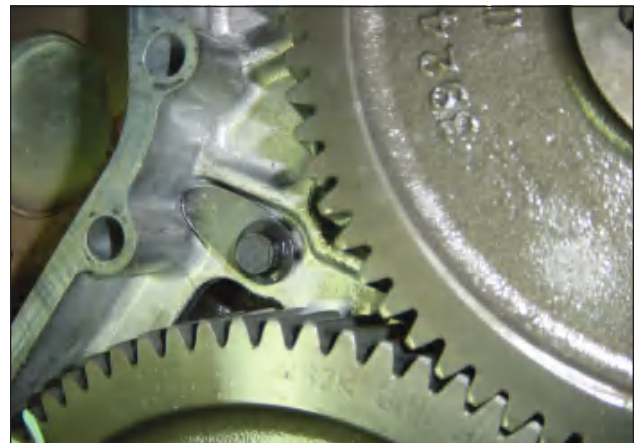
A picture showing an egg-shaped washer that covers the dowel pin.

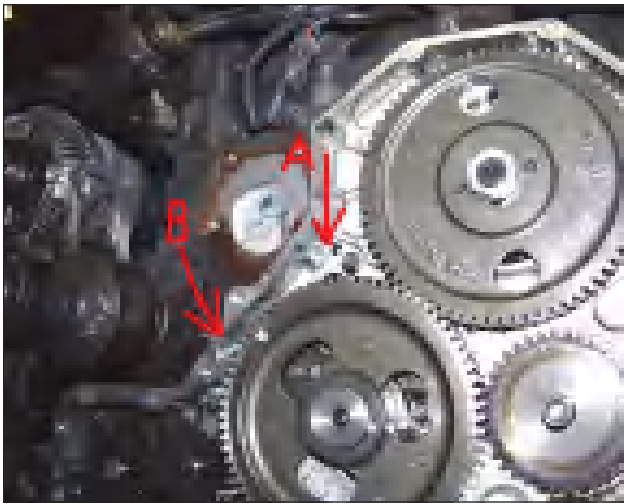
For those not familiar with the dowel pin the arrow shows its location.

Several methods of securing the pin into its bore have been developed by shops that service B-series engines. These methods have been covered in previous TDR magazines (Issue 38, page 136; Issue 33, page 46). Additionally, there is a thread on the TDR web site that takes you through the "how-to" should one wish to use the drill/jig method. However, on a recent visit to TST's shop outside Columbus, Indiana, I discovered yet another way to perform this preventive maintenance type procedure.

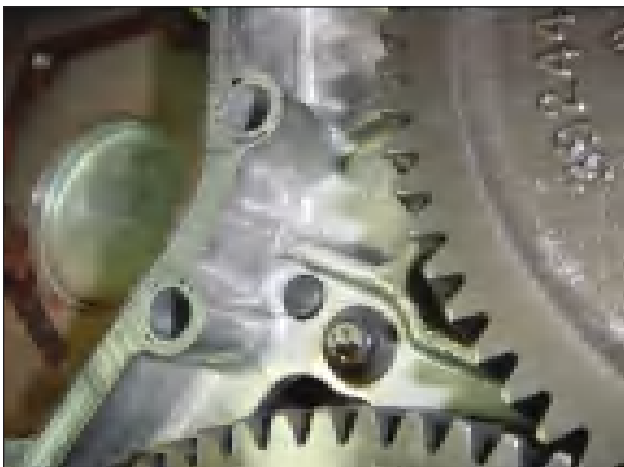
A close-up picture of the dowel pin.

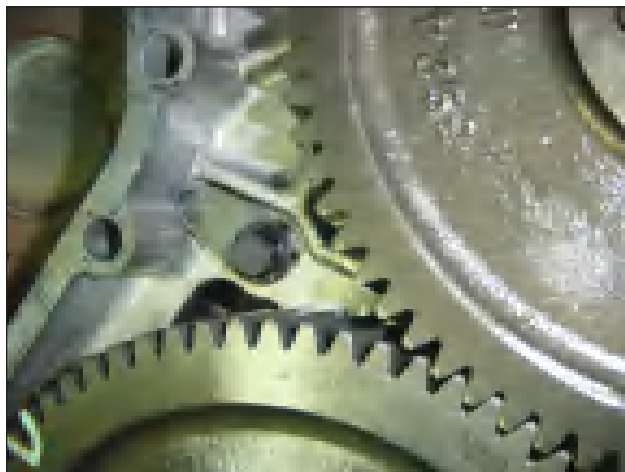
- 12) Locate the dowel pin and look to see if it is fully seated. Most of the pins will be flush with the gear housing or just below flush if they have not backed out. If the pin seems to be backed out find a small punch. With a hammer and punch tap on the head of the dowel pin and drive it into the block as far as possible.

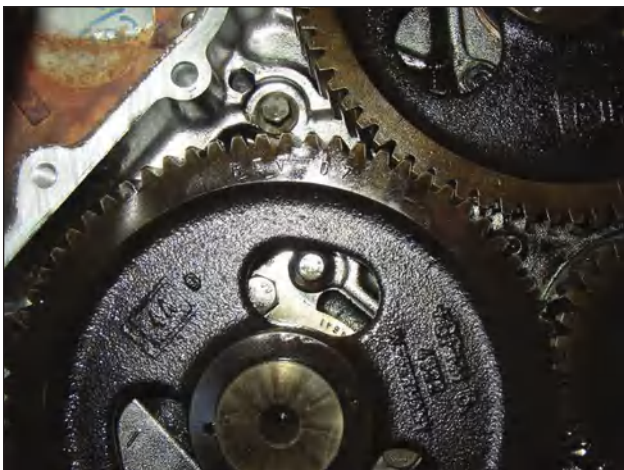
When I checked the dowel pin, commonly known among members as the Killer Dowel Pin (KDP) in my '89 Turbo Diesel D250 with 182,000 miles, it had not moved. I drove the dowel pin back about 0.020-inch and peened the bore. For members who want to tighten the 10-mm gear case bolts, I have included photos of the three gear case bolts behind the cam gear that should be tightened also. The top bolt is located at about 12:30 o'clock.

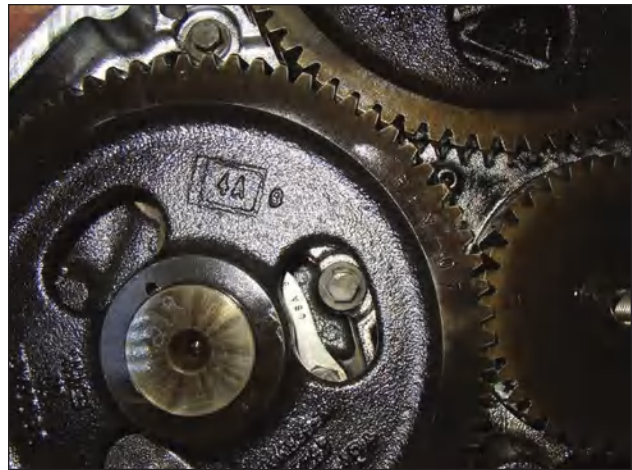
The second bolt is at 2:00 o'clock. Both of these bolts are easily accessed through a hole in the camshaft gear when the crankshaft is rotated.

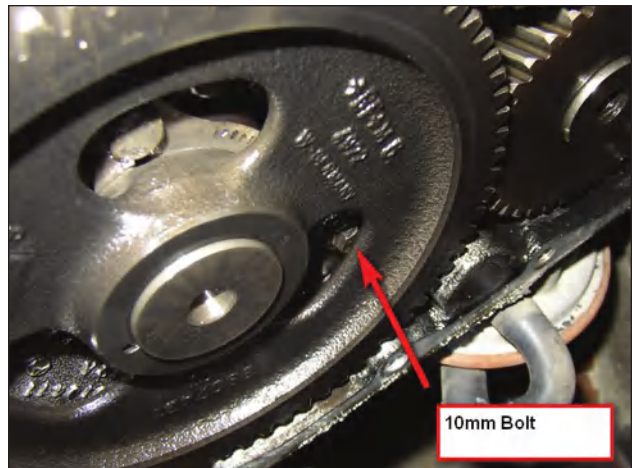
The third one is difficult to access and is at about 4:30 o'clock. I cut the head off a 10-mm wrench and welded it to a screwdriver to make a crow's foot type wrench to get to it. It is good to have a cheap 10-mm wrench or two to sacrifice for this project.

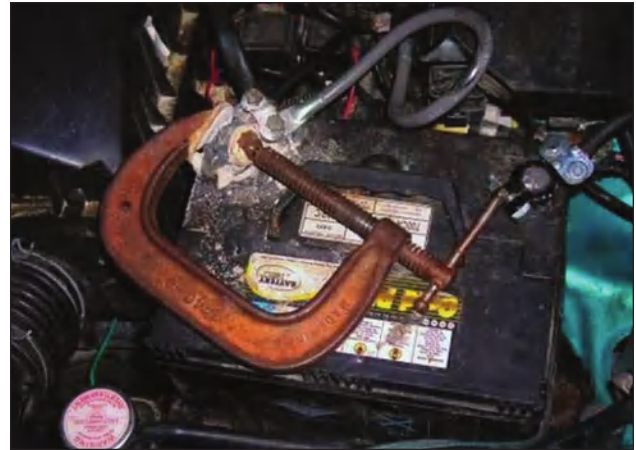
I received many suggestions on how to correct the torque converter lock/unlock issue and followed up on all of them. Check the battery cables first!

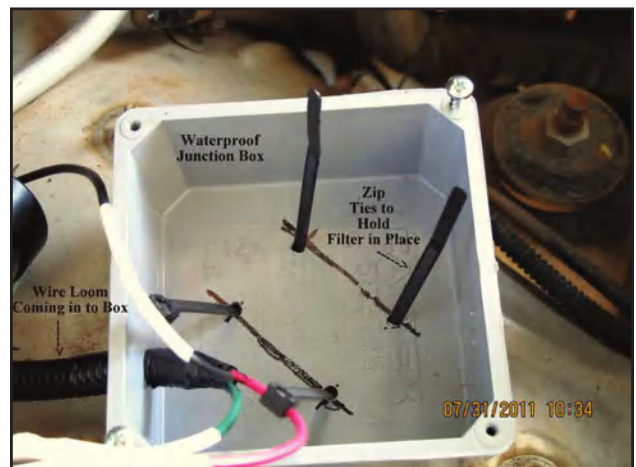
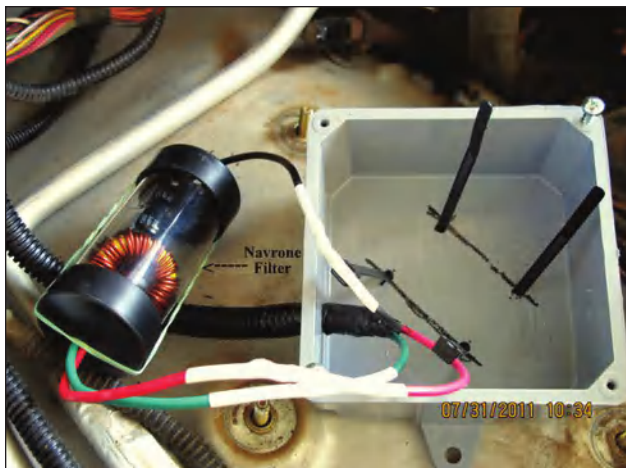
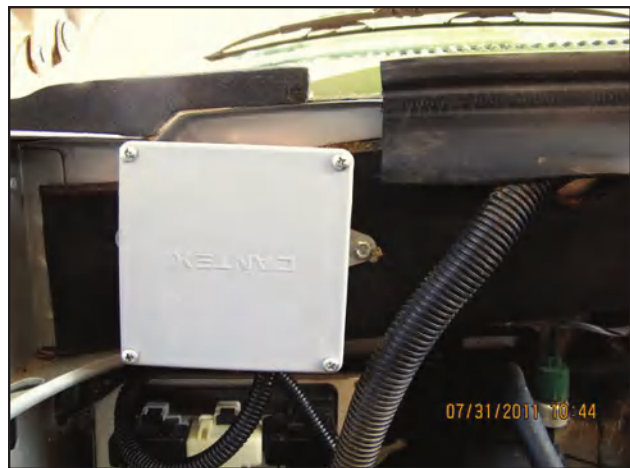
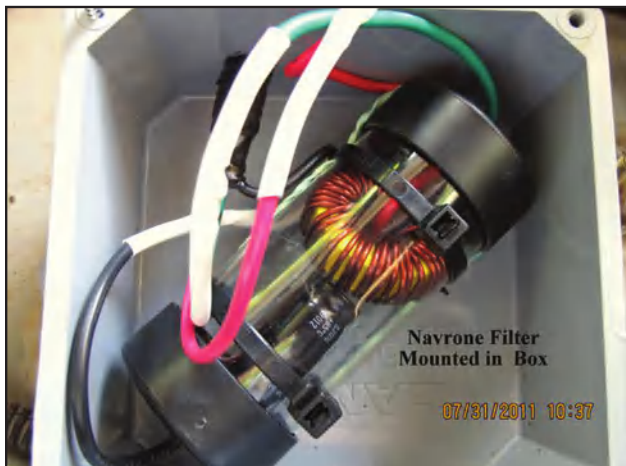
I also installed a Navrone noise suppression filter Model N-25 by Navone Engineering at (<http://www.davidnavone.com/cart.asp?24&cat=2> or 800-669-6139) as seen in the photos which may be helpful to other members who might want to use this electrical noise filter. I rerouted the alternator charge line and ground at the same time. After completion of the project, I have driven the truck on the highway and could not reproduce the torque converter unlock/lock issue.

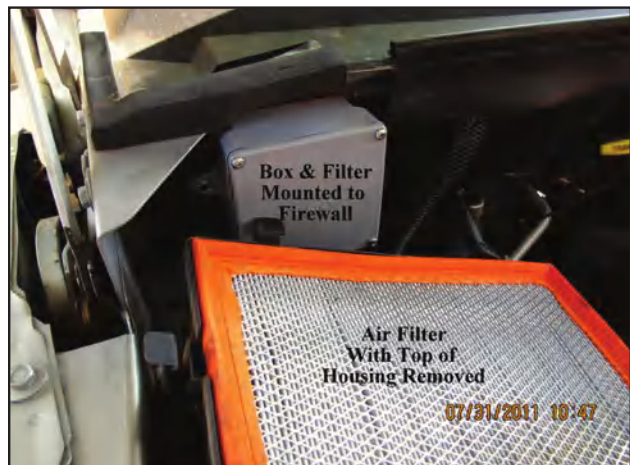
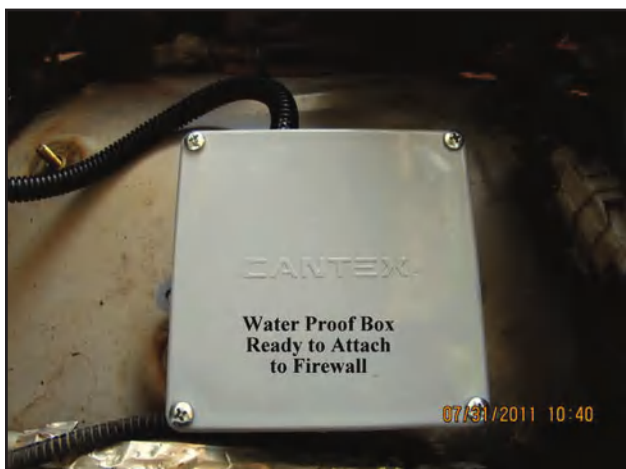
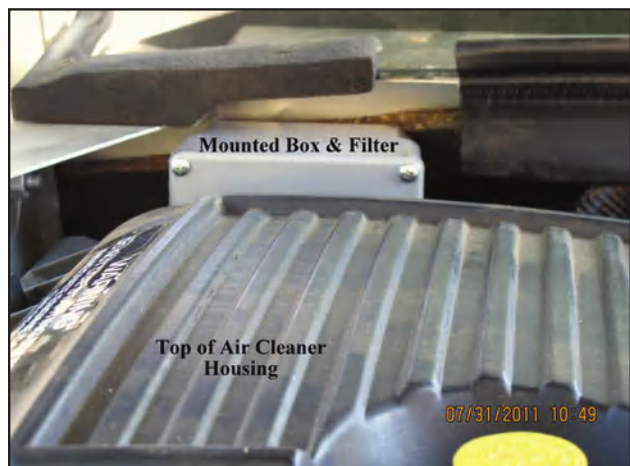
Photos of final installation with air cleaner housing re-installed.

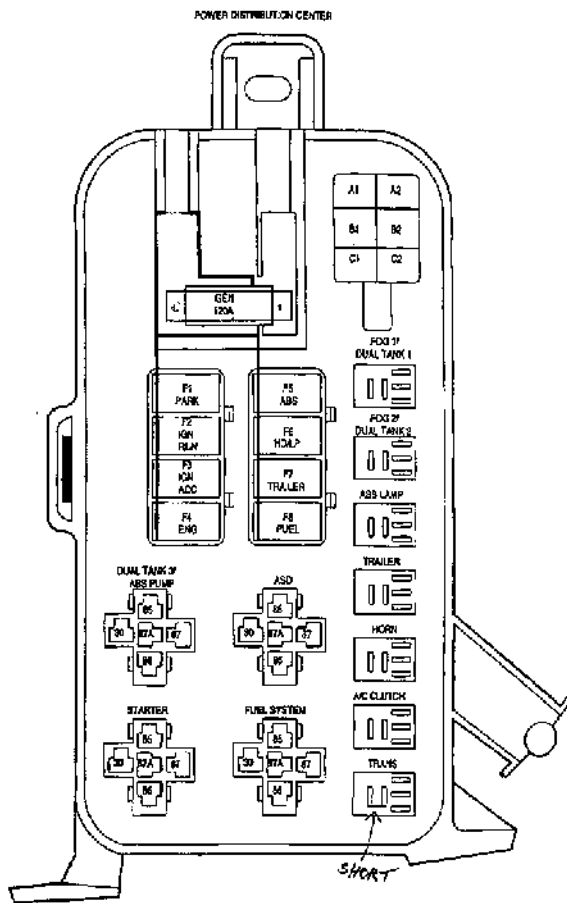
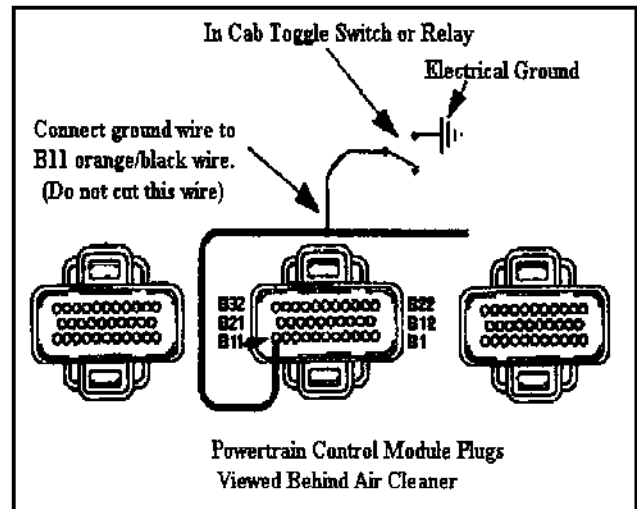
1. Install jumper wire in place of the trans relay in the Power Distribution Center (black box behind driver side battery) as shown in diagram below. This jumper wire will supply 12-volt positive to the transmission torque converter clutch solenoid. This jumper will be electrically hot thus it should be installed so as not to short against ground.
2. Install ground wire from the B11 orange wire with black stripe to a switch or relay such that the ground source can be turned on and off. The B11 wire is located in the middle computer connector located on the firewall behind the air cleaner.

**Add Jumper Wire**  
**Do NOT Reinstall Relay**  
**Power Distribution Center**  
**Next to Driver Side Battery**

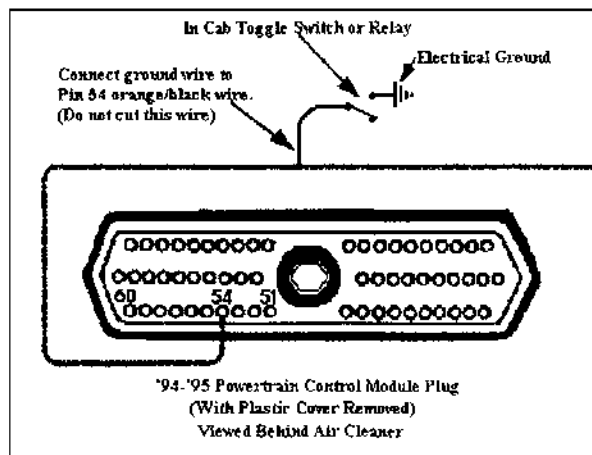
Install ground wire from the pin 54 orange wire with black stripe to a switch or relay such that the ground source can be turned on and off. The pin 54 orange wire with black stripe is located in computer connector located on the firewall behind the air cleaner.
