# TURBO DIESEL Buyer's Guide

A Publication of the *Turbo Diesel Register*

## A WORD ABOUT THE TURBO DIESEL BUYER'S GUIDE

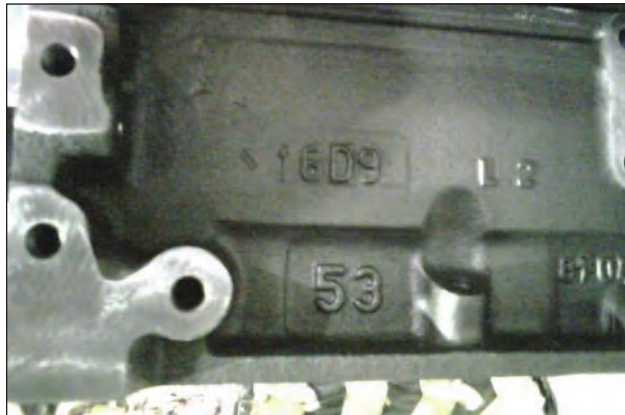
You can't miss it, "block 53," on the driver's side of the engine, toward the front gear case, behind the vacuum pump.

Disquieting reports concern members who have a truck with a 53 block casting number. Although this is not the first time this problem has been addressed (see Issue 48, page 30, Block Identification and Block Replacement), I've seen little documentation as to its cause, repair procedures, or longevity of any repairs. This infamous casting number has some history (albeit limited) of the cast iron block cracking below and behind the center expansion or freeze-plug (passenger side of engine). Model years affected are late '98.5 production 24-valve engines up to 2001. Okay, now that affected model year owners have flashlight in hand and are searching for the block number, its location is found on the lower left front corner (driver's side) of the engine block behind the vacuum pump/power steering pump assembly.

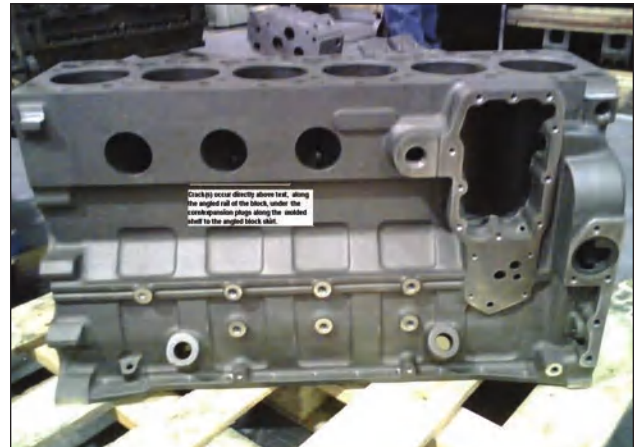
Crack(s) occur directly above text, along the angled rail of the block, under the core/expansion plugs along the molded shelf to the angled block skirt.

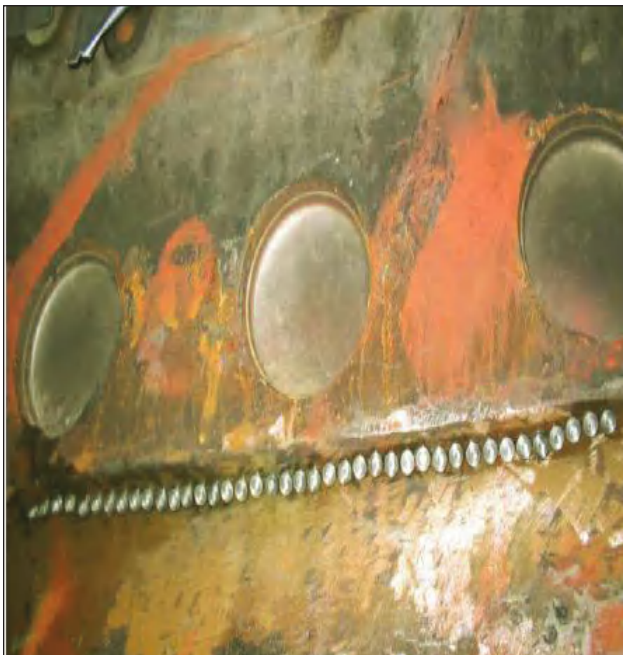
The crack is then drilled with many precise holes. A fixture that is provided with the kit controls the depth of the holes and their spacing along the crack. Pins are then inserted into the holes. Manufactured by Lock-N-Stitch, the pins have a special break-off head that breaks very close to flush with the block. A grinding wheel will take the pins to flush.

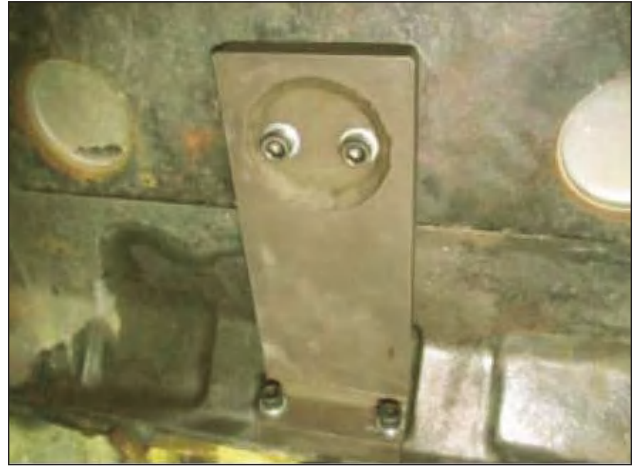
Reinforcement Bracket

Before you call this a complete repair, take some time to prevent future cracking. Lock-N-Stitch sells a support bracket (\$375 each) that adds strength to the block in this weak area. It is recommended that one support bracket be used for cracks that are up to 3", two brackets for cracks that are 3" to 6", and three brackets for cracks that are 6" to 12".

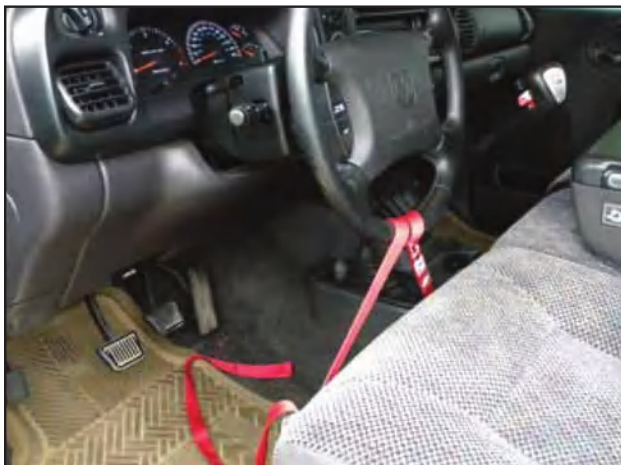
To fix one of these issues I decided to replace the bearing in the bottom of the steering column with the bushing offered by <http://rocksolidramtrucksteering.com>. The instructions supplied with the kit were very straightforward and it appears to be somewhat easier to do on my truck given it is a manual rather than the automatic trucks with the column gear selector. One note worth mentioning here is that any time you uncouple the steering system, the steering wheel is free to turn inside the cab. This must not be allowed to happen as it may bring about the destruction of the “clock spring” inside the column. The clock spring is actually a thin ribbon cable type electrical connection between the portion of the column that rotates and the part that doesn’t rotate. The catch here is that the cable or clock spring is a fixed length so if you connect the steering back up in a different orientation than it currently is, you may run out of cable when turning left or right. The best way to avoid this is to put the truck’s front wheels straight ahead prior to disassembly. Then take a cargo strap and attach it to one of the driver’s seat floor supports, thread it through the steering wheel and connect to the other seat support as shown below:

**This technique makes the steering stay put while you work which avoids clock spring damage.**

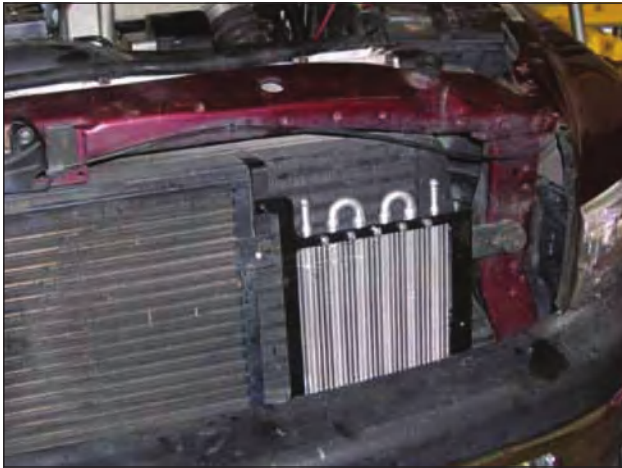
fluid cooler that would fit on the driver's side of the air conditioning condenser in front of the intercooler. I designed a bracket and mounted the cooler in line in the return hose from the steering gear box back to the power steering pump reservoir.

**An automatic transmission fluid cooler in its new job as a power steering fluid cooler.**

This fluid cooler plumbed into the return line worked like a charm to keep the power steering fluid cool. Even on a 100° day, after driving in traffic, you can put your hand on the return line going from the cooler to the pump reservoir and it is warm/hot to the touch, a major improvement over the “roast your finger” stock system.

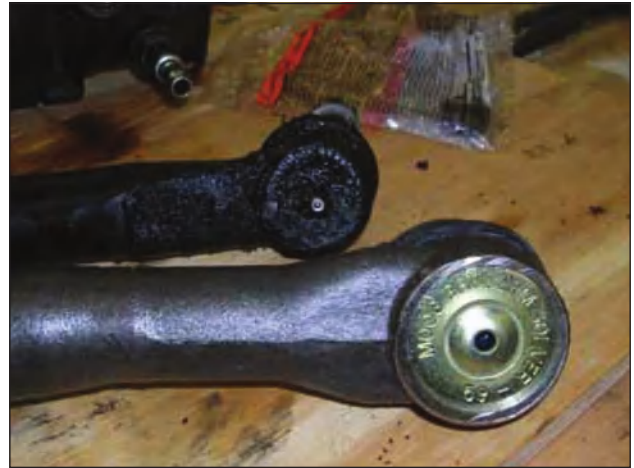
I chose Moog parts for all my front suspension replacements. It is easy to see why the Moog components are better, below is the new Moog track bar lying next to the stock bar.

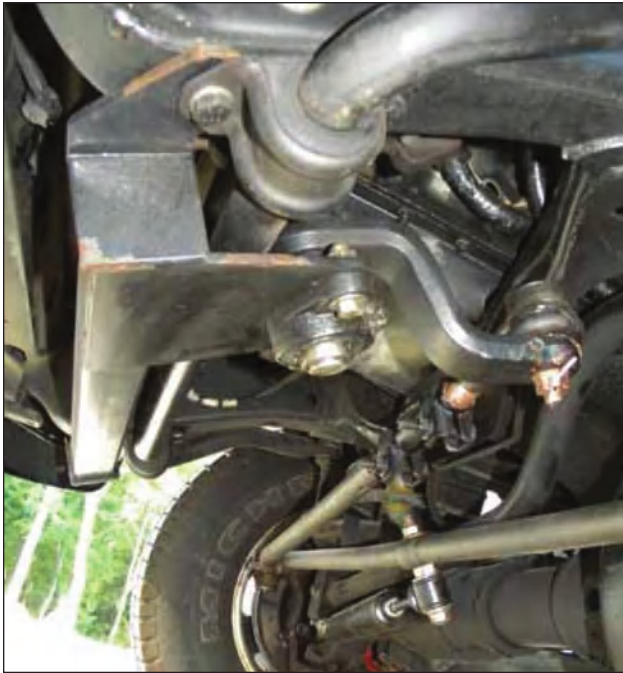
The picture below shows the BD steering box stabilizer installation after two years of use.

**The BD steering box stabilizer enhances the truck's steering system by giving the steering shaft support out past the point of load application which reduces stress on the steering box's output shaft bearings. It also stiffens the frame rail near the steering box mounting location, reducing side-to-side flexation.**

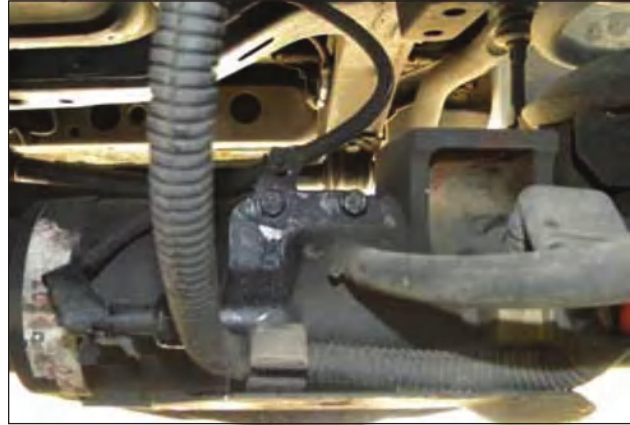
Spline engagement housing on back side of front axle.

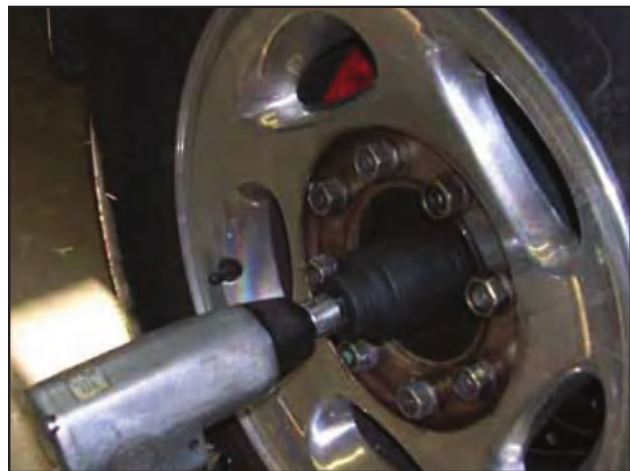
**My old Chicago Pneumatic 1/2" impact wrench having a go with a 3/4" socket adapter and 1 11/16" socket. Both nuts are standard clockwise tighten so remember patience and penetrating oil. My impact wrench took about 20 seconds per side and the nuts were off.**

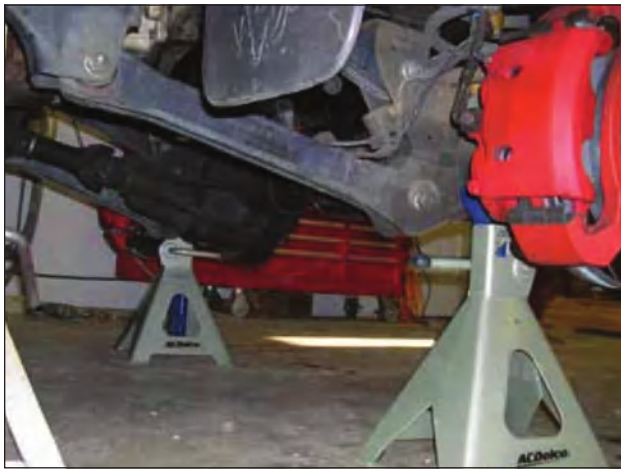
The jack stand configuration I used is shown below.

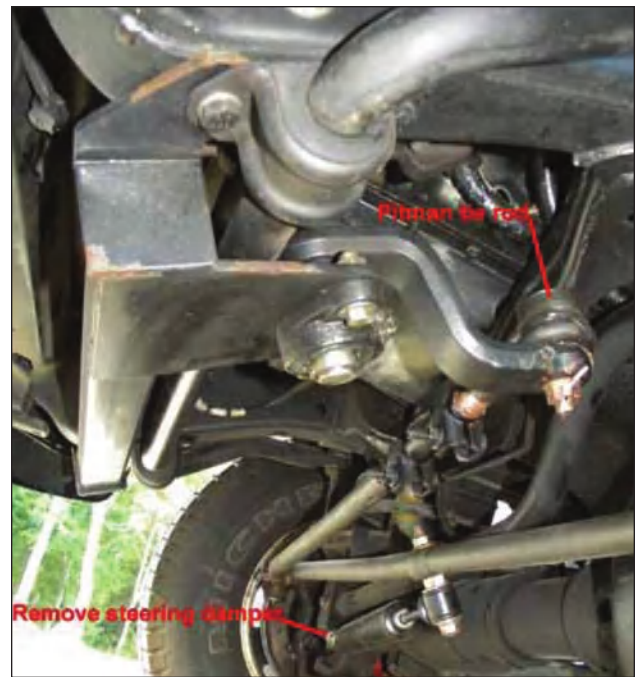
Remove steering damper.

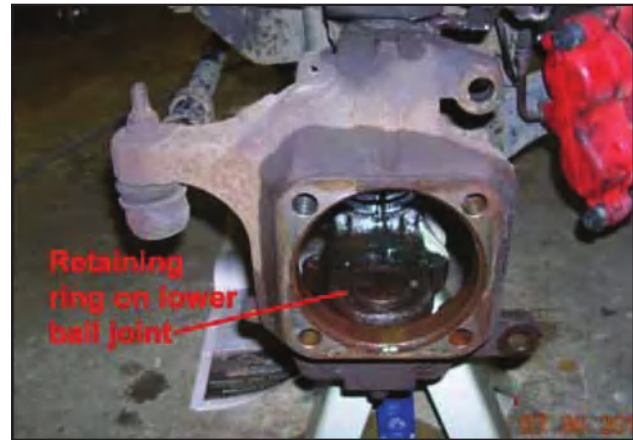
With the bearing hubs and half shafts out, remove the nuts on the ball joints and the large retaining ring off the bottom ball joint as shown below.

Also note extensive use of penetrating oil, it really does help.

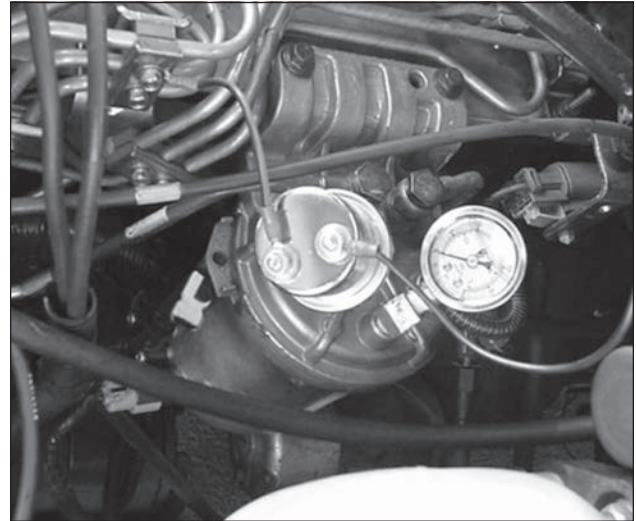
**In the photo, note that the Editor's truck (a '99 model) is outfitted with two gauges—one is a mechanical, liquid-filled gauge and the other is a Westach electrical gauge with a pressure sending-unit mounted to the filter head assembly.**

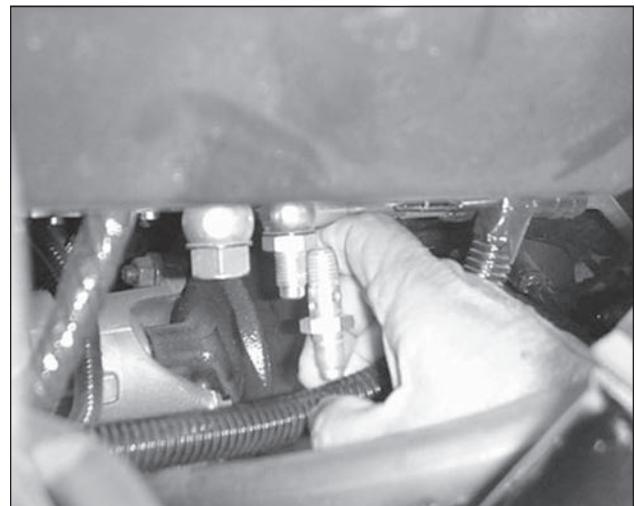
In order to install a gauge, the '98 and '99 24-valve engines have a filter head with easily accessible 1/8 NPT fittings. On the 2000 and up trucks the service design team at Cummins was mindful of the need to test the fuel transfer pump's delivery pressure. Thus, your truck is equipped with a "banjo adapter with a Schrader valve assembly." Say what? For clarification let's look at a photo and a description.

On the inside, the part with the rifled opening attaches the fuel line to the fuel pump. On the outside, the Schrader valve (think A/C valve or, better yet, a tire valve) has a press-for-pressure needle. Here is the catch, you can take the pressure needle out of the Schrader valve.

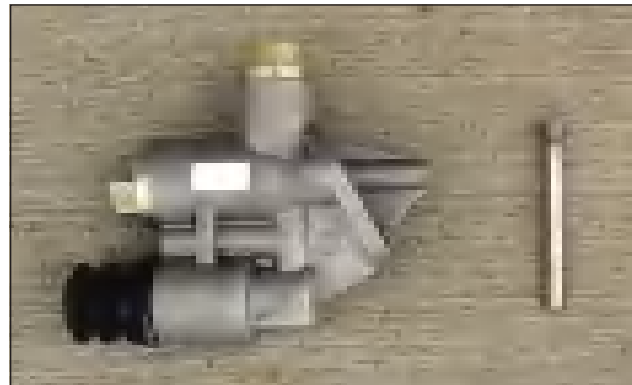
Carter lift pump with plunger removed.

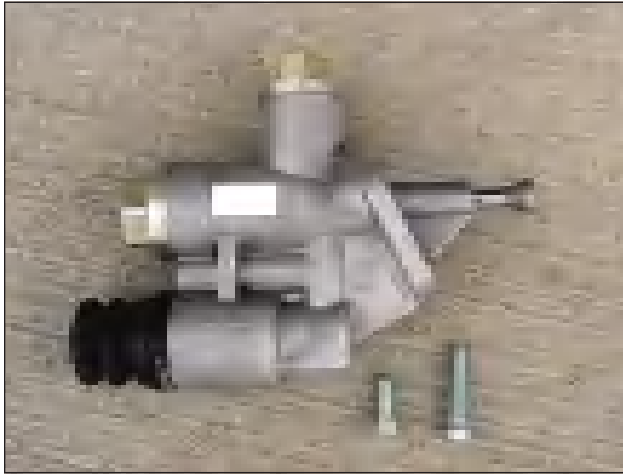
**Carter lift pump with regular mounting bolt and longer temporary bolt.**

Here is the secret: When you remove the fuel lift pump, take one of the two mounting bolts and find a replacement that is the same metric thread size but about  $\frac{3}{4}$ " longer. You probably have one in your parts box or you can borrow one from elsewhere on the engine. When reinstalling your lift pump use the longer bolt as your starter bolt. Once you get the lift pump and fuel heater partially tightened down, install one of the original bolts in the other hole. Once it is partially tightened, remove the longer bolt and replace it with the other original bolt. Tighten the two bolts to 18 ft-lbs torque. (Tighten the two bolts alternately to prevent damage to the fuel pump housing.) I thought this was the easier and less time consuming way than removing the starter and trying to be a contortionist by working my way around the front differential.

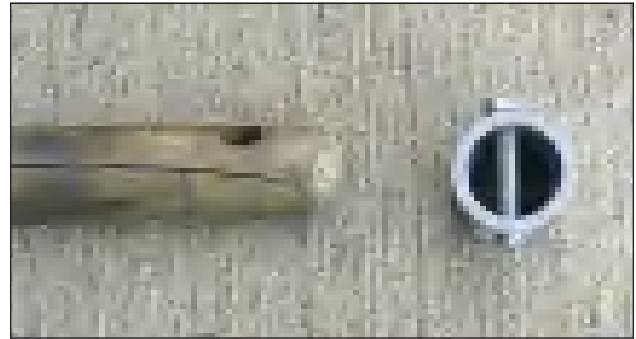
**Broom handle,  $\frac{3}{4}$ " coupling with hole drilled and bolt.**

Another method that's been used at Geno's Garage is using an old broom handle to push the primer button. I decided to make my broom handle a little easier to use by taking a  $\frac{3}{4}$ " PVC coupling and sliding it on the end of the broom handle and drilling a hole about a  $\frac{1}{8}$ " below the top ridge and installing a bolt in it. This is to help prevent the rubber boot from tearing. This will always come in handy when you have to prime the fuel system. When you hear the fuel hit the pump, try starting your truck.

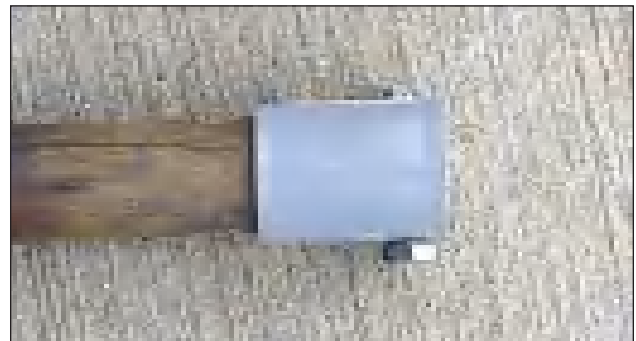
**Broom handle,  $\frac{3}{4}$ " coupling with hole drilled and bolt.**

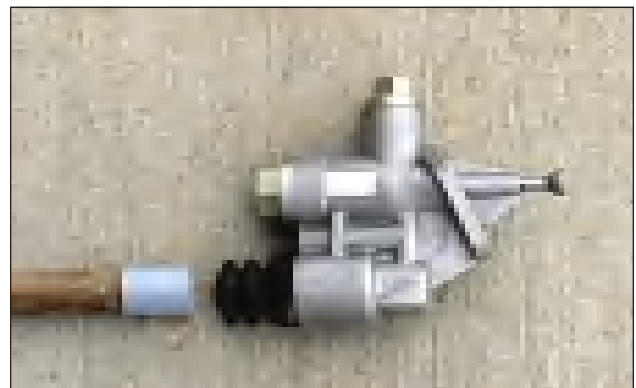
**Broom handle assembled.**

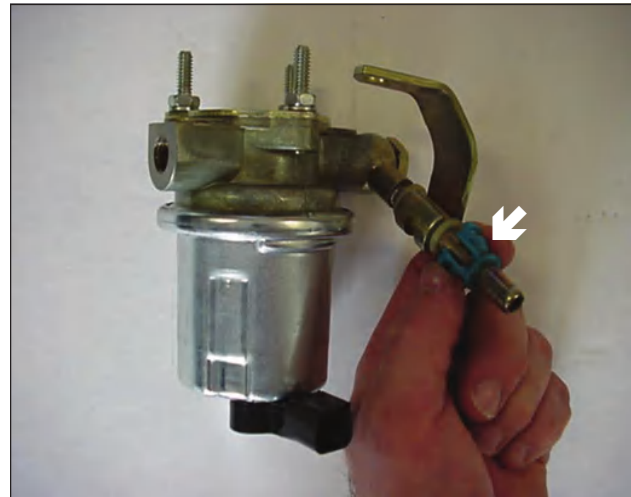
Step (2): Remove the fuel supply line from the transfer pump. From the bench-picture you can see the two, blue quick-connects that you push in to release the fuel supply line.

Pinch the blue disconnect and the fuel line will come loose.

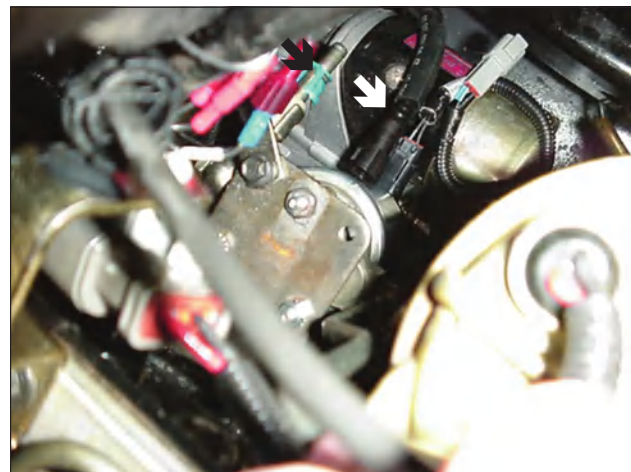
The fuel line to the transfer pump and the fuel line that goes to the fuel tank are pictured here.

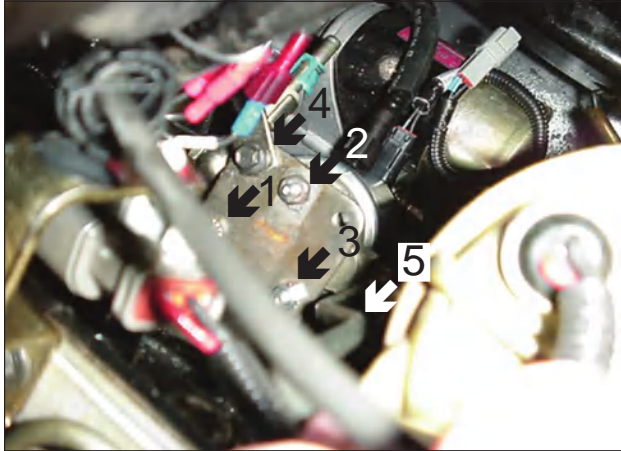
The three 15mm nuts that hold the fuel transfer pump in place (1-3) and 10 mm bolt holding the fuel line (4). Arrow 5 points to a fuel line that you have to remove with a 17 mm stubby wrench.

Step (5): Loosen the three 15mm nuts that hold the transfer pump to the bracket. Remove the 10mm bolt that positions the fuel line to the bracket. Remove the 15mm nuts that you previously loosened and remove the transfer pump.

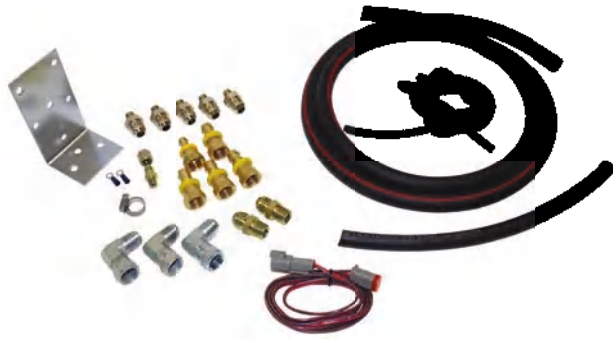
Moving to \$210: Purchase a spare Cummins fuel transfer pump. Purchase a transfer pump relocation kit for \$59 (Vulcan Performance/Geno's Garage), and move the transfer pump to an easy-to-access location on the truck's frame rail.

The benefits of relocation: the transfer pump is not subjected to continual engine vibration; the transfer pump is closer to the fuel tank and operates more like a pusher pump. Should the pump fail, the pump is very easy to access.

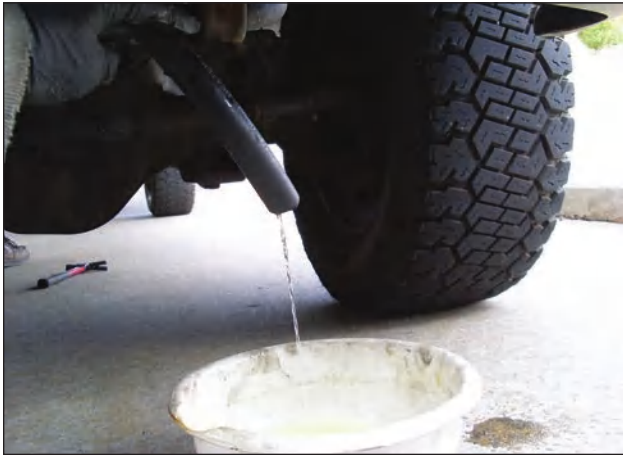
**Extend the fuel filter drain hose to save the aggravation of having the fuel drain onto the frame which is caused by the existing short drain hose.**

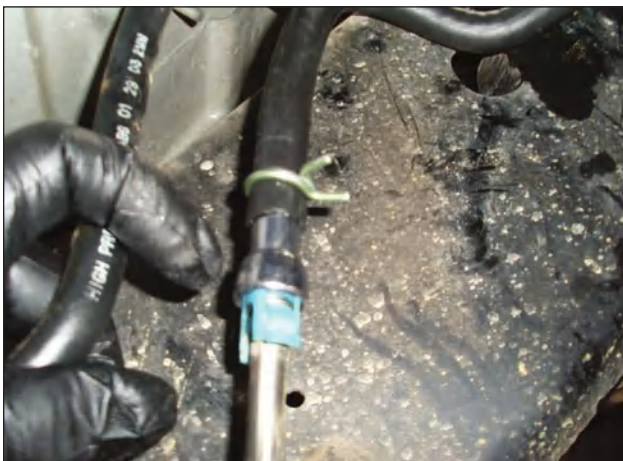
**Pinch the outer tangs of the fuel line quick-fitting to separate the rubber hose from the hard fuel line.**

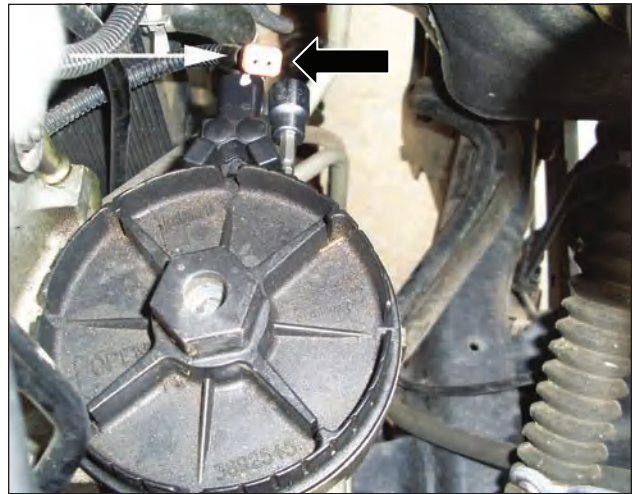
**Unplug the water-in-fuel sensor. Note how the wires and cables have been pushed to the side of the fuel filter.**

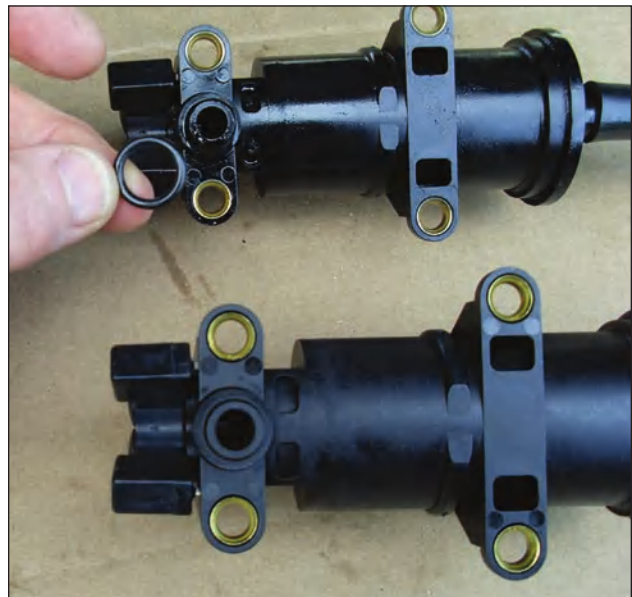
**Do not forget to remove the old O-ring. An O-ring on top of an O-ring doesn't work too well. Ask me how I know.**

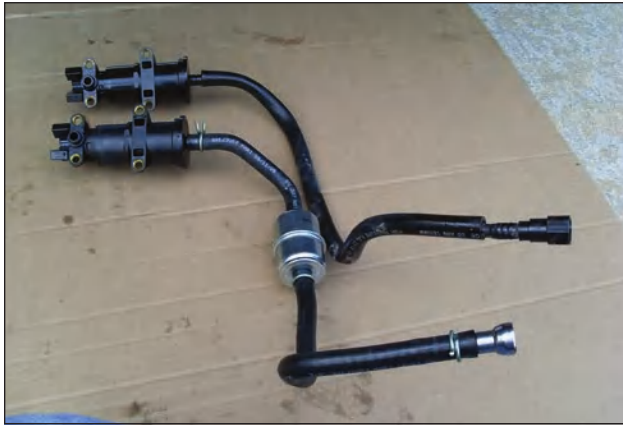
With the old transfer pump and fuel line removed you can see the orientation of the new fuel lines and primary fuel filter.

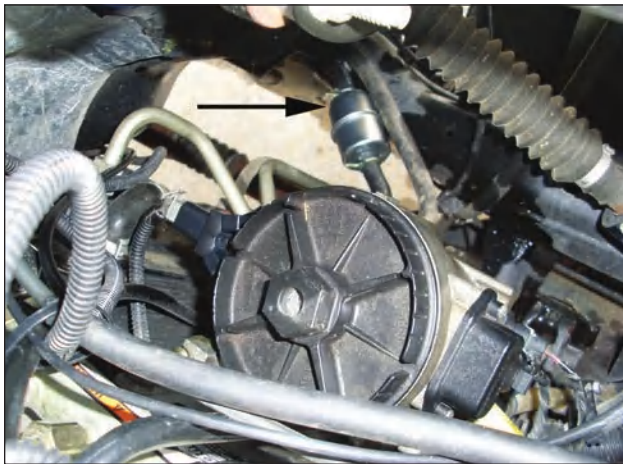
The installed orientation of the new fuel filter.

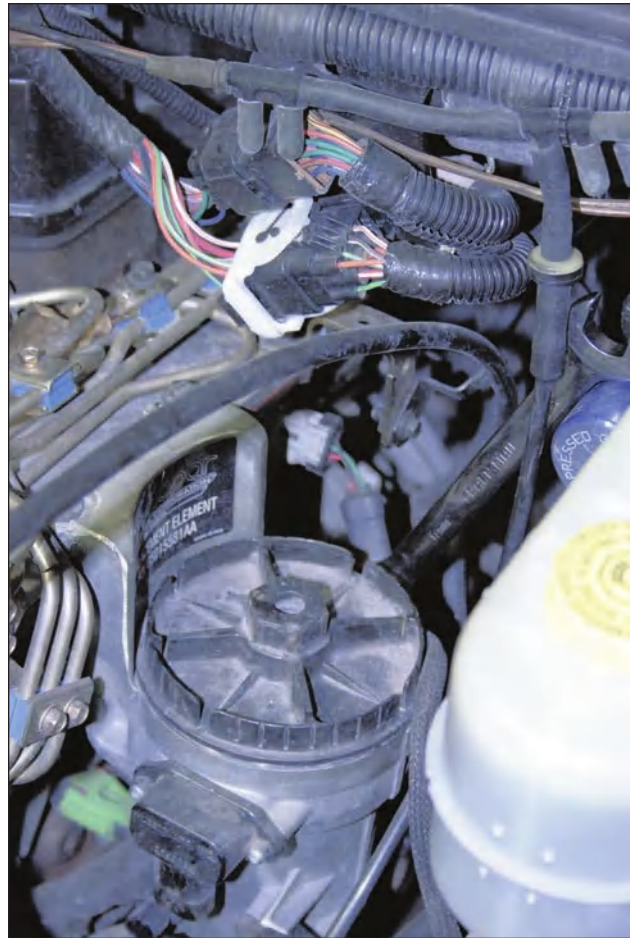
Photo A

It is not necessary to remove the fuel filter housing to replace the lift pump. The arrow points to a 17mm wrench that is used to remove a banjo bolt that holds a fuel line from the fuel transfer pump to the fuel filter canister.

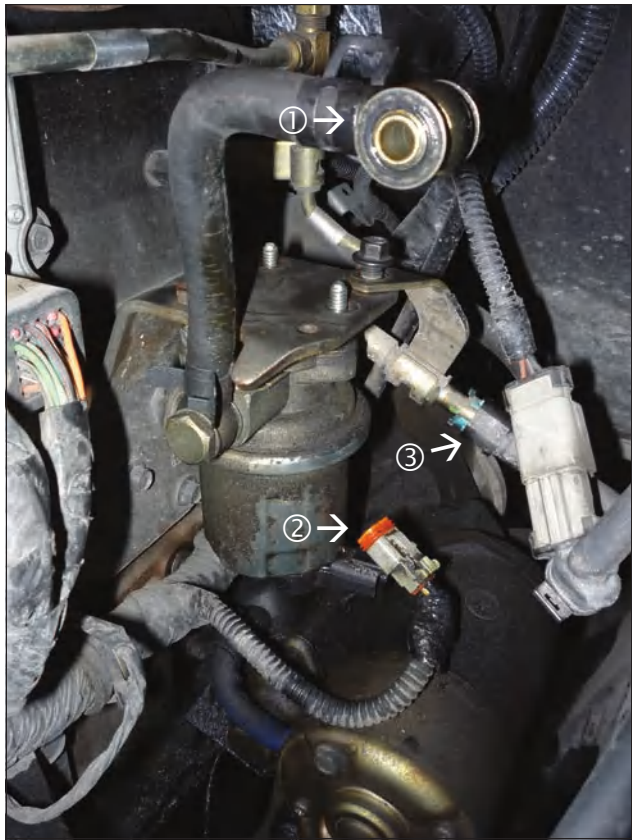
**Photo B**

For clarity I went ahead and removed the fuel filter housing. You can easily see the following:

① the pump outlet pipe; ② the Deutsch electrical connector disconnected; ③ the fuel transfer pump inlet piping, with blue quick-disconnect fitting. The fuel transfer pump is attached to the support bracket with three nuts (13mm) and one inlet pipe bracket support fastener (10mm head). Those that have changed a few of these fuel transfer pumps know how frustrating it is for the 13mm nuts to loosen the studs. If the stud spins with the 13mm nut you have to go underneath the support bracket with a thin 7/16 open wrench to hold the stud to keep it from rotating. Look at photo C, item ① and you'll see what I mean.

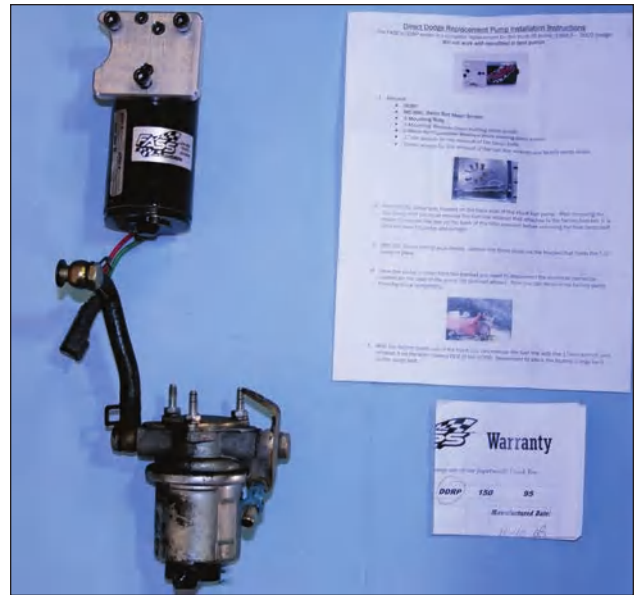
**Photo C**

The old and the new. The inlet and outlet pipes are moved over to the DDRP unit when it is installed. The DDRP comes with a female Deutsch connector to plug-n-play into the factory wiring.

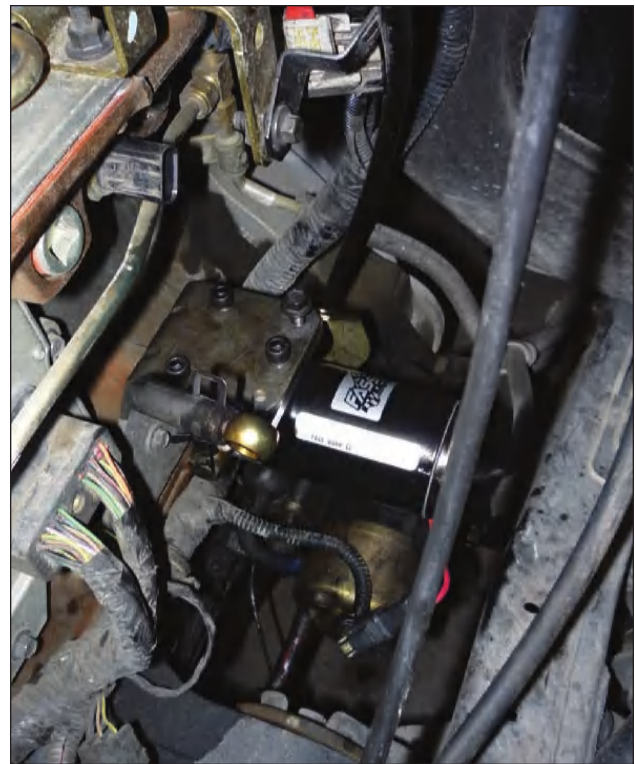
**Photo D**

The installed DDRP unit. The kit contents provide an inlet screen (144 micron) for the inlet banjo bolt. The pump is primed easily with WD-40. The unit is quieter than the OEM unit.

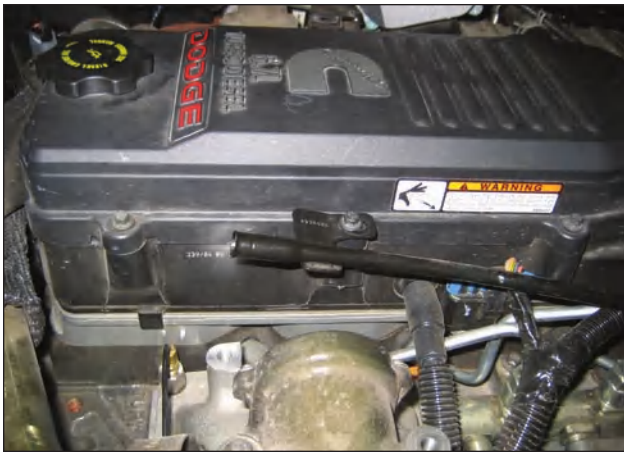
Relocate the oil dipstick tube to the valve cover.

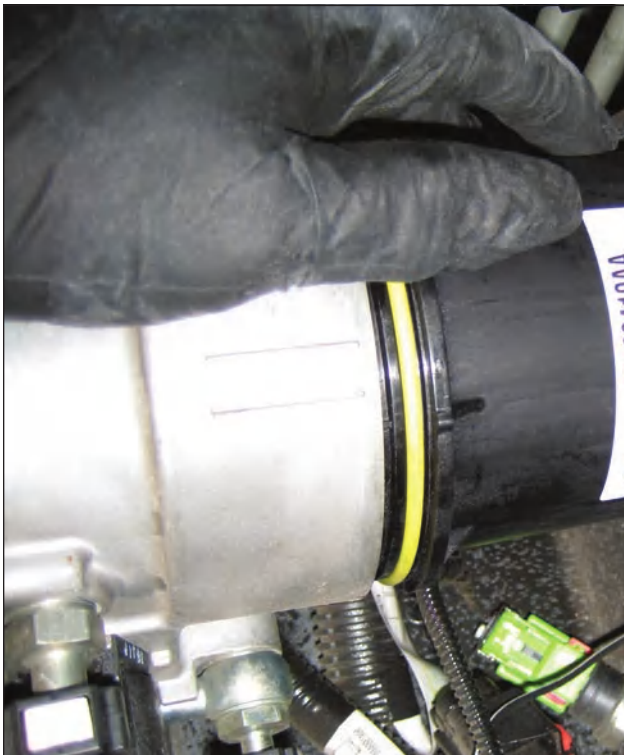
With one hand above and one hand below you can get to the fuel filter from above.

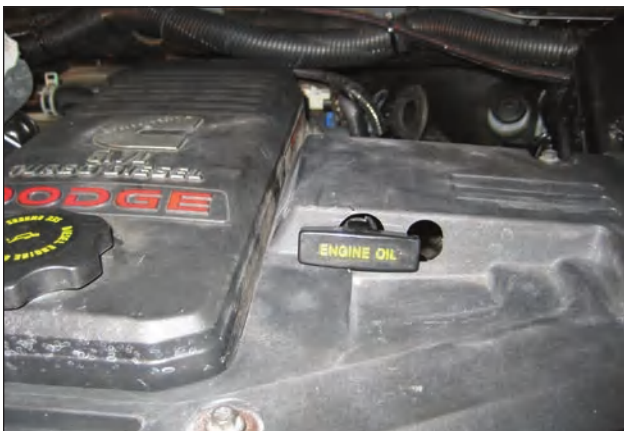
Modified "bat wing" with new dipstick location.

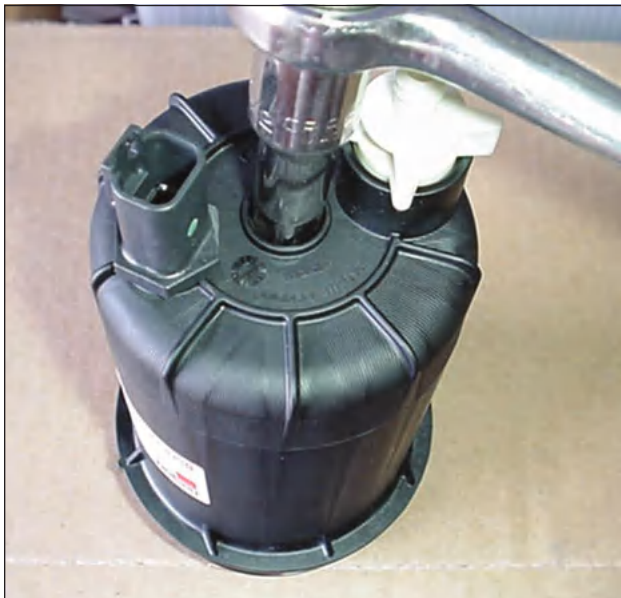
**I'll bet you didn't know that there was a 1/2" drive indentation on the bottom of the filter canister.**

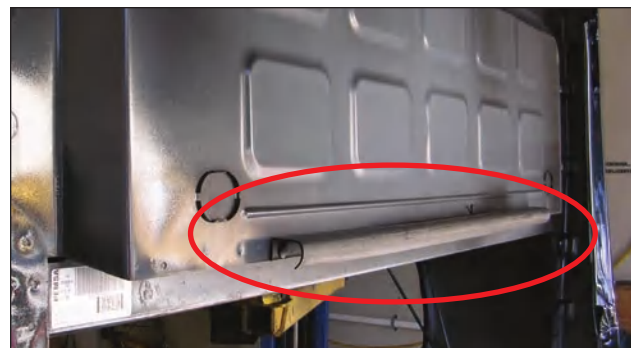
The plastic truck bed snubber.

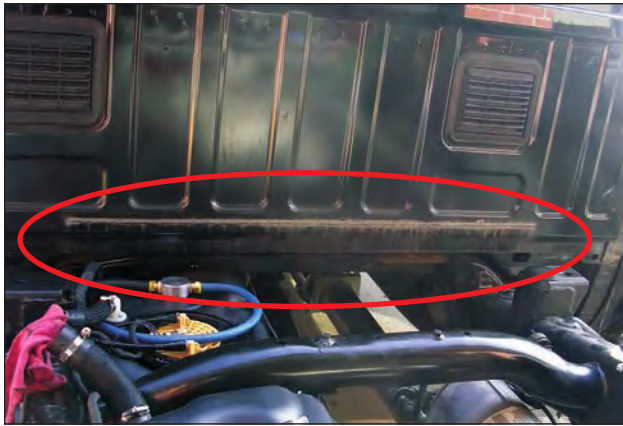
The abrasion at the cab.

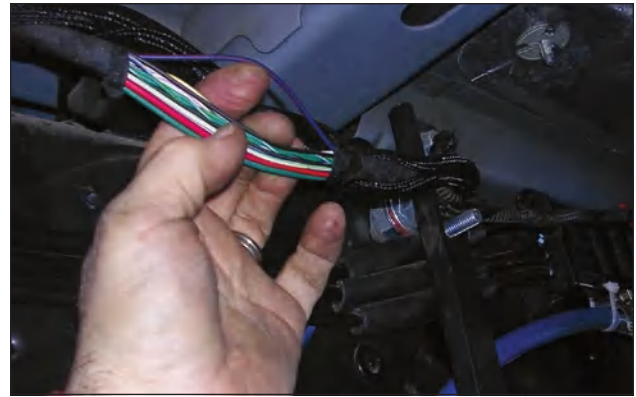
Intercept the wiring harness at the area of the driver's door and you can manually operate the fuel transfer pump.

Here's how: With my 2010 truck I learned that the 12-volt positive wire to the fuel transfer pump is blue with a red stripe. From underneath the truck intercept the wiring harness at the driver's door area, slice into the cover and locate the blue/red power wire. With a long wire fastened to battery positive you can crimp wires and turn the fuel pump on to drain the tank.

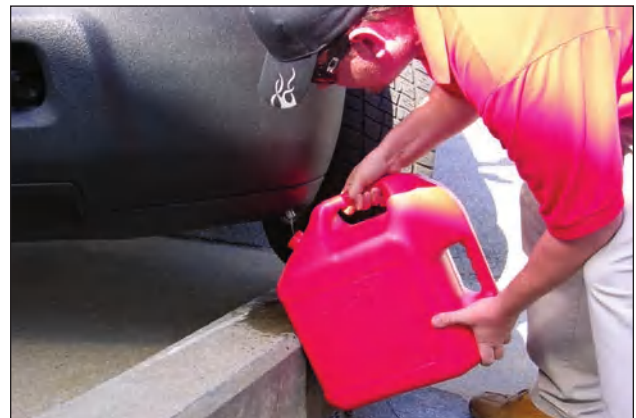
Utilizing the fuel drain line extension tip from Issue 75 it is easy to drain the fuel tank.

Oops, turning the pump on solves only half of the problem. Where do you disconnect the fuel supply line? (This is a trick question.) Answer: don't over think this one. Simply open the fuel drain petcock at the fuel filter. And, if you've previously taken five minutes to extend the fuel drain line (see Issue 75, page 80) and the fuel will drain directly into a five-gallon jug(s)

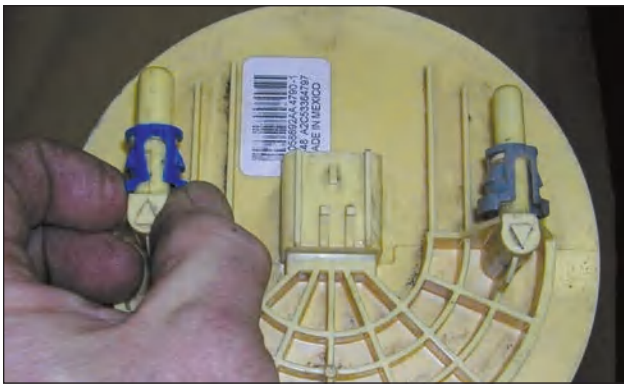
The pesky “pinch-in” clips that hold the fuel lines to the fuel pump assembly.

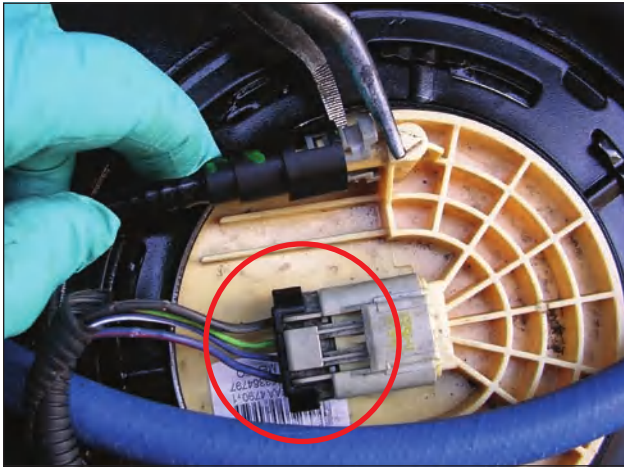
To remove the wiring harness you have to pinch down the grey tab to release the connector.

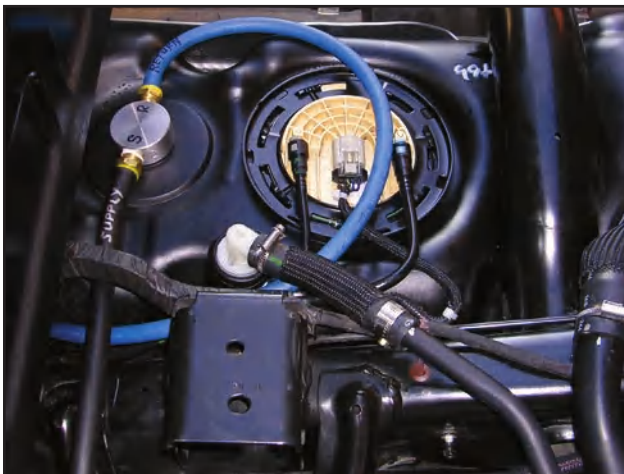
From this photo (yes, the bed was really removed) you can see how it all goes together.

- I've given you clear pictures of these fuel lines and electrical wires because you will not get a visual of these from the on-your-back vantage point. For a visual you'll need a flashlight and a mirror or you can take a peek from the driver's side wheel well.

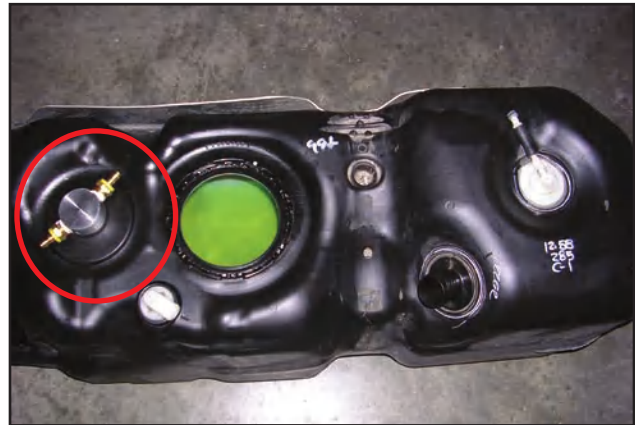
Here is a picture of the tank that has been removed from the truck. Look to the front and you can see the location of the new FASS drawstraw.

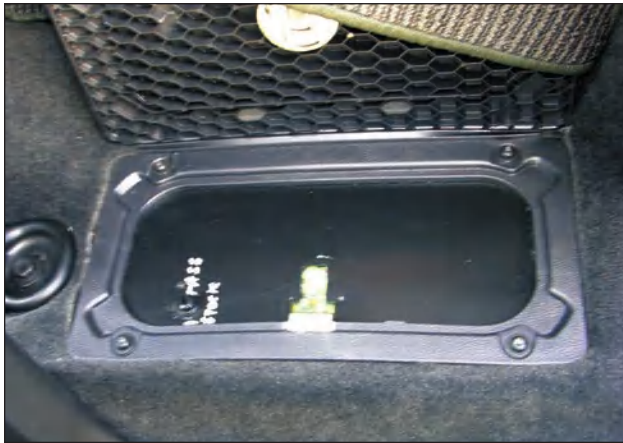
Open the driver's side rear floor compartment and you can see my FASS switch panel.

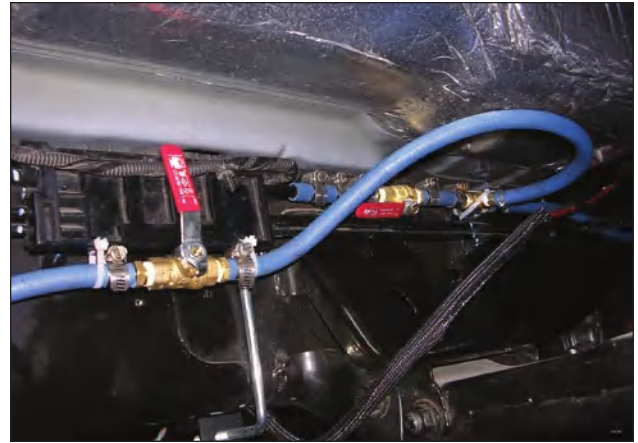
Stock valve is open, FASS valve is closed.

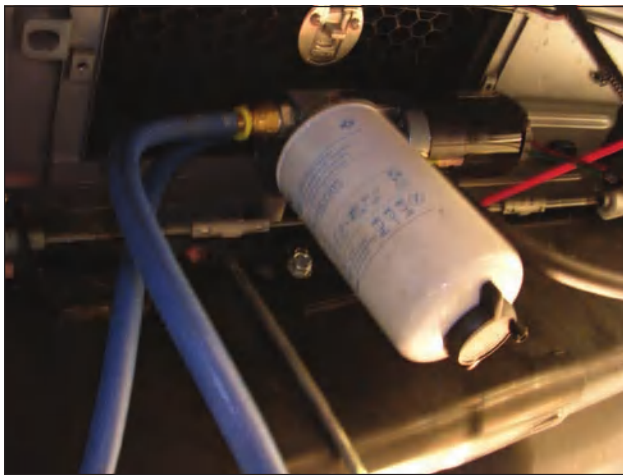
The FASS unit from the underside.

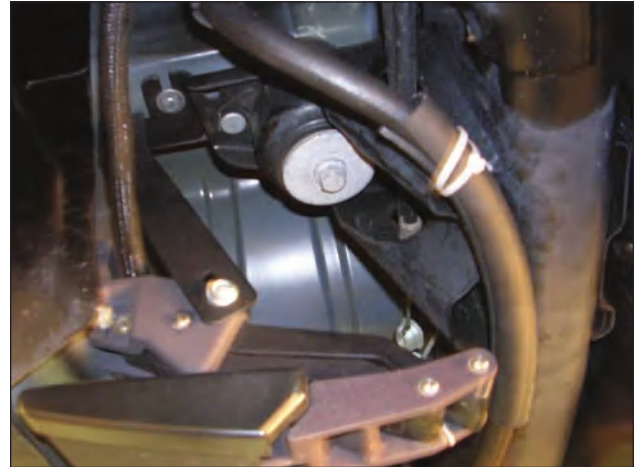
Heater hose for fuel line protection.

- I spliced some 3/4" heater hose and wrapped it around the new fuel lines to protect them.

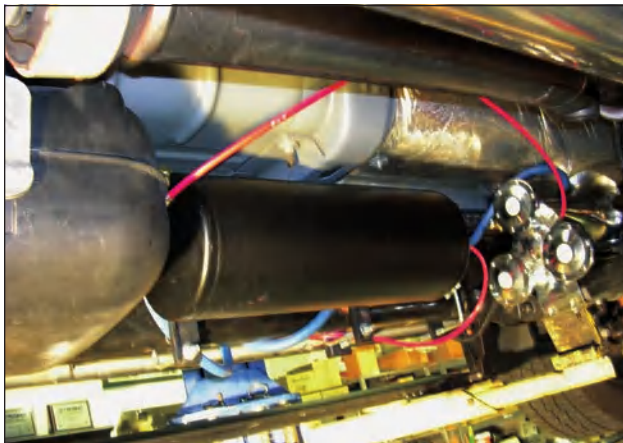
The inside of the driver's side frame rail holds an air tank and air horns.

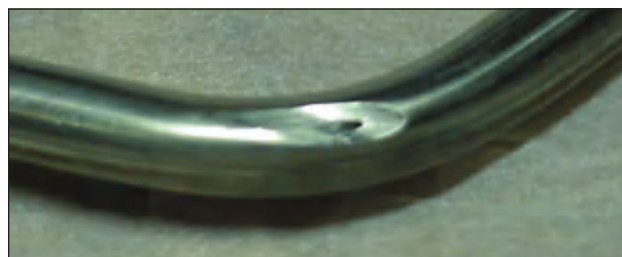
The module has metal pipes exiting the top of the module (supply and return) and has hard plastic tubing coils that extend to the bottom of the module where a removable screen covers the pickup and return. Most of them that I've dissected have a one-way check valve in the fuel pickup to assist in holding fuel prime. Many members have noted that these lines sometimes chafe and develop a pinhole, which allows for fuel aeration, not a good thing! The perforated tubing seems to have rubbed on a sharp edge, or on the mounting hardware for the lower float we previously discussed. The return also returns fuel to the bottom of the module (above tank bottom about 1/4"). This is preferable, as it allows returned fuel to be released into the remaining fuel rather than spraying on the tank's upper surface introducing foam and air.

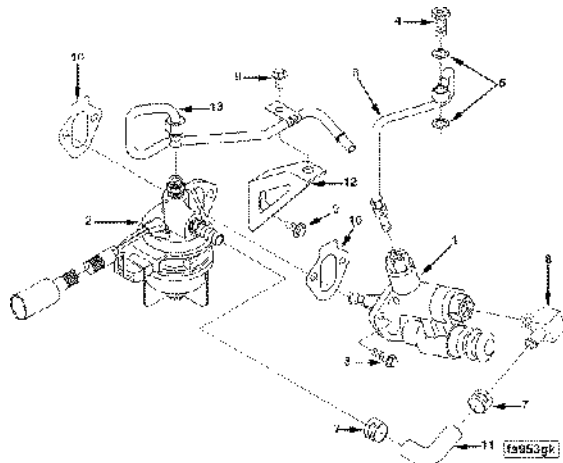
1998 12-valve illustration, part number 13 differs on 1994-1997 designs.

pre-filter screen, then the fuel heater then back out through a port and over to the transfer lift pump. This connection is made by a rubber supply line elbow that makes a sharp ninety-degree bend. I change this rubber elbow (item 11) when a transfer lift pump is serviced. Often this line is a major source of air leakage and subsequent fuel aeration.

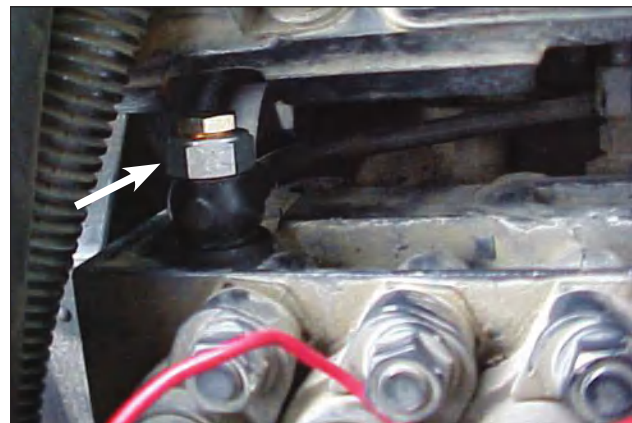
The Bosch P7100 over-flow valve.

problematic, but more on that subject in a minute) that runs behind the fuel filter. If the pressure gauge starts to rise, it means that the lift pump is making good pressure and that the overflow valve may be opening too soon. An overflow valve that opens at too low of a pressure will result in poor performance. Too much fuel will return to the fuel tank which robs the injection pump of fuel pressure that is necessary for proper operation. If the line pinch test makes little or no difference on the fuel pressure gauge, it would suggest that the lift pump is weak.

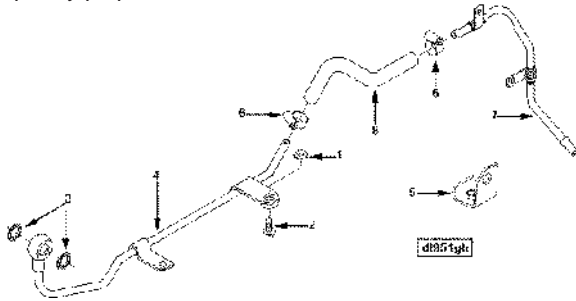
Notice the return line parts diagram: (illustration for 1998 12-valve). Part number 8, rubber fuel return line, is about three times as long on the earlier 12 valve applications. Also, part no. 7 is different as well.

Last, but not least (as evidenced by the numbers of problems that this hose has caused) is the rubber fuel return line. The illustration shows the rubber line used on a '98 12-valve. The '94-'97 trucks use a rubber line (5/16") that is about three times as long. The illustration is misleading. This hose is very difficult to see and access as it is tucked behind the fuel filter assembly.

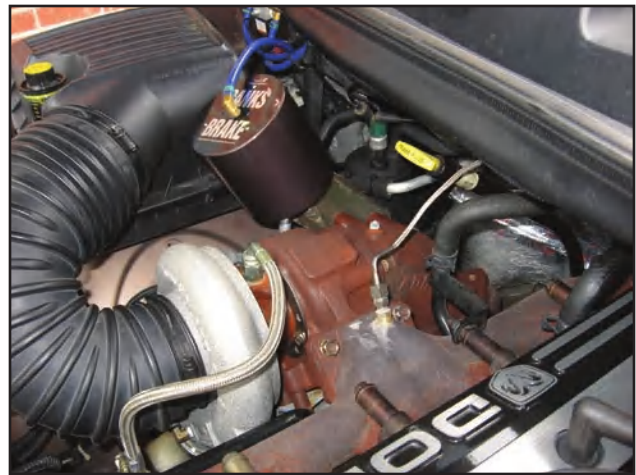
**The Banks Brake on my truck is typical of turbo-mount brakes, replacing the stock transition elbow that connects the turbocharger to the downpipe. Being under the hood makes them less exposed to the elements than the inline models and also makes installation a simpler, bolt-on procedure. Mounting close to the engine also keeps the run of hoses to a minimum with less chance of damage. If you have twins or a non-stock single turbo though, this type is not an option.**

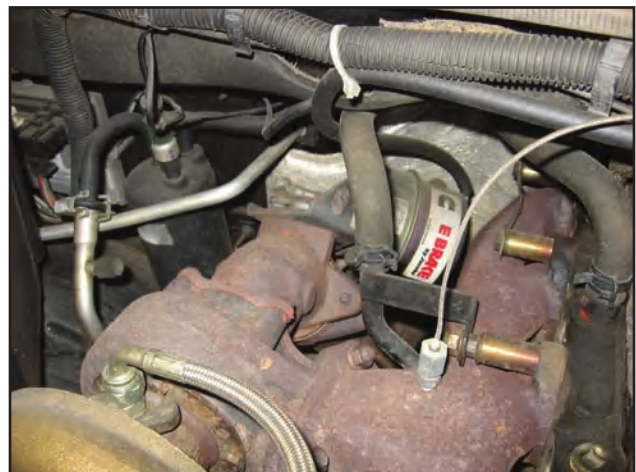
**This picture is of the Cummins/Jacobs version of a turbo-mount brake installed on a 2002 truck. The vacuum cylinder is smaller and is positioned down lower next to the firewall than the Banks version.**

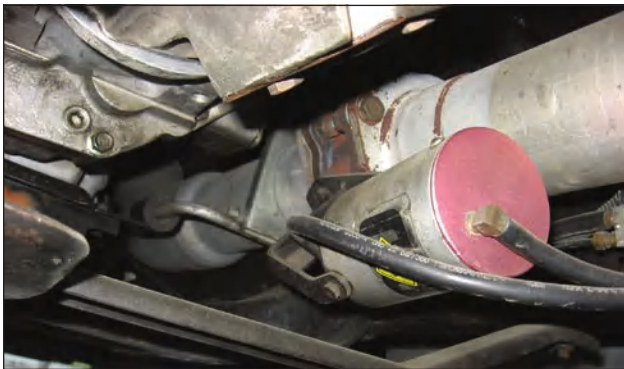
**You can see that the inline, under-truck mounted exhaust brakes install in the exhaust pipe instead of directly on the turbo. They are a little more work to install because the existing exhaust pipe must be cut to allow the brake housing to be inserted. They are more exposed to the weather in this location. This one has the flanges nicely welded to the 4" pipe for a leak-free installation.**

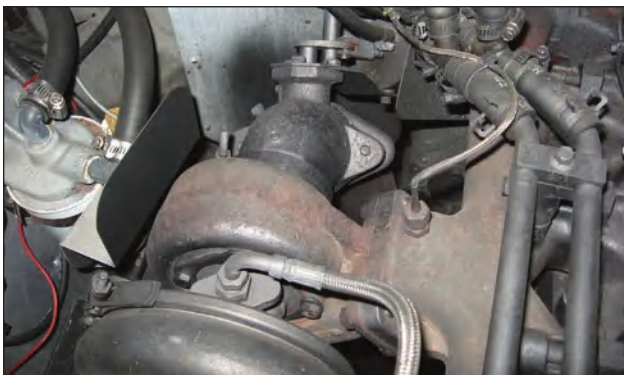
**This picture shows a PacBrake installed on a First Generation, manual transmission equipped truck and is very similar to the Jacobs in the positioning of the air cylinder.**

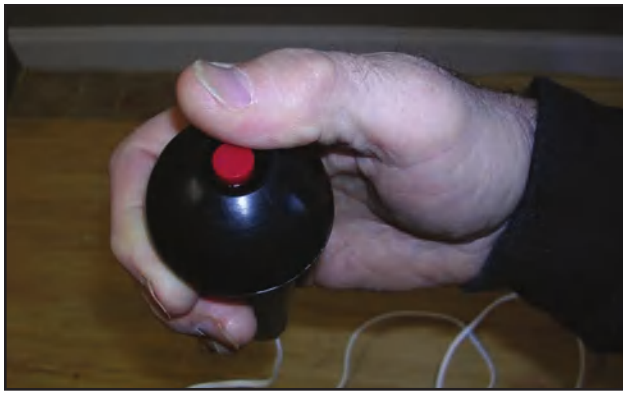
**Those with a manual transmission can use this gear shift with a switch at the top to turn on/off the exhaust brake. Trick, eh?**
