# TURBO DIESEL Buyer's Guide

A Publication of the *Turbo Diesel Register*

## A WORD ABOUT THE TURBO DIESEL BUYER'S GUIDE

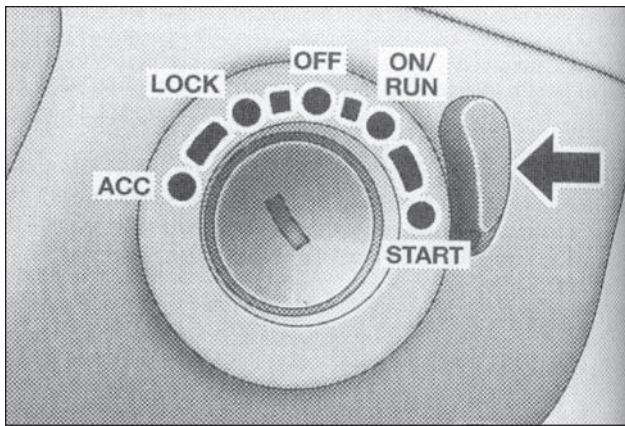
***I'll save you the time finding the photobucket video. The technique is the same as it has been since 1994. (I think it is that long ago.) Here is a diagram from your owner's Manual so that we're using the same words.***

**Using Dodge's vernacular, here is the method:**

- Insert key
- Move it from Lock to Off, pause
- Move to On/Run
- Back to Off
- Move to On/Run
- Back to Off
- Move to On/Run and stop

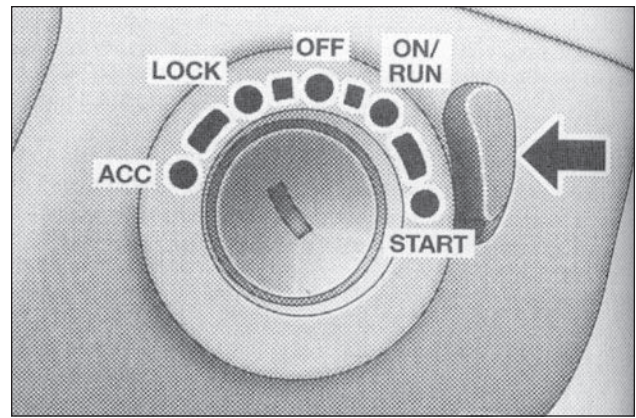
I'll save you the time finding the photobucket video. The technique is the same as it has been since 1994. (I think it is that long ago.) Here is a diagram from your owner's Manual so that we're using the same words.

Using Dodge's vernacular, here is the method:

- Insert key
- Move it from Lock to Off, pause
- Move to On/Run
- Back to Off
- Move to On/Run
- Back to Off
- Move to On/Run and stop

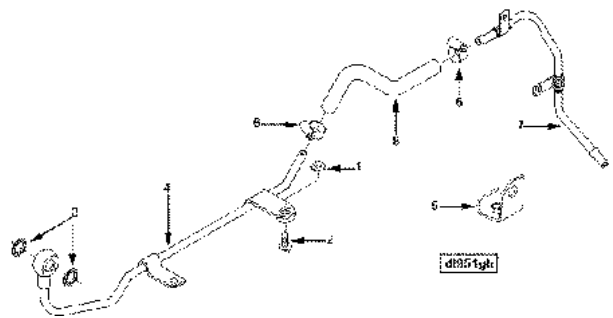
Look closely for the problematic fuel return line.
