Part 1: Change the CCV Filter

"Perform Service" at 67,500 miles

Part 2: Clean the EGR Valve (2007.5-2018) 2019-up EGR Valve cannot be cleaned.

Part 3: Remove and Clean the EGR Cooler

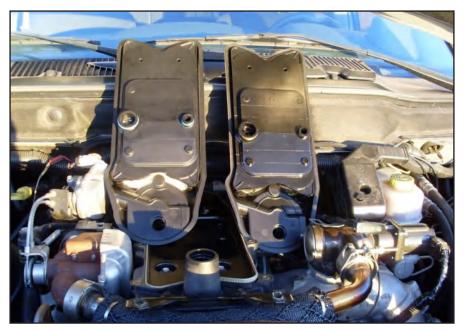
New CCV filter on the left. At 30,000 miles the CCV filter on the right looked clean and was reinstalled.

- · Replace the CCV filter.
- · Reassemble in reverse order.

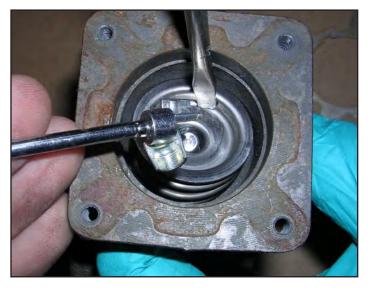
- Drop the EGR housing and valve into the cleaning solution for an overnight soak.
- Remove and do a preliminary clean-up with a toothbrush.

For complete cleaning you'll want to disassemble the EGR valve from the housing. The procedure is as follows:

- Using your fingers, a screwdriver or a socket, press down on the valve spring retainer.
- With the retainer pressed completely down the valve keepers should release from the valve. A light tap with a screwdriver or magnetic pick up tool may be needed.
- · Remove the retainer and keepers.
- The valve can now move freely. Clean the valve and the valve seats. We used a toothbrush and a Scotchbrite pad for cleaning.
- Reassemble the EGR valve. The valve motor is not indexed. Reassemble it so that its connector is pointed towards the front of the truck.
- Reassemble the EGR valve back onto the air intake.

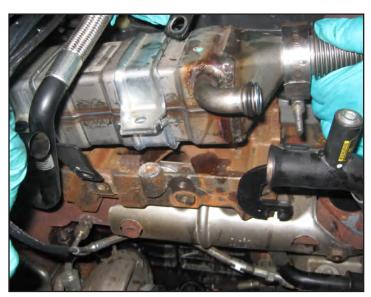
Our task is to remove and clean the EGR cooler assembly. This is the "before" picture.

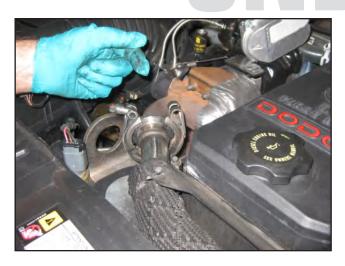
- On the passenger side of the engine, remove the 11mm nut from the clamp that holds the EGR cooler assembly to the exhaust gas crossover pipe.
- Remove the 8mm bolt at the front of the engine that holds the crossover pipe in place. Removing this bolt loosens the crossover pipe giving you room to wiggle the pipe to an out-of-the-way location.

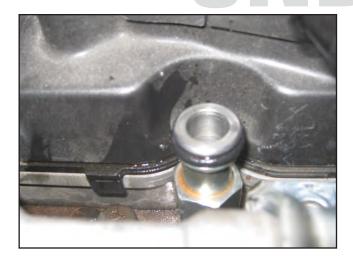
• Now that the coolant tube is completely loose. Pull the tube up off of the vertical fitting that is on the cylinder head.

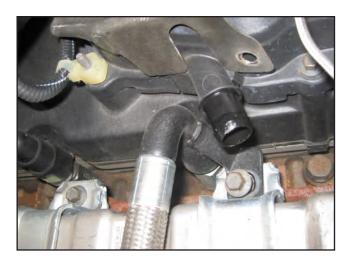
• Remove the CCV hose from over the EGR cooler.

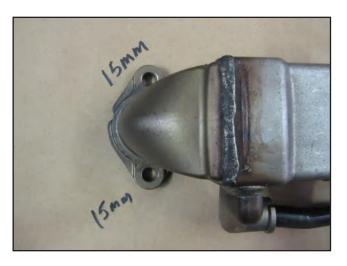
- Remove two 15mm nuts that hold the EGR cooler onto the exhaust manifold. Yes, these are hard to reach.
- Lift the cooler off of the exhaust manifold.
